# Dynamic Modulus of Cold-in-Place Recycling (CIR) Material

Md Rashadul Islam, Sylvester A. Kalevela and Jill A. Rivera

Report No. CDOT 2018-13  
May 2018

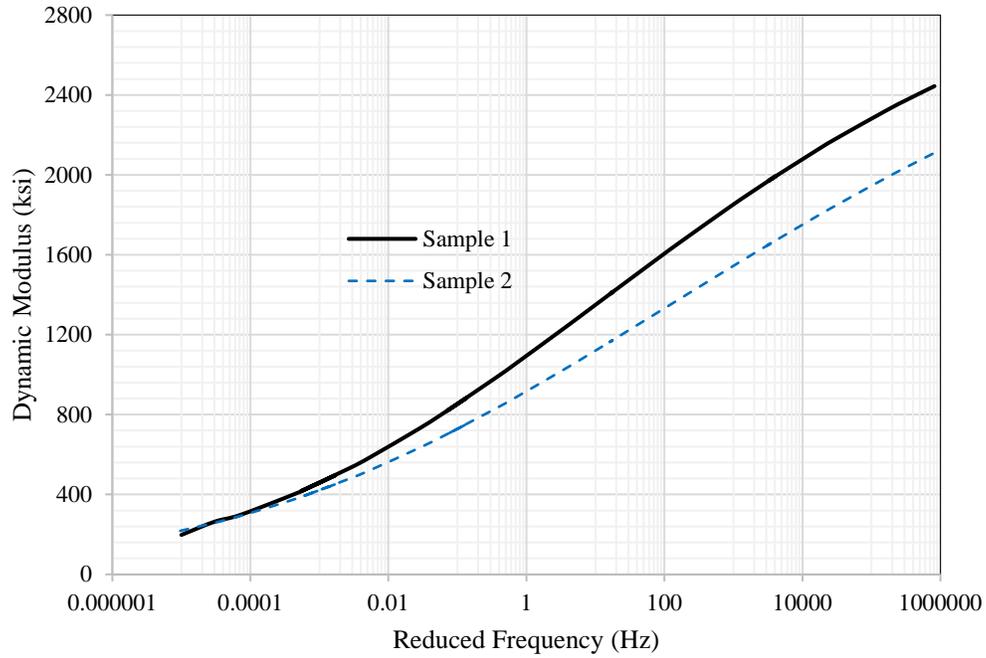
**Figure 94. Dynamic Moduli of Samples from West of Mack**

Two CIR cores were tested for this site. The sample-wise modulus and the average modulus are listed in Table 12. Figure 94 also shows the dynamic moduli variation with the reduced frequency of both samples.

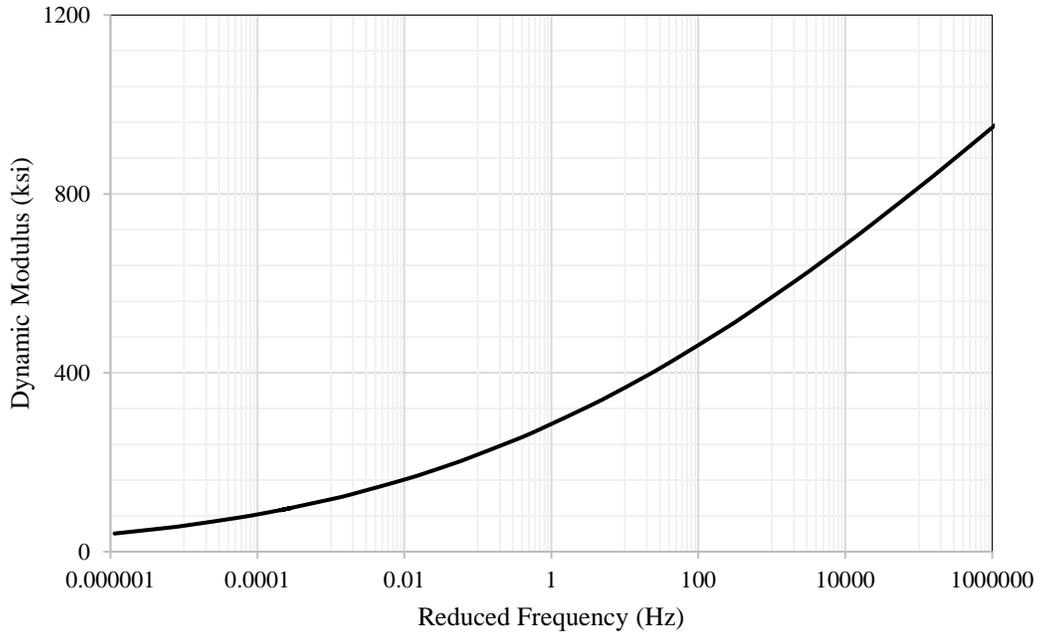
**Figure 95. Dynamic Moduli of One Sample from Fruita to Clifton**

One CIR cores was tested for this site. The sample-wise modulus and the average modulus are listed in Table 13. Figure 95 also shows the dynamic moduli variation with the reduced frequency of the sample tested.

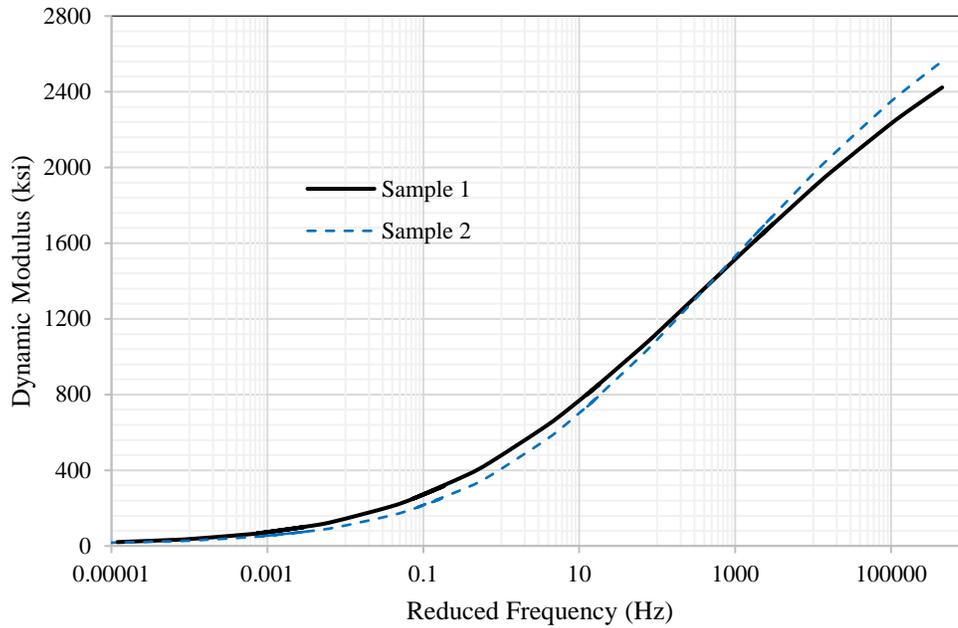
**Figure 96. Dynamic Moduli of Samples from Delta East**

Two CIR cores were tested for this site. The sample-wise modulus and the average modulus are listed in Table 14. Figure 96 also shows the dynamic moduli variation with the reduced frequency of both samples.

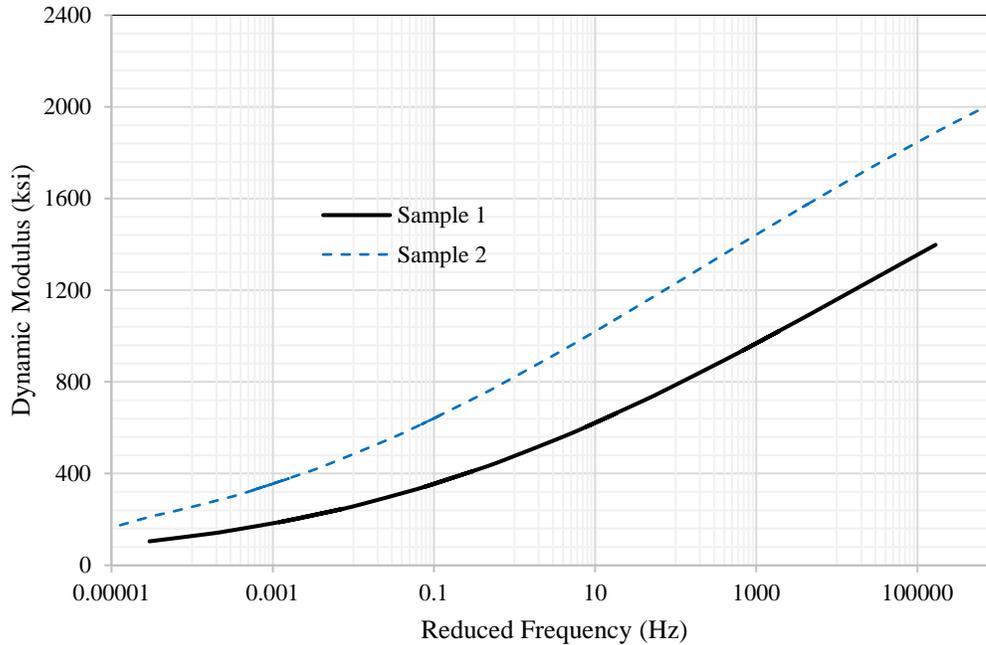
**Figure 97. Dynamic Moduli of Samples from North of Hotchkiss**

Two CIR cores were tested for this site. The sample-wise modulus and the average modulus are listed in Table 15. Figure 97 also shows the dynamic moduli variation with the reduced frequency of both samples.

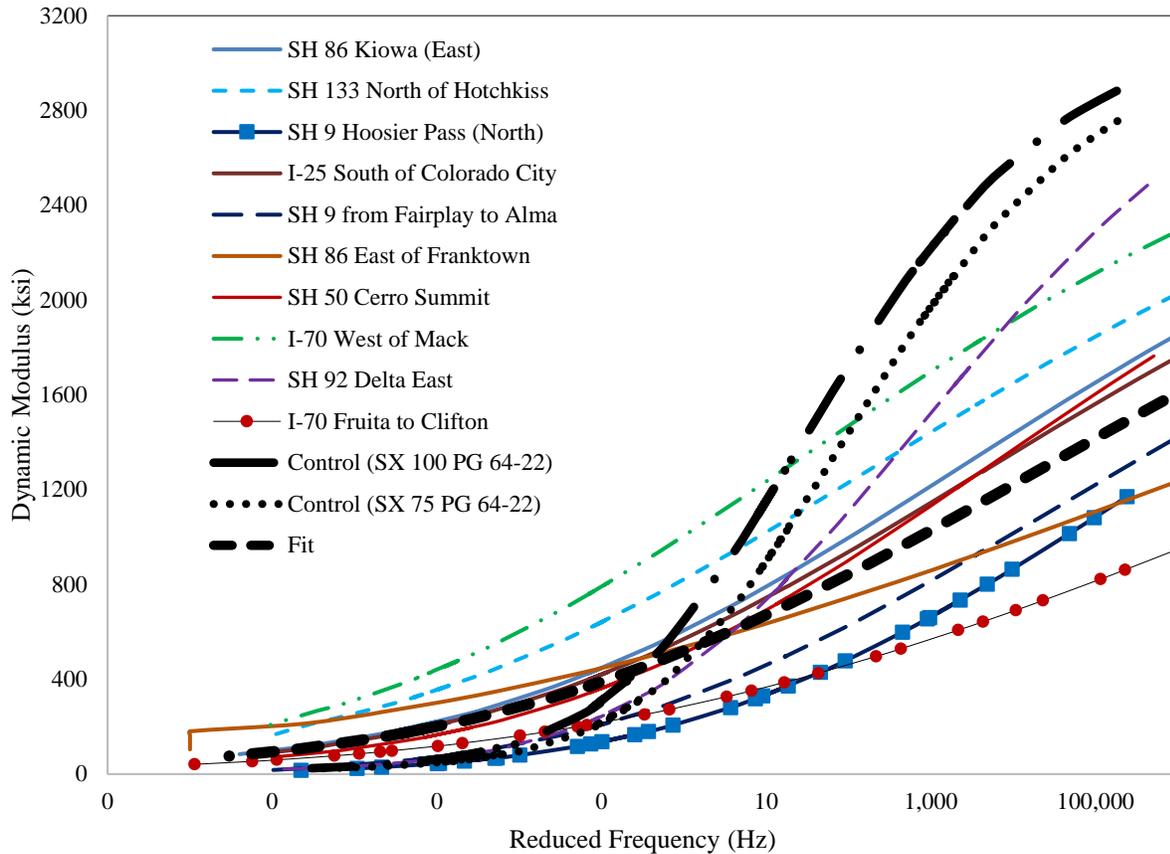
**Figure 98. Dynamic Moduli of all Mixes Including Conventional Mixtures**

The dynamic moduli for all fitted data for all 10 sites have been plotted in Figure 98. The figure also has two conventional [SX(100) PG 64-22 and SX(75) PG 64-22] mixtures’ dynamic moduli for the comparison. Figure 98 shows that at lower reduced frequency (or higher temperature zone), the dynamic moduli of CIR materials are higher than that of the control mixture. At higher reduced frequency (or lower temperature), the dynamic moduli of CIR materials are smaller (roughly 50%) than that of the control mixture. This means CIR is more susceptible to rutting but less susceptible to cracking compared to conventional mixtures. The fitted dynamic moduli (named as ‘Fit’ in Figure 98), lies almost in the middle of the all dynamic moduli range. The fitted dynamic modulus

data can be used by CDOT for future CIR overlay design. As full details of CIR of individual sites are not available, different dynamic moduli values for different CIR mixes cannot be recommended.

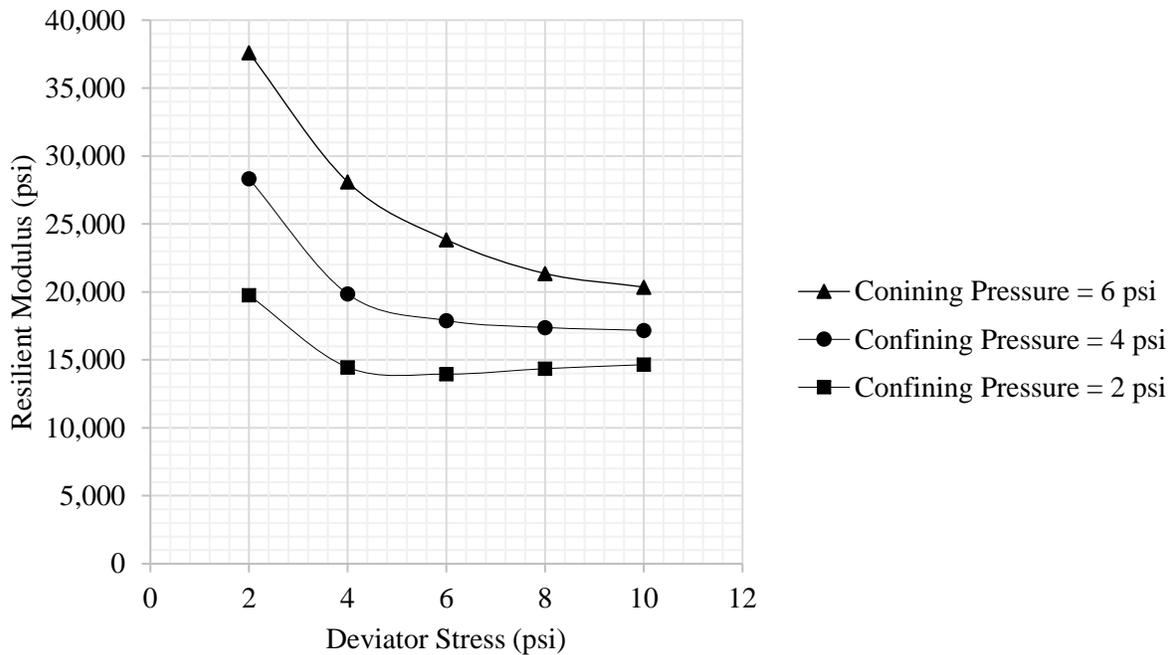
**Figure 99. Resilient Modulus of the Blended Base and Subgrade at SH 9 from Fairplay to Alma Subgrade**

**Site #1 SH 9 From Fairplay to Alma.** The base and subgrade materials were blended to determine the resilient modulus which is presented in Table 19 and Figure 99. The resilient modulus increases with cell pressure because as the cell pressure increases, the confinement increases which resists deformation. Consequently, the resilient modulus increases. Thus, the resilient modulus decreases with an increase in deviator stress. A decreasing resilient modulus occurs when a soil has a clayey component and shear deformation occurs upon applying a load.

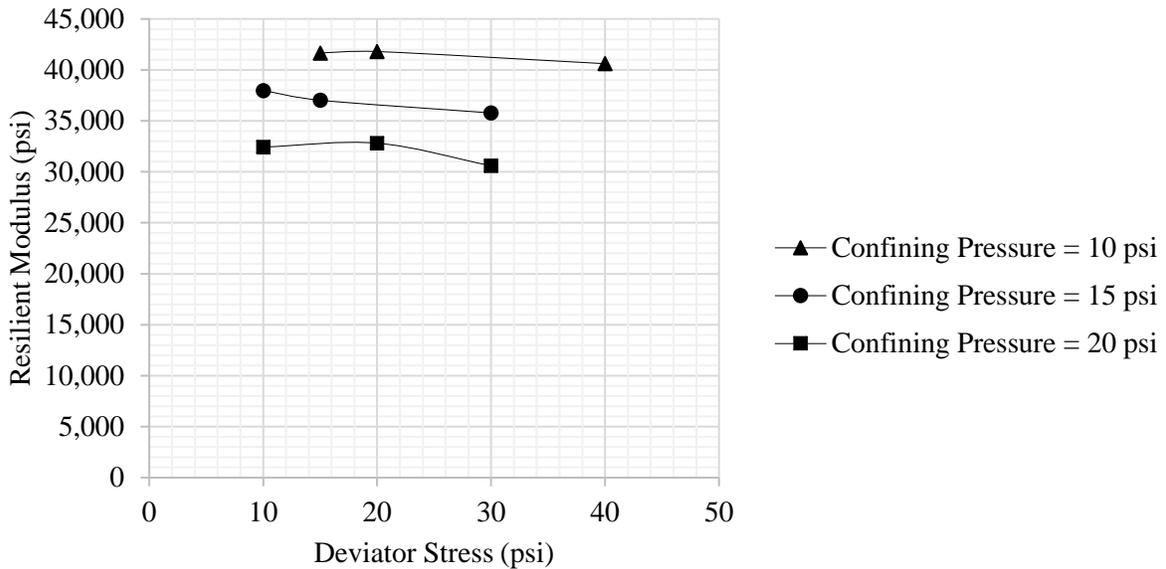
**Figure 100. Resilient Modulus of the Subgrade at SH 9 Hoosier Pass.**

**Site #2 SH 9 Hoosier Pass.** For this site, only subgrade material was found, and the resilient modulus is presented in Table 20 and Figure 100.

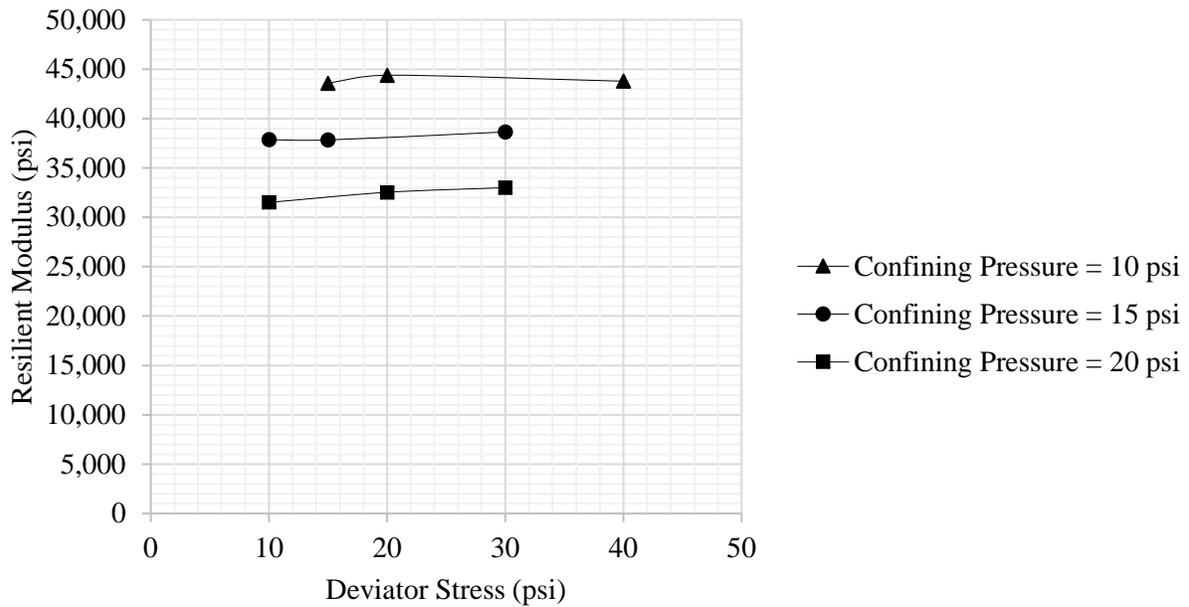
**Figure 101. Resilient Modulus of the Subgrade at SH 86 Franktown.**

**Site #3 SH 86 East of Franktown.** The resilient modulus of the subgrade of this site is presented in Table 21 and Figure 101.

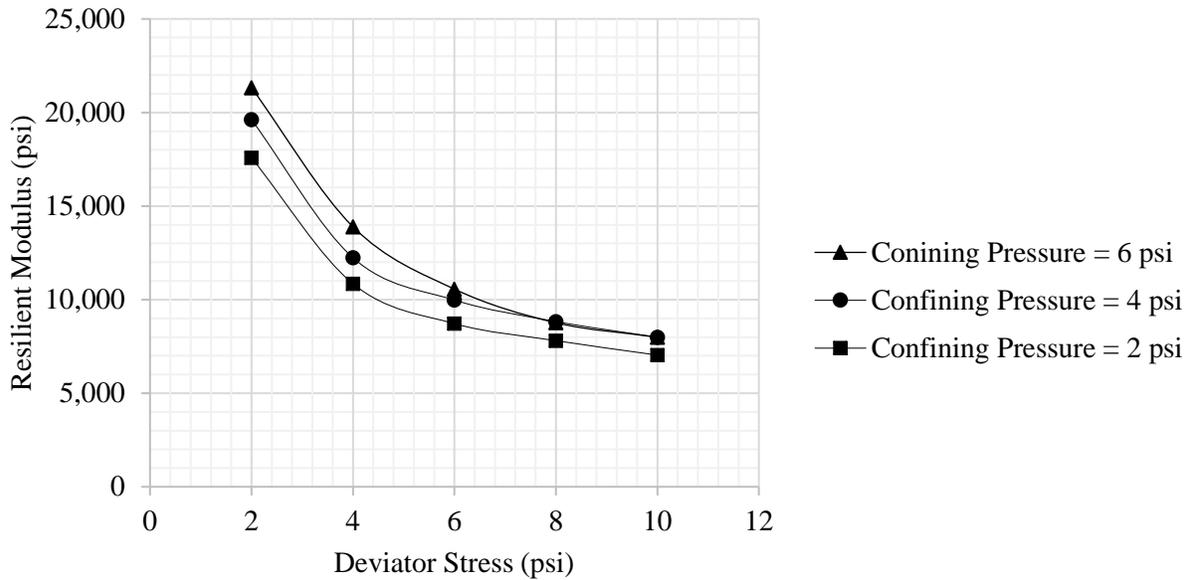
**Figure 102. Resilient Modulus of the Subgrade at SH 86 Kiowa (Eastbound).**

**Site #4 SH 86 Kiowa (Eastbound).** The resilient modulus of the subgrade of this site is presented in Table 22 and Figure 102.

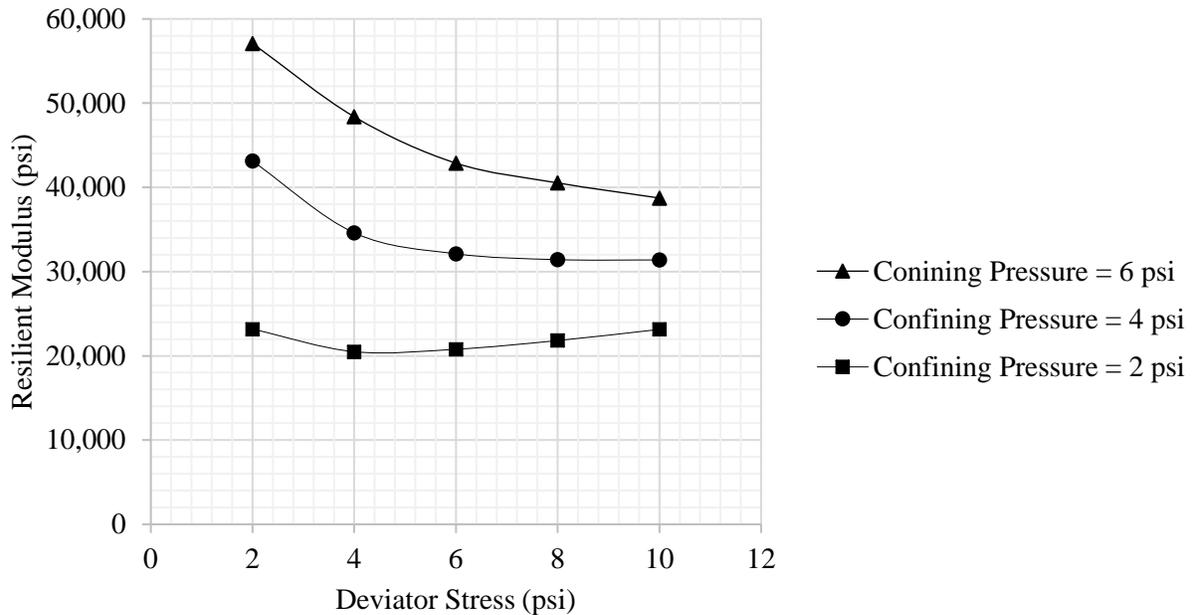
**Figure 103. Resilient Modulus of the Subgrade at I-25 South of Colorado City.**

**Site #5 I-25 South of Colorado City.** The resilient modulus of the subgrade of this site is presented in Table 23 and Figure 103.

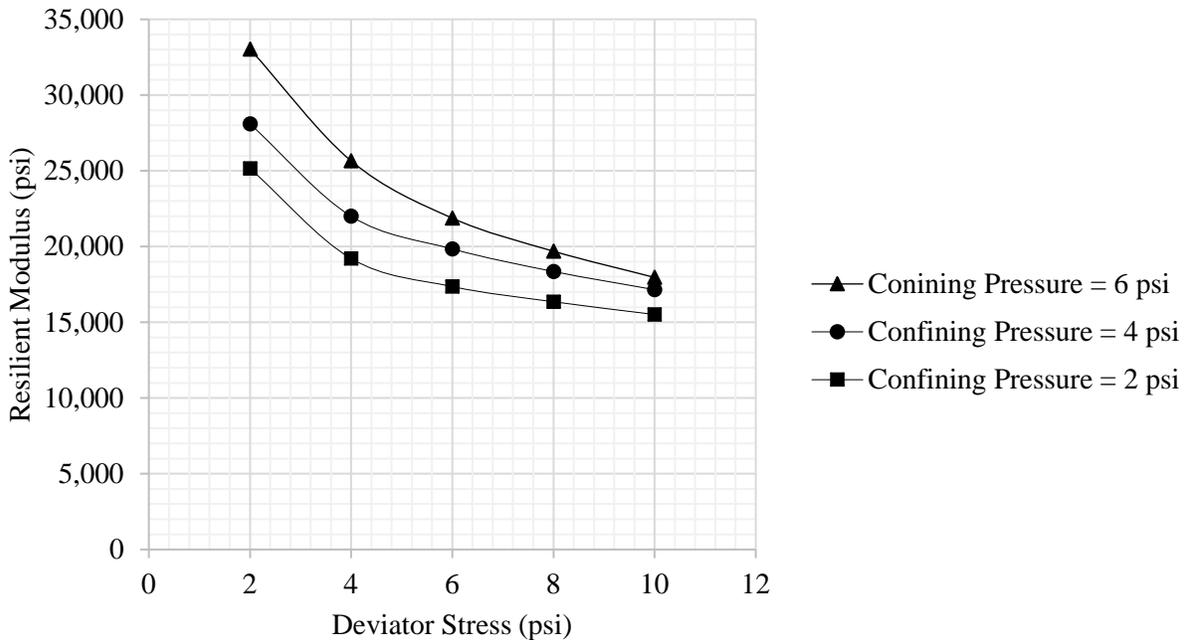
**Figure 104. Resilient Modulus of the Subgrade.**

**Site #6 SH 50 Cerro Summit.** The resilient modulus of the subgrade of this site is presented in Table 24 and Figure 104.

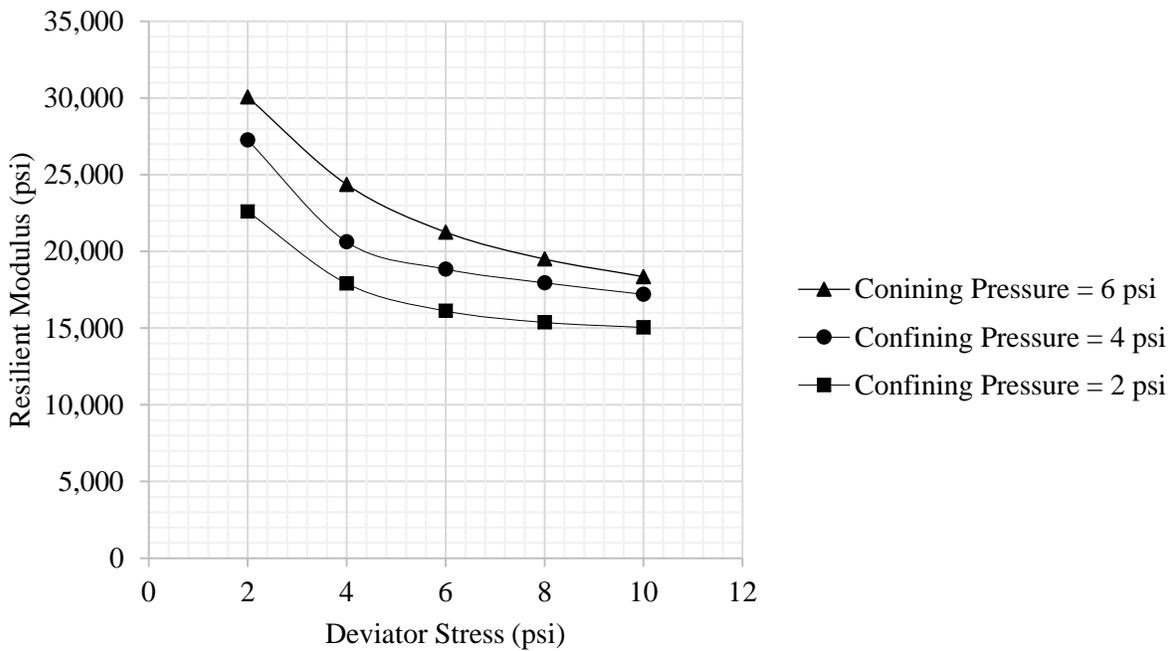
**Figure 105. Resilient Modulus of the Subgrade at I-70 West of Mack.**

**Site #7 I-70 West of Mack.** The resilient modulus of the subgrade of this site is presented in Table 25 and Figure 105.

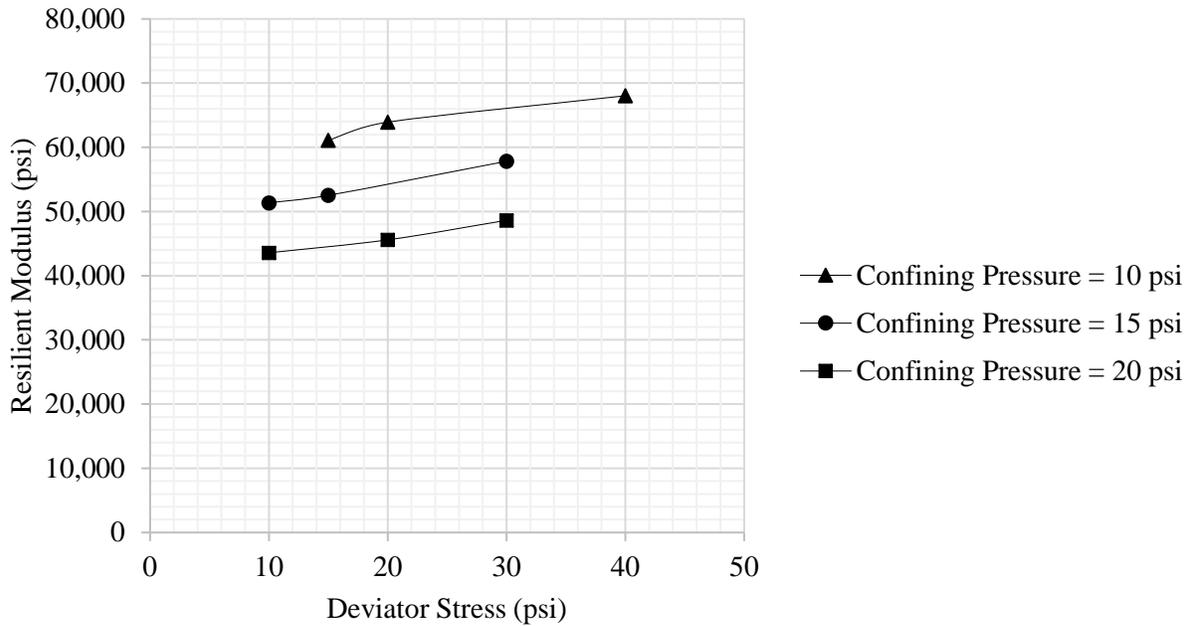
**Figure 106. Resilient Modulus of the Subgrade at I-70 Fruita to Clifton.**

**Site #8 I-70 Fruita to Clifton.** The resilient modulus of the subgrade of this site is presented in Table 26 and Figure 106.

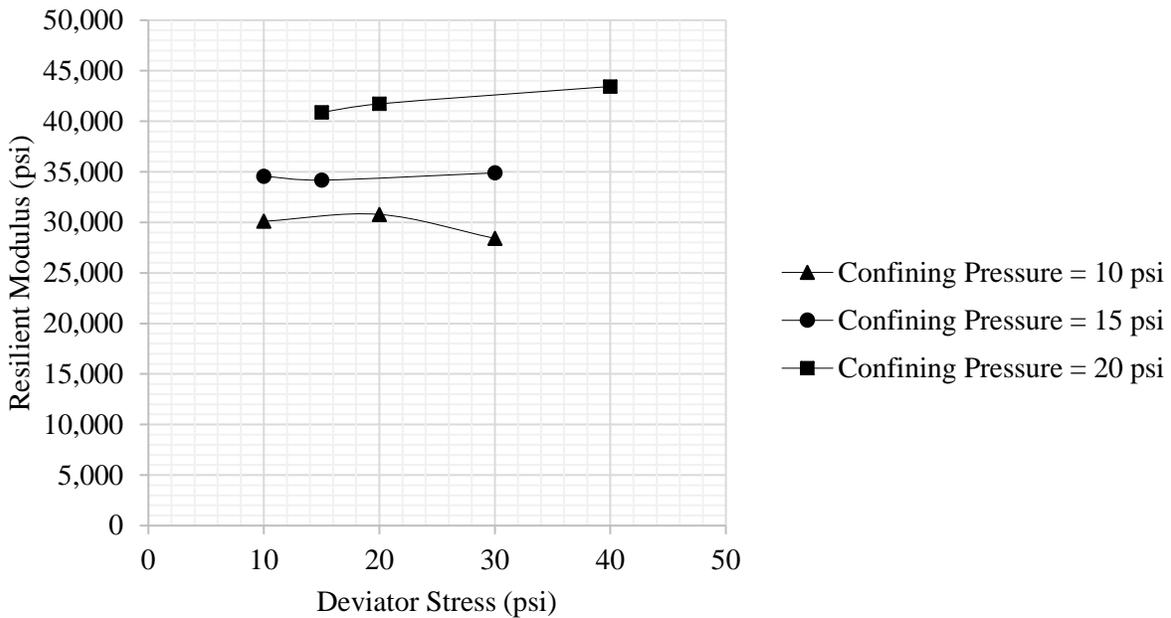
**Figure 107. Resilient Modulus of the Subgrade at SH 92 Delta (Eastbound)**

**Site #9 SH 92 Delta East.** For this site, the base and subgrade materials could be separated, and the resilient moduli were determined separately. The resilient modulus of the subgrade of this site is presented in Table 27 and Figure 107.

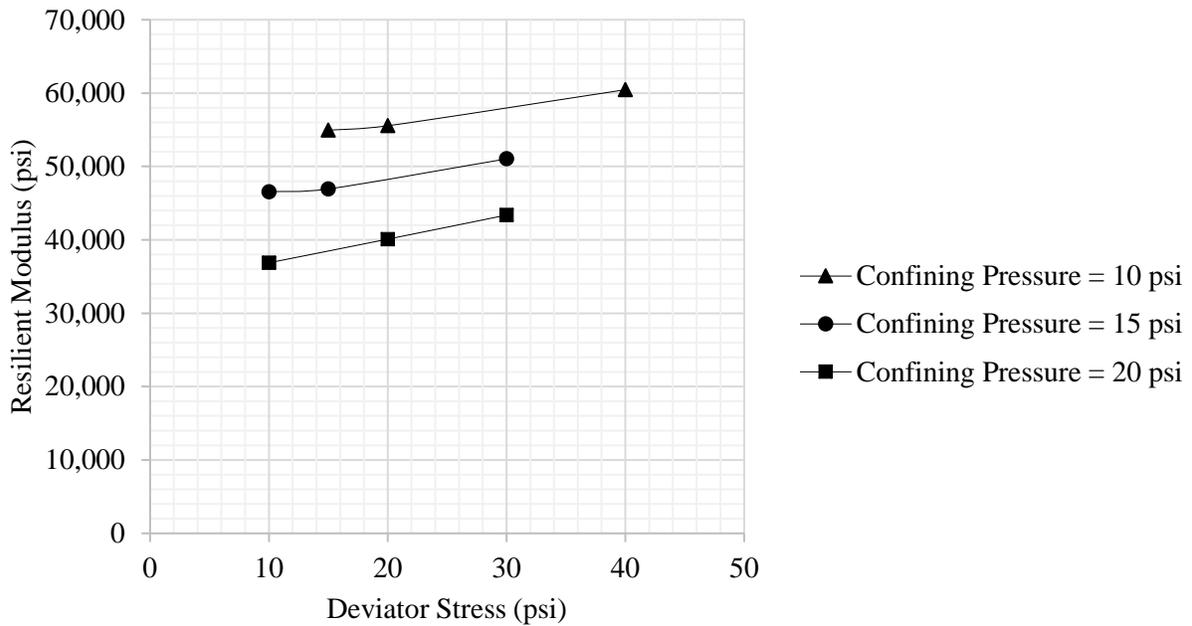
**Figure 108. Resilient Modulus of the Base at SH 92 Delta (Eastbound)**

The resilient modulus of the base of this site is presented in Table 28 and Figure 108.

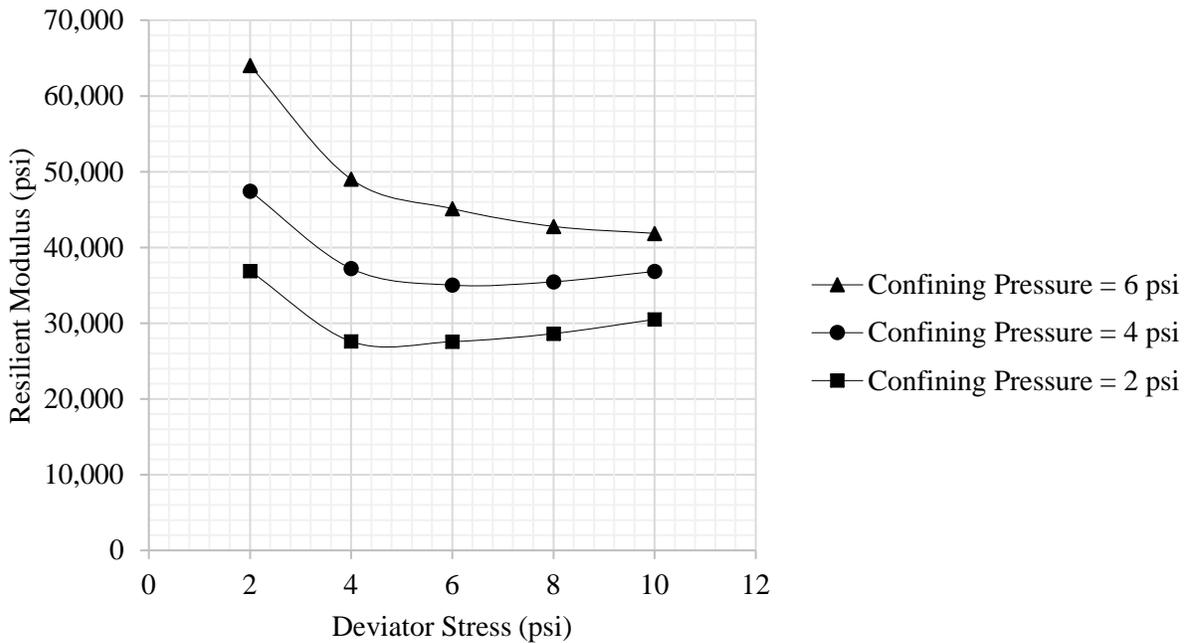
**Figure 109. Resilient Modulus of the Subgrade at SH 133 Hotchkiss.**

**Site #10 SH 133 Hotchkiss.** For this site, the base and subgrade materials could be separated, and the resilient moduli were determined separately. The resilient modulus of subgrade is presented in Table 29 and Figure 109.

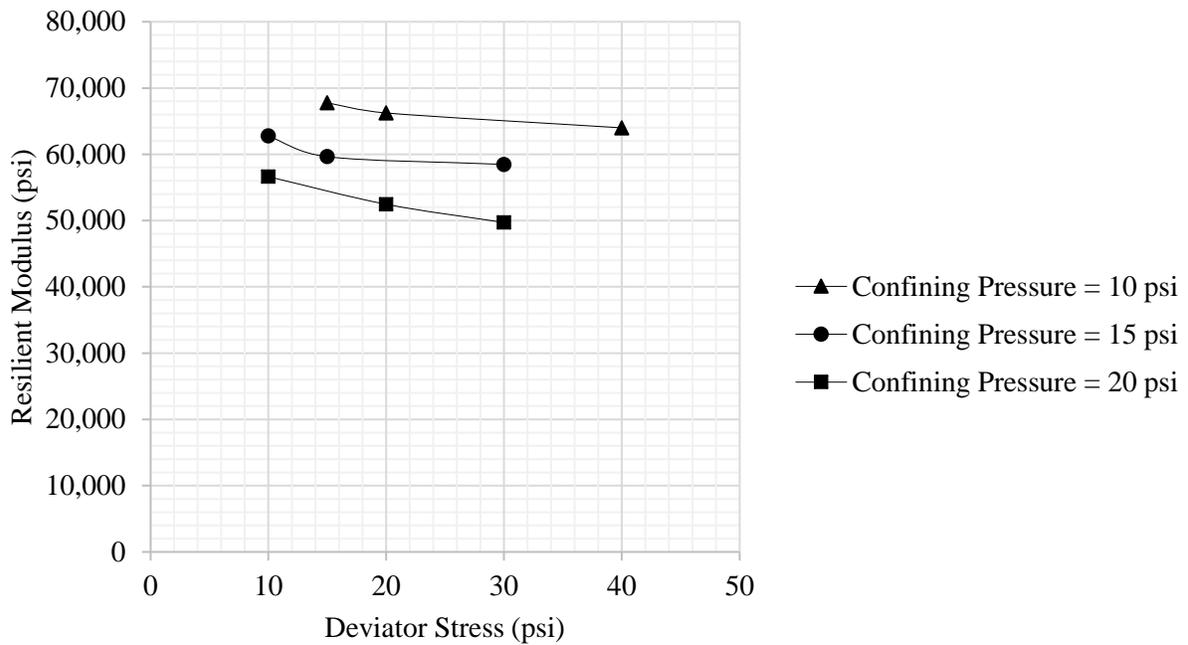
**Figure 110. Resilient Modulus of the Base at SH 133 Hotchkiss.**

The resilient modulus of the base of this site is presented in Table 30 and Figure 110.

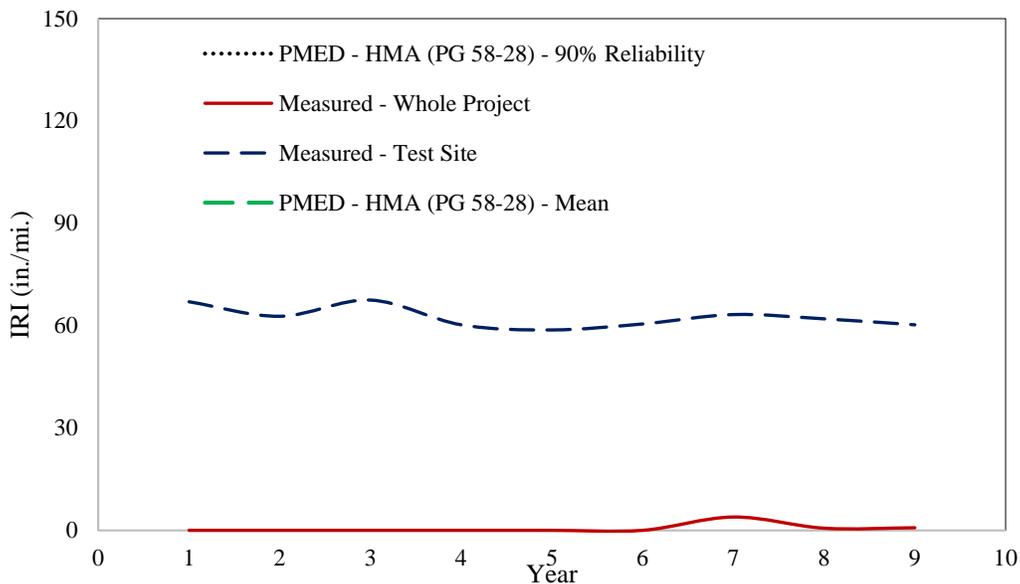
**Figure 111. IRI at SH 9 from Fairplay to Alma Showing Amount of Measured and PMED Predicted IRI**

The PMED analysis using the CIR material was not possible for this site. Figure 111 shows the PMED-90% Reliability using the HMA SX (75) PG 58-28 are slightly higher than the measured IRI values. The PMED-Mean IRI values using the HMA SX (75) PG 58-28 are closer to the measured IRI values especially after 4 years versus the PMED-90% Reliability.

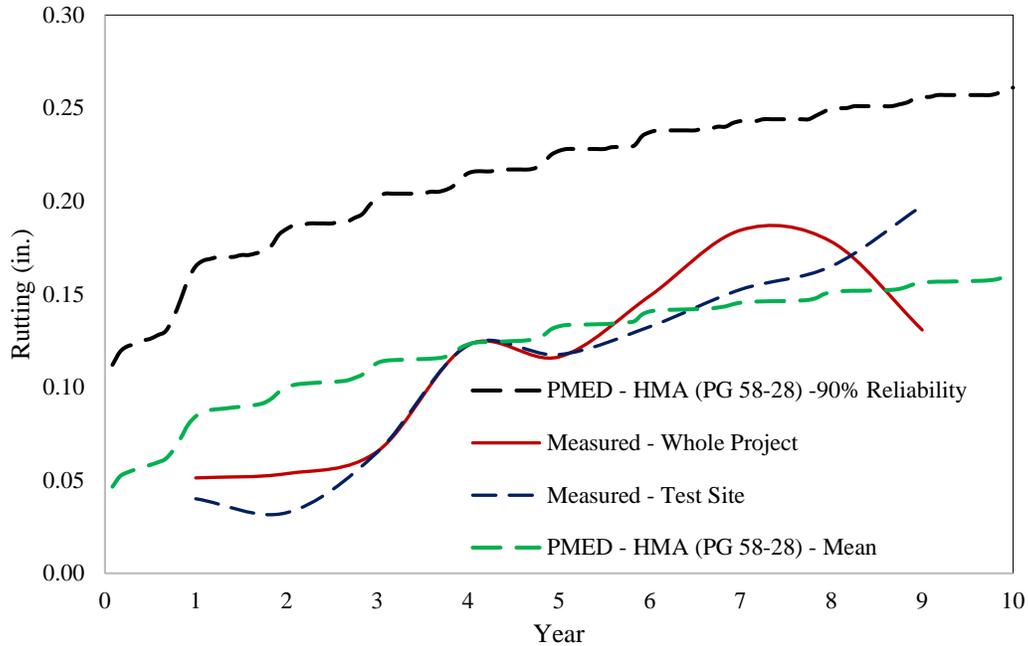
**Figure 112. Total Rutting at SH 9 from Fairplay to Alma Showing Amount of Measured and PMED Predicted Rutting**

The measured total rutting values are in good agreement with the PMED-predicted mean rutting values using the HMA SX(75) PG 58-28 compared to the PMED-predicted IRI at 90% reliability, Figure 112. The PMED-predicted rutting values at 90% reliability using the HMA SX (75) PG 58-28 are higher than the measured rutting values.

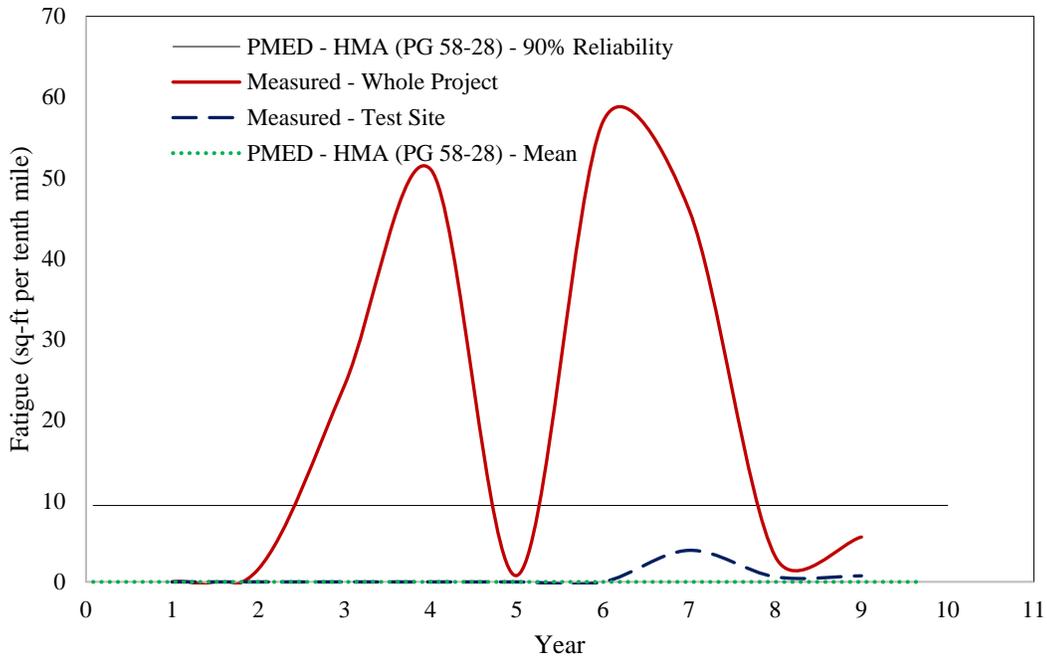
**Figure 113. Fatigue Cracking at SH 9 from Fairplay to Alma Showing Amount of Measured and PMED Predicted Cracking**

The measured fatigue cracking values on the whole project of SH 9 From Fairplay to Alma site are much higher than the PMED-predicted fatigue cracking values using the HMA SX (75) PG 58-28, Figure 113. The PMED-predicted fatigue cracking values by HMA SX (75) PG 58-28 mix at mean level is very small (close to zero), while at 90% reliability, it produces about 9.5 square feet per tenth-mile, which is due to the reliability.

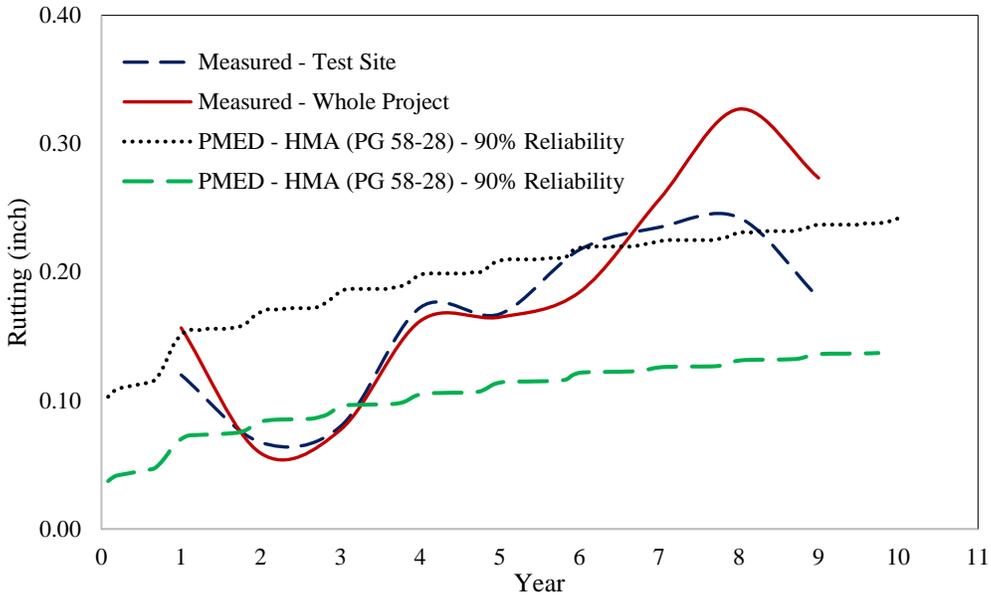
**Figure 114. IRI at Hoosier Pass (Northbound) Showing Amount of Measured and PMED Predicted IRI**

The measured and the PMED-predicted IRI of Hoosier Pass (Northbound) are presented in Figure 114 below. It shows the PMED-predicted IRI values at 90% reliability and the PMED-predicted mean IRI values using the HMA SX (75) PG 58-28 are lower than the measured IRI values. However, both the predicted and the measured IRI values tend to converge with time especially after 7 years.

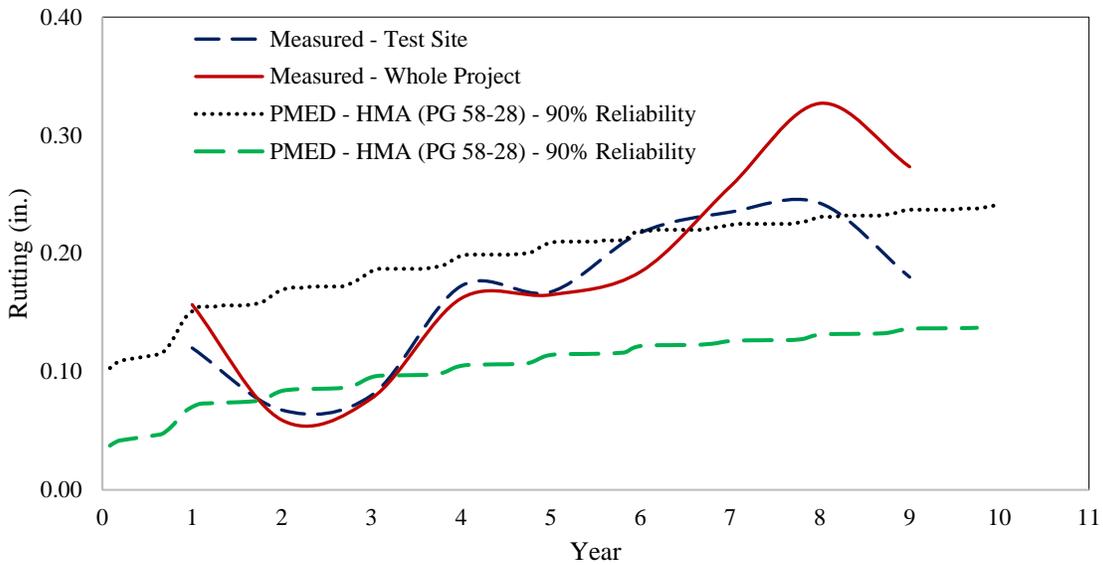
**Figure 115. Total Rutting at Hoosier Pass (Northbound) Showing Amount of Measured and PMED Predicted Rutting**

The measured and the PMED-predicted total rutting of Hoosier Pass (Northbound) are presented in Figure 115 below. The measured total rutting values are in good agreement with the PMED-predicted rutting values at 90% reliability using the HMA SX (75) PG 58-28 compared to the PMED-predicted mean rutting value. The PMED-predicted mean rutting values using the HMA SX (75) PG 58-28 are lower than the measured rutting values.

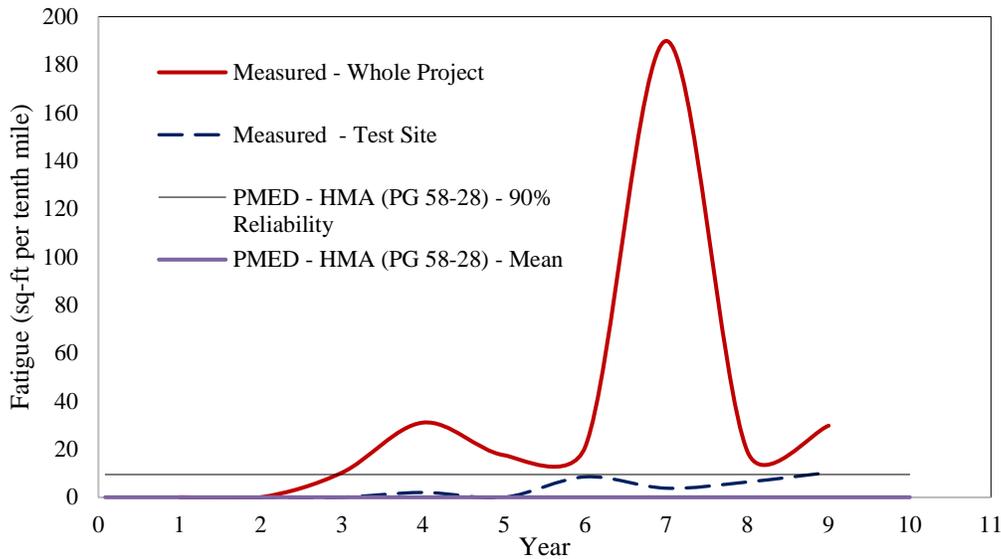
**Figure 116. Fatigue Cracking at Hoosier Pass (Northbound) Showing Amount of Measured and PMED Predicted Cracking**

The measured fatigue cracking values on the whole project of SH 9 Hoosier Pass (Northbound) site are much higher than the PMED-predicted fatigue cracking values using the HMA SX (75) PG 58-28, Figure 116. The PMED-predicted fatigue cracking values by HMA SX (75) PG 58-28 mix at mean level is very small (close to zero), while at 90% reliability, it produces about 9.5 square feet per tenth-mile, which is due to the reliability.

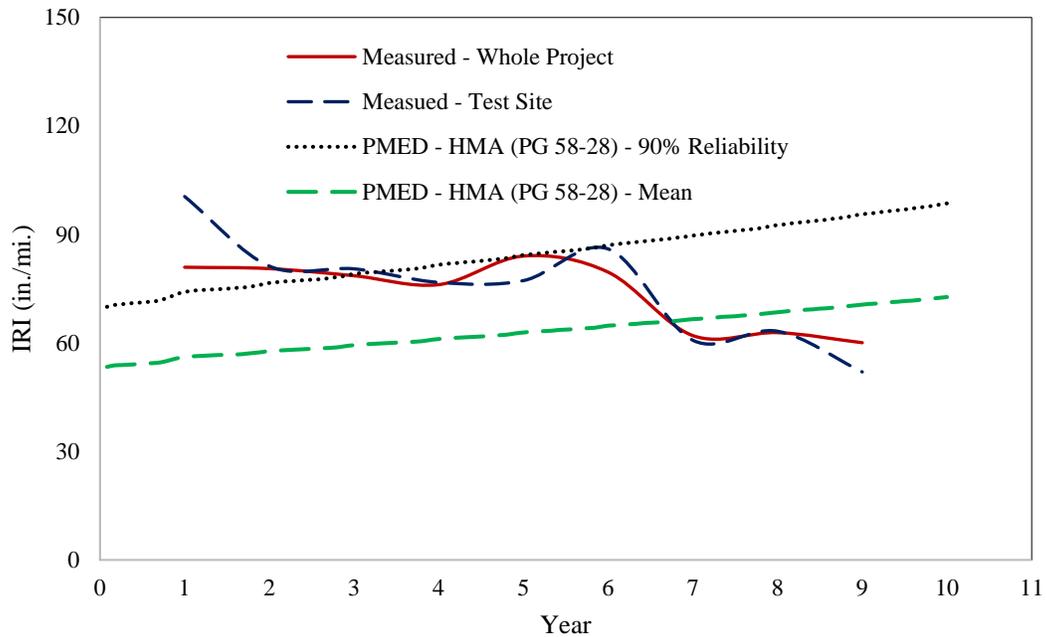
**Figure 117. IRI at SH 86 East of Franktown Showing Amount of Measured and PMED Predicted IRI**

The measured and the PMED-predicted IRI of SH 86 East of Franktown are presented in Figure 117 below. It shows the PMED-predicted IRI values both at mean level and at 90% reliability using the HMA SX (75) PG 58-28 are in good agreement with the measured IRI values.

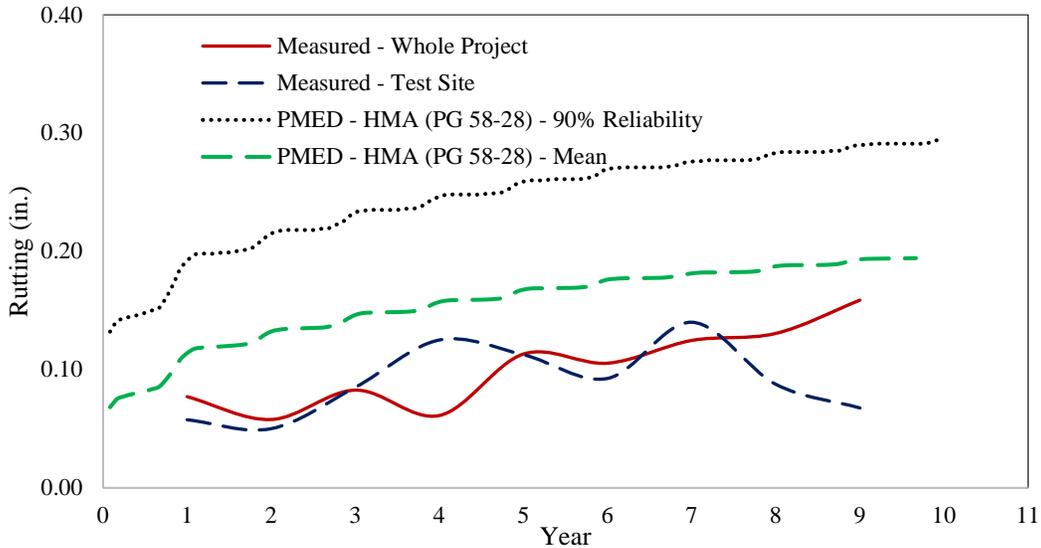
**Figure 118. Total Rutting at SH 86 East of Franktown Showing Amount of Measured and PMED Predicted Rutting**

The measured and the PMED-predicted total rutting of SH 86 East of Franktown are presented in Figure 118 below. The measured total rutting values are in good agreement with the PMED-predicted mean rutting values using the HMA SX (75) PG 58-28. The PMED-predicted rutting values at 90% reliability using the HMA SX (75) PG 58-28 are much higher than the measured rutting values.

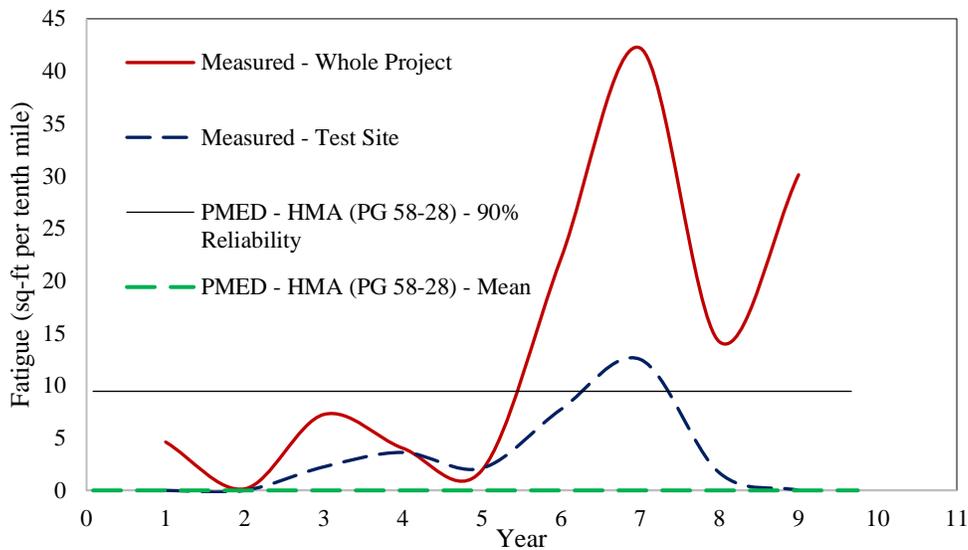
**Figure 119. Fatigue Cracking at SH 86 East of Franktown Showing Amount of Measured and PMED Predicted Cracking**

The measured fatigue cracking values on the whole project of SH 86 East of Franktown site are much higher than the PMED-predicted fatigue cracking values using the HMA SX (75) PG 58-28, Figure 119. The PMED-predicted fatigue cracking values by HMA SX (75) PG 58-28 mix at mean level is very small (close to zero), while at 90% reliability, it produces about 9.5 square feet per tenth-mile, which is due to the reliability.

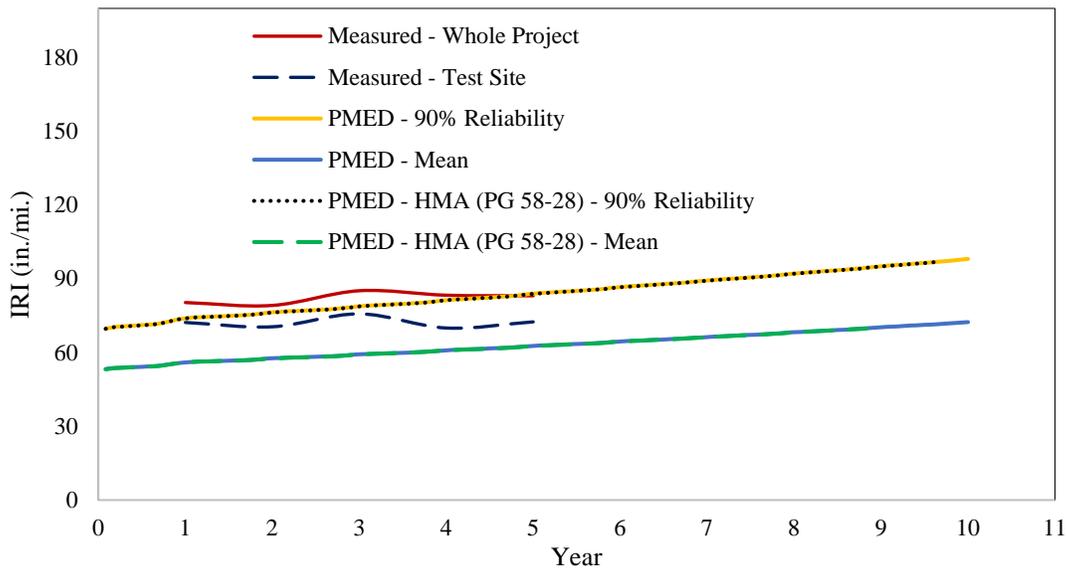
**Figure 120. IRI at SH 86 Kiowa (Eastbound) Showing Amount of Measured and PMED Predicted IRI**

The measured and the PMED-predicted IRI of SH 86 Kiowa (Eastbound) are presented in Figure 120 below. The first observation from this figure is that the PMED-outputs using the CIR and the HMA SX (75) PG 58-28 are almost the same. It also shows the PMED-predicted IRI values using both the CIR and the HMA SX (75) PG 58-28 at 90% reliability are in good agreement with the measured IRI values. The PMED-predicted mean IRI values using both the CIR and the HMA SX (75) PG 58-28 are lower than the measured IRI values.

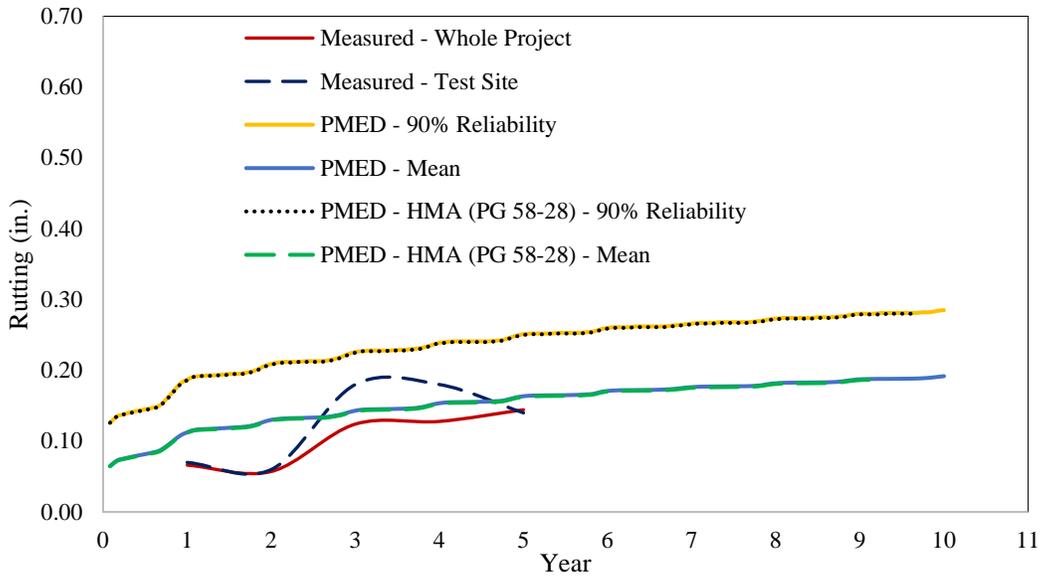
**Figure 121. Total Rutting at SH 86 Kiowa (Eastbound) Showing Amount of Measured and PMED Predicted Rutting**

The measured and the PMED-predicted total rutting of SH 86 Kiowa (Eastbound) are presented in Figure 121 below. The PMED-outputs using the CIR and the HMA SX (75) PG 58-28 are almost the same. The measured total rutting values are in good agreement with the PMED-predicted mean rutting values compared to the PMED-predicted IRI. The PMED-predicted rutting values at 90% reliability are higher than the measured rutting values.

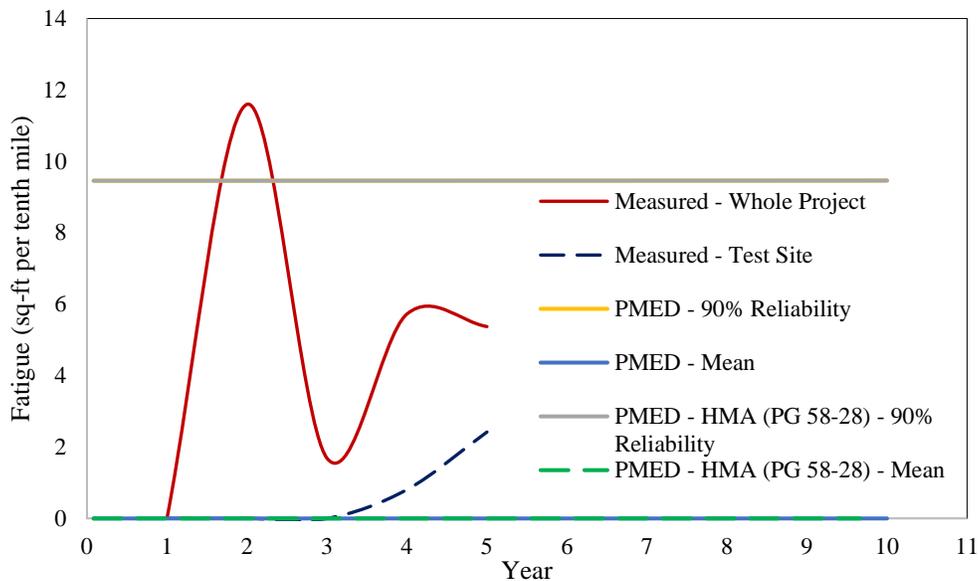
**Figure 122. Fatigue Cracking at SH 86 Kiowa (Eastbound) Showing Amount of Measured and PMED Predicted Cracking**

The measured and the PMED-predicted fatigue cracking of SH 86 Kiowa (Eastbound) are presented in Figure 122 below. The measured fatigue cracking values on the whole project are very similar to the PMED-predicted fatigue cracking values at 90% reliability. The PMED-predicted fatigue cracking values by HMA SX (75) PG 58-28 mix at mean level are very small (close to zero).
