# Dynamic Modulus of Cold-in-Place Recycling (CIR) Material

Md Rashadul Islam, Sylvester A. Kalevela and Jill A. Rivera

Report No. CDOT 2018-13  
May 2018

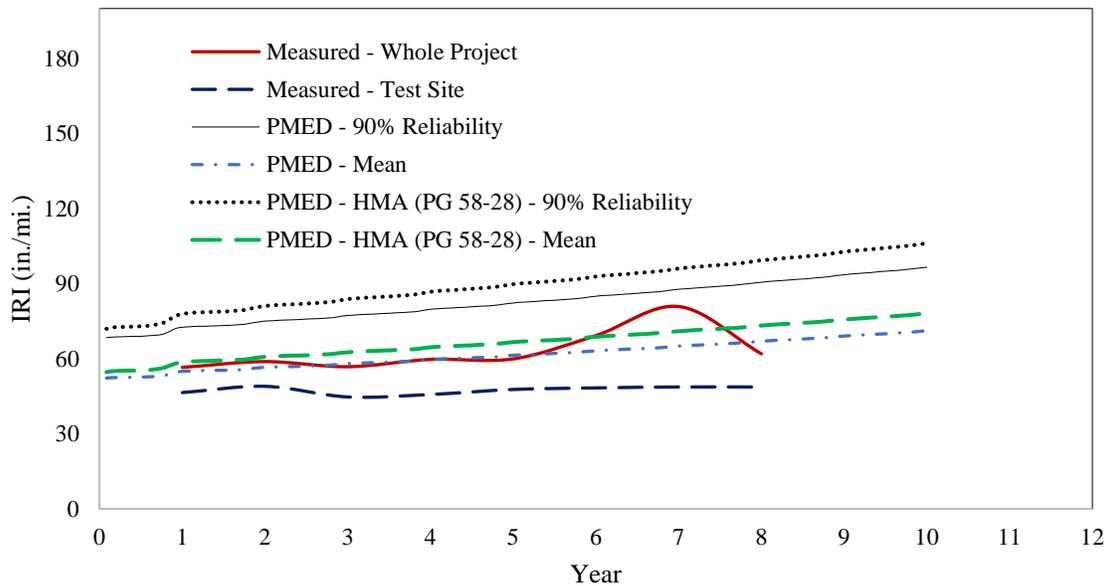
**Figure 123. IRI at I-25 South of Colorado City Showing Amount of Measured and PMED Predicted IRI**

The measured and the PMED-predicted IRI of I-25 South of Colorado City are presented in Figure 123 below. The PMED-outputs using the CIR and the HMA SX (75) PG 58-28 are similar, not the same as observed in the previous site. However, the HMA SX (75) PG 58-28 produces higher IRI compared to the CIR material. Figure 123 also shows the PMED-predicted IRI values at 90% reliability are higher than the measured IRI values. The PMED-predicted mean IRI values for both CIR and HMA SX (75) PG 58-28 consideration are in good agreement with the measured IRI values.

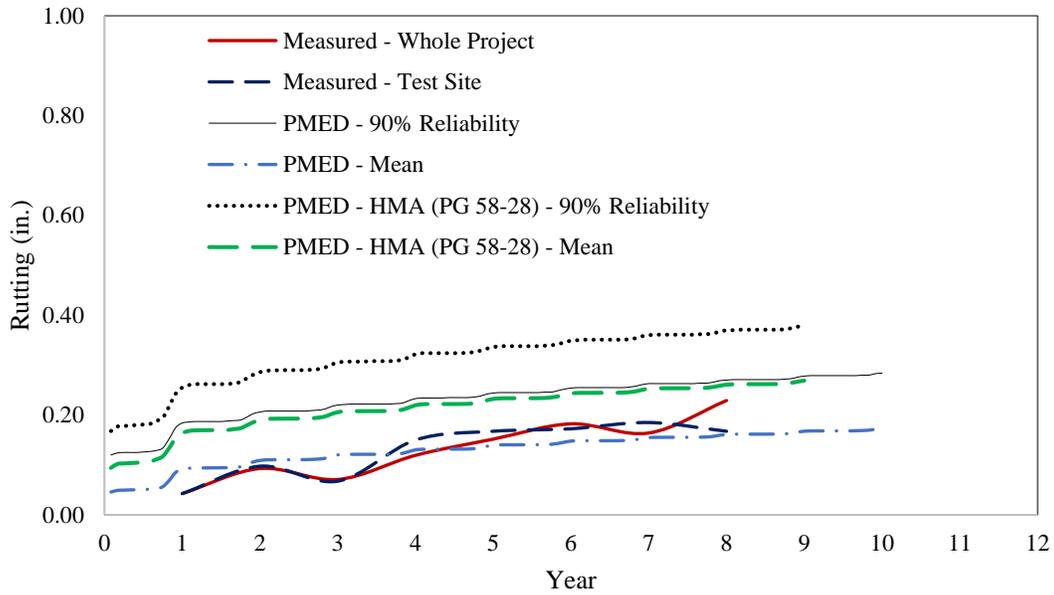
**Figure 124. Total Rutting at I-25 South of Colorado City Showing Amount of Measured and PMED Predicted Rutting**

The measured and the PMED-predicted total rutting of I-25 south of Colorado City are presented in Figure 124 below. The measured total rutting values are in good agreement with the PMED-predicted mean rutting values compared to the PMED-predicted IRI at 90% reliability. The PMED-predicted rutting values at 90% reliability for both HMA and CIR conditions are higher than the measured rutting values.

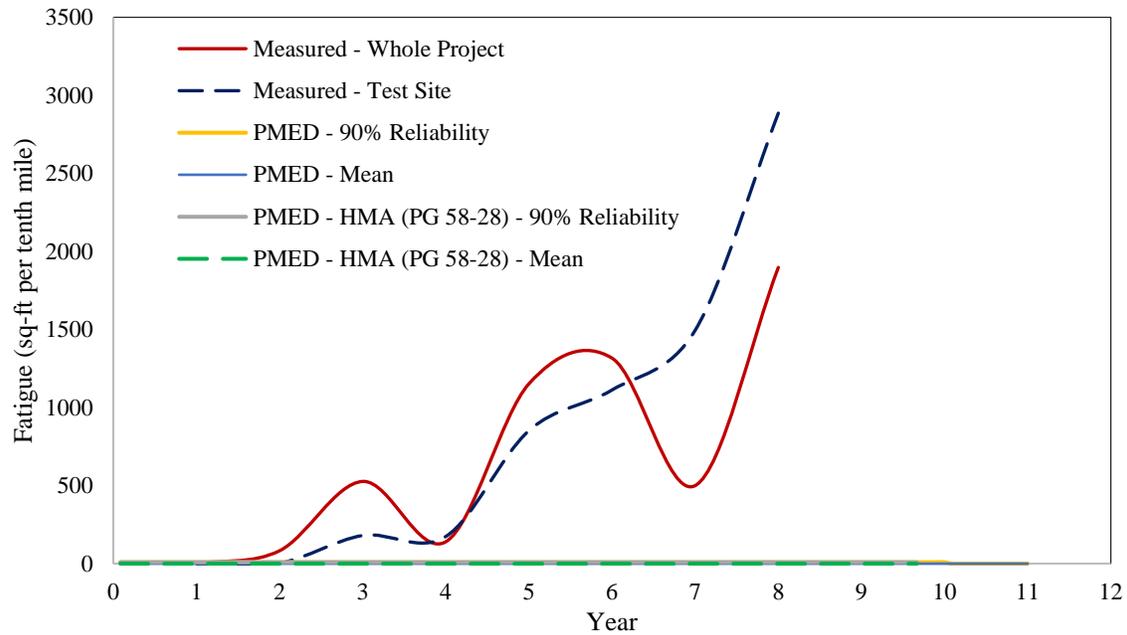
**Figure 125. Fatigue Cracking at I-25 South of Colorado City Showing Amount of Measured and PMED Predicted Cracking**

The measured and the PMED-predicted fatigue cracking of I-25 south of Colorado City are presented in Figure 125 below. The measured fatigue cracking values on the whole project and test site are much higher than the PMED-predicted fatigue cracking values for any consideration. The PMED-predicted fatigue cracking values by both HMA and CIR mix at mean level are very small (close to zero), while at 90% reliability, they produce about 9.5 square feet per tenth-mile.

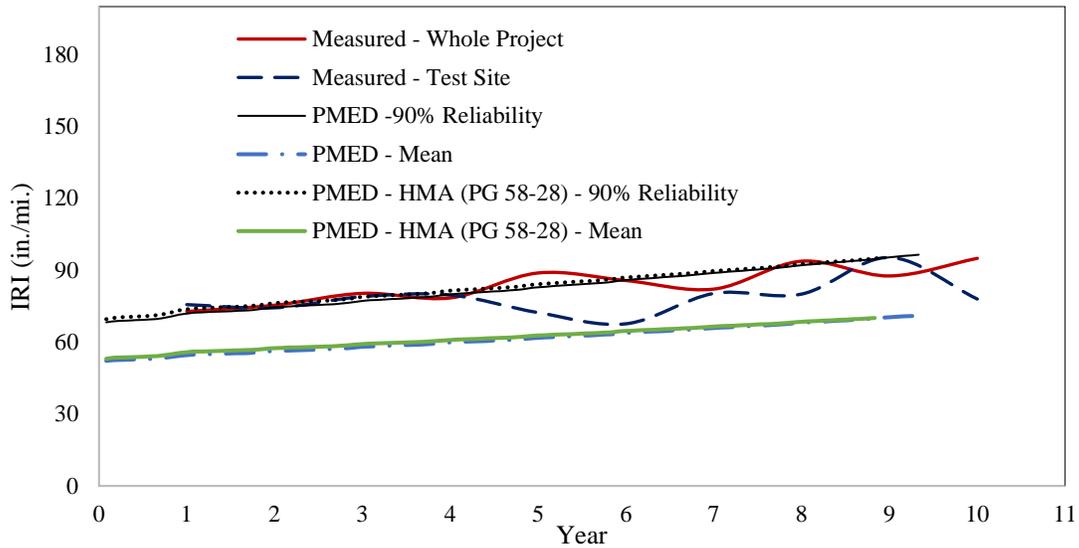
**Figure 126. IRI at SH 50 Cerro Showing Amount of Measured and PMED Predicted IRI**

The measured and the PMED-predicted IRI of SH 50 Cerro Summit are presented in Figure 126 below. The first observation from this figure is that the PMED-outputs using the CIR and the HMA SX (75) PG 58-28 are almost the same. The measured IRI values are bounded by the PMED-predicted IRI values at 90% reliability level and at mean level. However, the PMED-predicted IRI values at 90% reliability are in better agreement with the measured IRI values compared to the PMED-predicted mean IRI values.

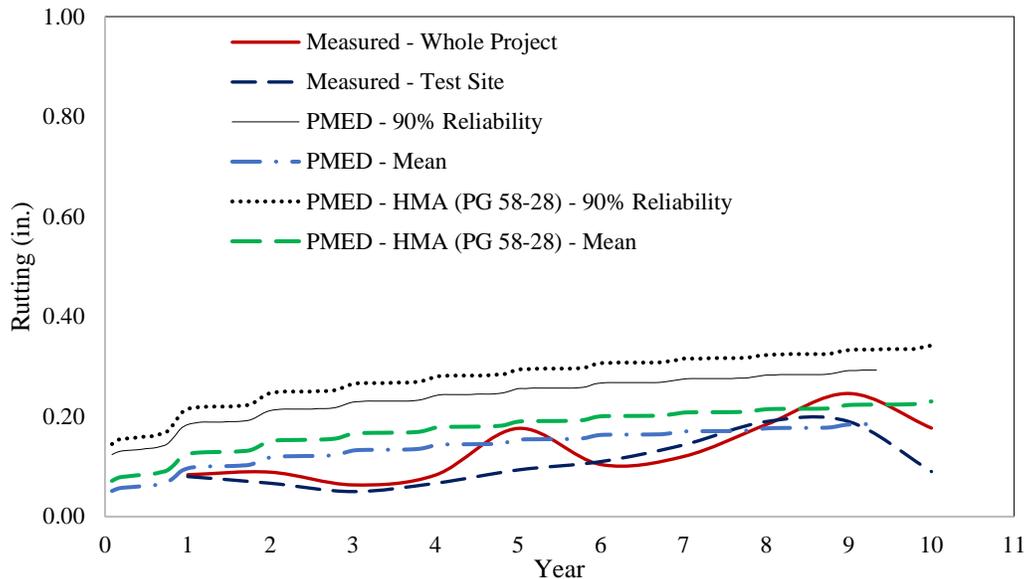
**Figure 127. Total Rutting at SH 50 Cerro Summit Showing Amount of Measured and PMED Predicted Rutting**

The measured and the PMED-predicted total rutting of the SH 50 Cerro Summit are presented in Figure 127 below. The measured total rutting values are very close to the PMED-predicted mean rutting values; the PMED-predicted rutting values at 90% reliability are higher than the measured values (similar to the previous site (Site #5)).

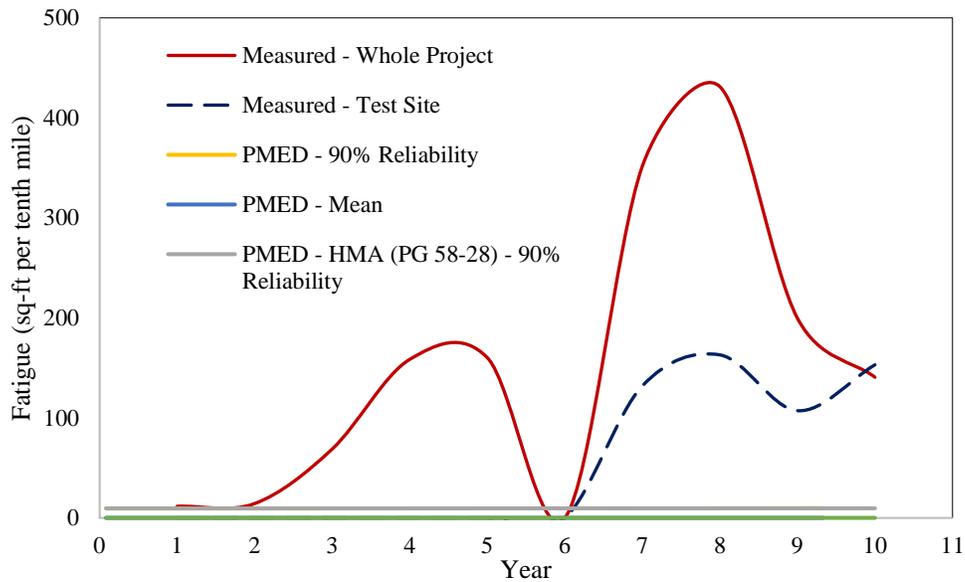
**Figure 128. Fatigue Cracking at SH 50 Cerro Summit Showing Amount of Measured and PMED Predicted Cracking**

The measured and the PMED-predicted fatigue cracking of SH 50 Cerro Summit are presented in

Figure 128 below. The measured fatigue cracking values at the whole project and test site are higher than the PMED-predicted fatigue cracking values. The PMED-predicted fatigue cracking values by both HMA and CIR mix at mean level are very small (close to zero), while at 90% reliability, they produce about 9.5 square feet per tenth-mile.

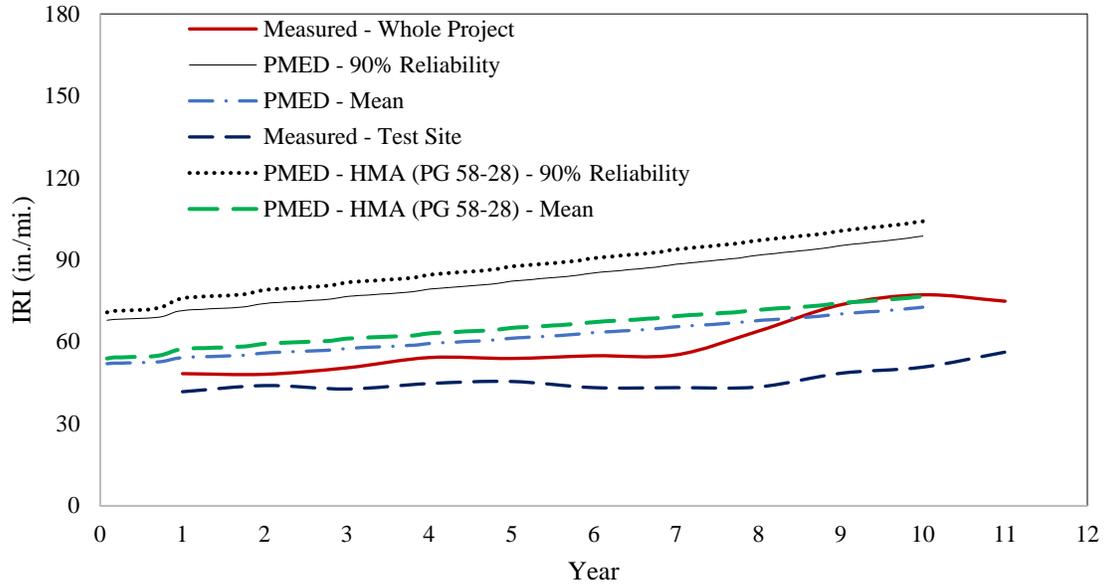
**Figure 129. IRI at I-70 West of Mack Showing Amount of Measured and PMED Predicted IRI**

The measured and the PMED-predicted IRI of I-70 West of Mack are presented in Figure 129 below. It shows that the HMA SX (75) PG 58-28 produces higher IRI compared to the CIR material both at 90% reliability and at mean level. The PMED-predicted mean IRI values using both the CIR and HMA SX (75) PG 58-28 are very close to the measured IRI values.

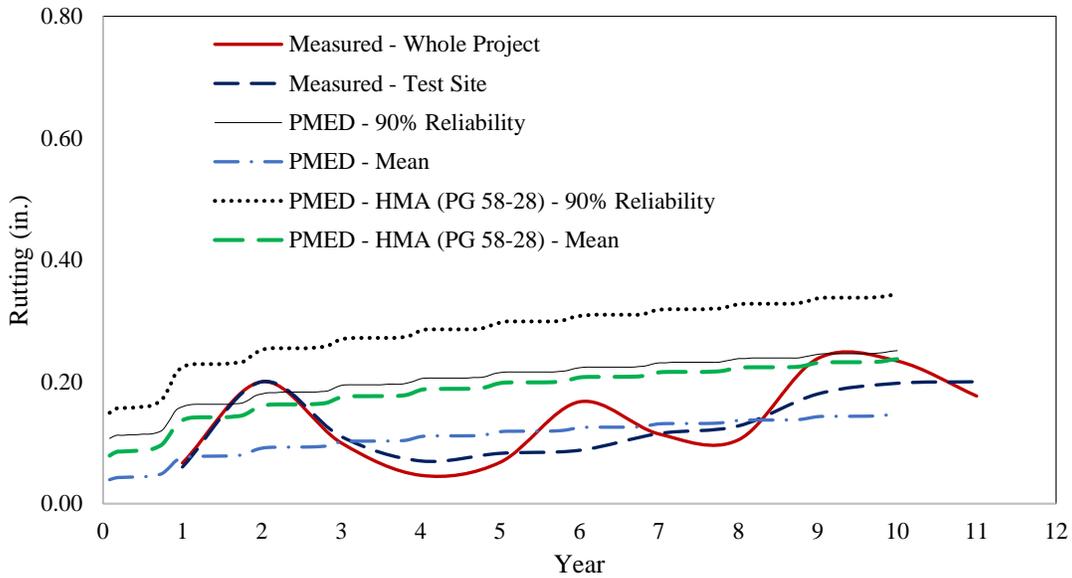
**Figure 130. Total Rutting at I-70 West of Mack Showing Amount of Measured and PMED Predicted Rutting**

The measured and the PMED-predicted total rutting of I-70 West of Mack are presented in Figure 130 below. The measured total rutting values are in good agreement with the PMED-predicted mean rutting values for all cases except the PMED-prediction at 90% reliability with HMA material. The PMED-predicted rutting values at 90% reliability for HMA material are slightly higher than the measured rutting values.

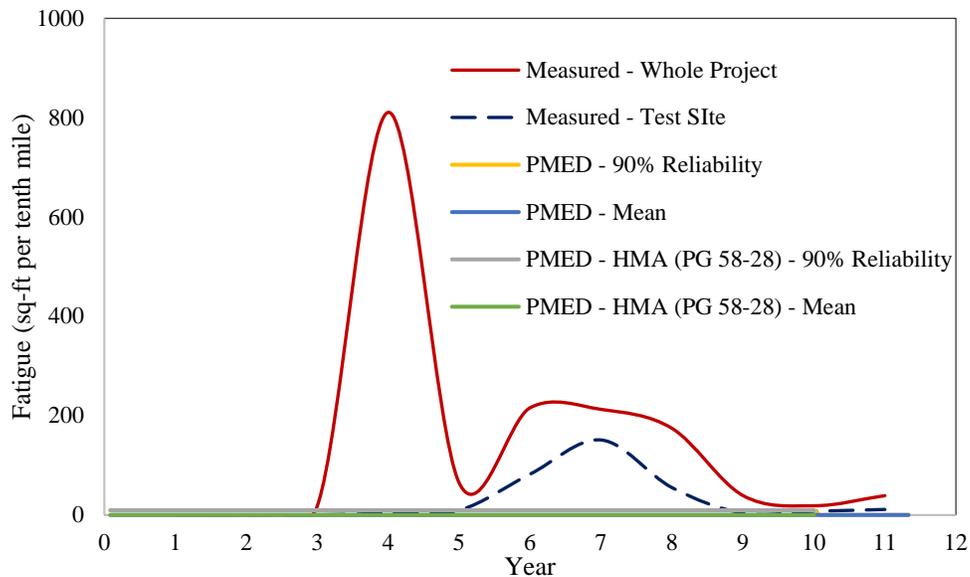
**Figure 131. Fatigue Cracking at I-70 West of Mack Showing Amount of Measured and PMED Predicted Cracking**

The measured fatigue cracking values at the whole project and test site are higher than the PMED-predicted fatigue cracking values, Figure 131. The PMED-predicted fatigue cracking values by both HMA and CIR mix at mean level are very small (close to zero), while at 90% reliability, they produce about 9.5 square feet per tenth-mile.

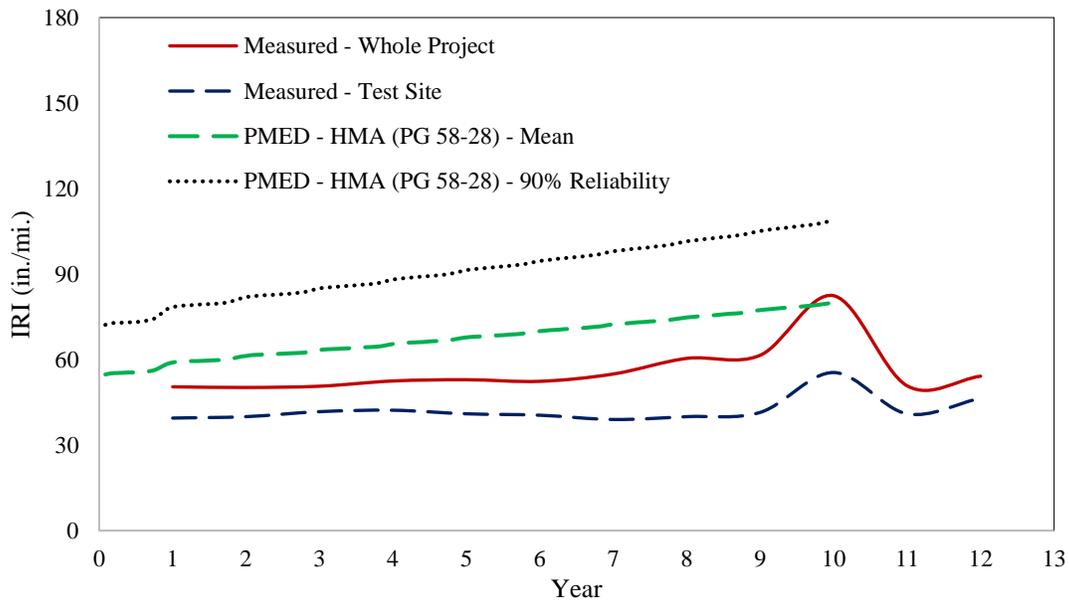
**Figure 132. IRI at I-70 Fruita to Clifton Showing Amount of Measured and PMED Predicted IRI**

The measured and the PMED-predicted IRI of Fruita to Clifton are presented in Figure 132 below. It shows that the PMED-predicted mean IRI values using the HMA SX (75) PG 58-28 are closer to the measured IRI values compared to the PMED-predicted IRI at 90% reliability. The PMED-predicted IRI values at 90% reliability using the HMA SX (75) PG 58-28 are higher than the measured IRI values.

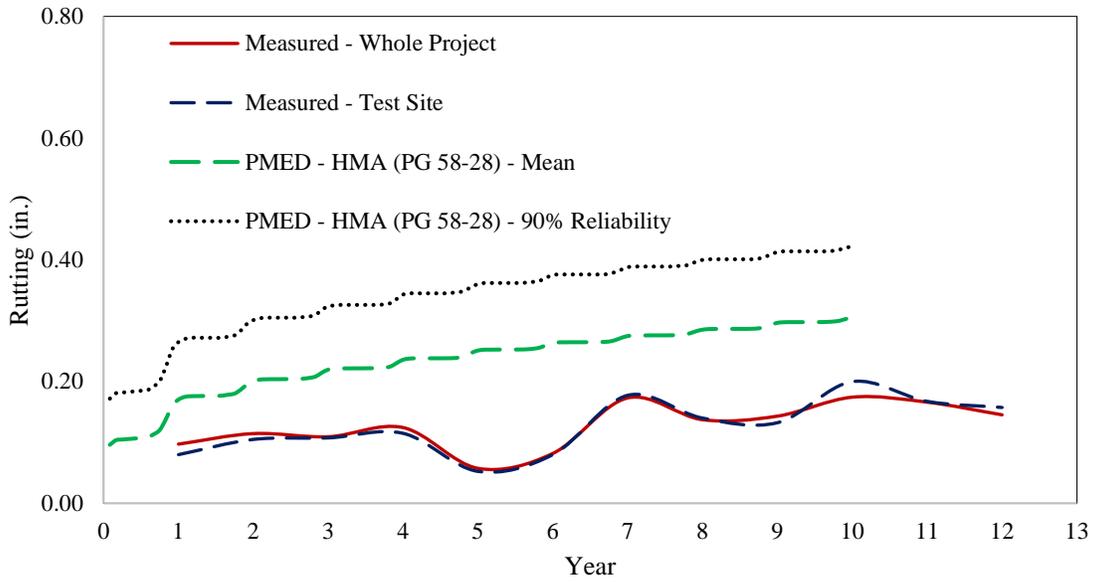
**Figure 133. Total Rutting at I-70 Fruita to Clifton Showing Amount of Measured and PMED Predicted Rutting**

The measured and the PMED-predicted total rutting of Fruita to Clifton are presented in Figure 133 below. The measured total rutting values are lower than the PMED-predicted rutting values using the HMA SX (75) PG 58-28 at both 90% reliability and mean level.

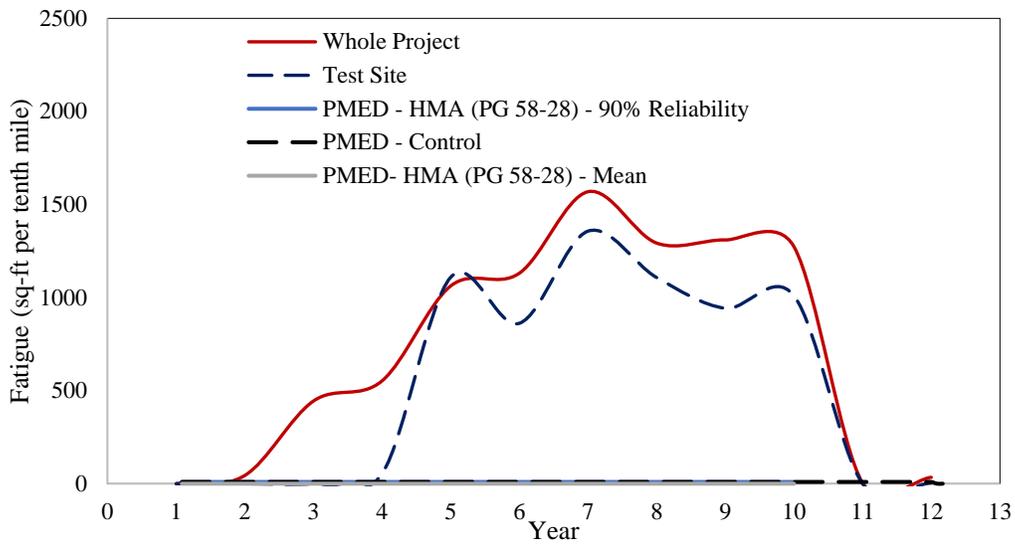
**Figure 134. Fatigue Cracking at I-70 Fruita to Clifton Showing Amount of Measured and PMED Predicted Cracking**

The measured and the PMED-predicted fatigue cracking of Fruita to Clifton are presented in Figure 134 below. The measured fatigue cracking values are much higher than the PMED-predicted fatigue cracking values using the HMA SX (75) PG 58-28. The PMED-predicted fatigue cracking values by HMA SX (75) PG 58-28 mix at mean level are very small (close to zero), while at 90% reliability, they produce about 9.5 square feet per tenth-mile.

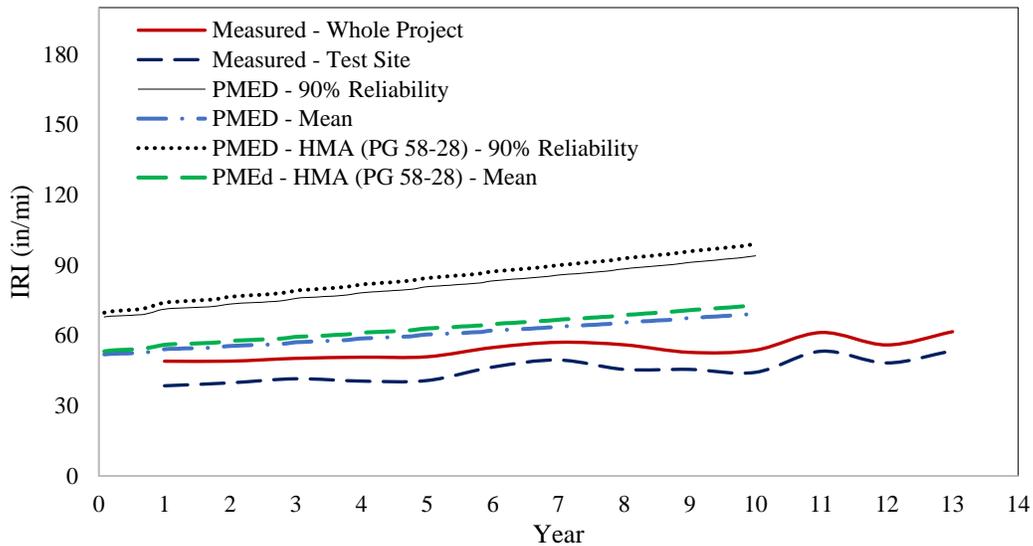
**Figure 135. IRI at SH 92 Delta (Eastbound) Showing Amount of Measured and PMED Predicted IRI**

The measured and the PMED-predicted IRI of SH 92 Delta are presented in Figure 135 below. The first observation from this figure is that the PMED-outputs using the CIR and the HMA SX (75) PG 58-28 are very close to each other. It also shows the PMED-predicted mean IRI values are in good agreement with the measured IRI values. The measured IRI values are lower than the PMED-predicted IRI values.

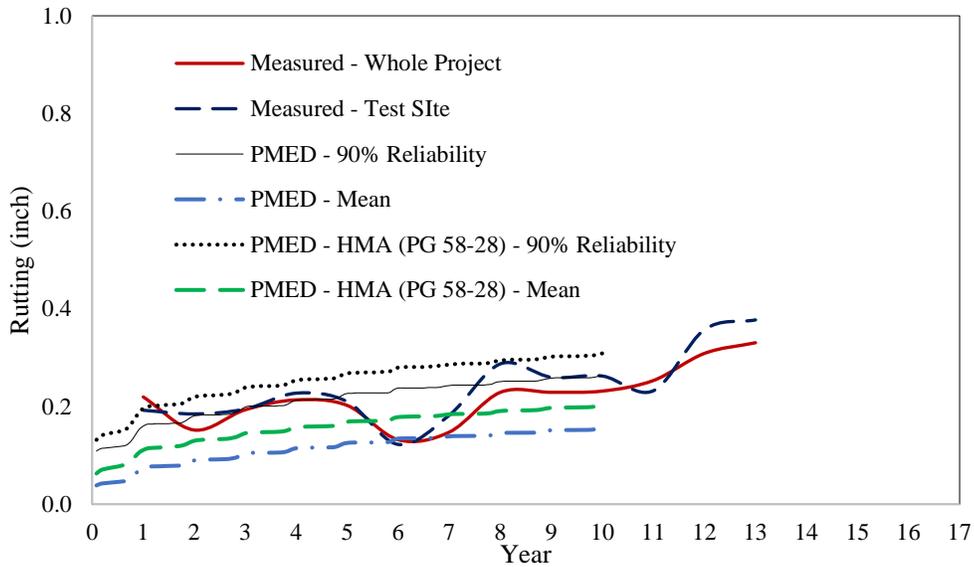
**Figure 136. Total Rutting at SH 92 Delta (Eastbound) Showing Amount of Measured and PMED Predicted Rutting**

The measured and the PMED-predicted total rutting of SH 92 Delta are presented in Figure 136 below. The measured total rutting values are in good agreement with the PMED-predicted total rutting values at different conditions. The predictions by CIR consideration and HMA consideration are close to each other.

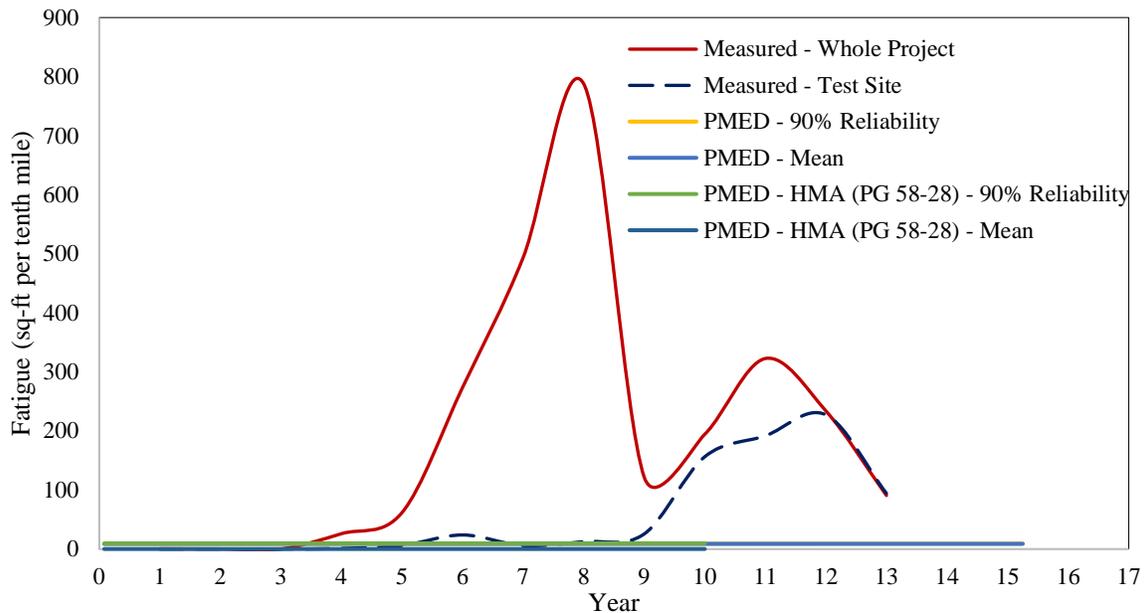
The measured fatigue cracking values at the whole project and test site are higher than the PMED-predicted fatigue cracking values, Figure 137. The PMED-predicted fatigue cracking values by both HMA and CIR mix at mean level are very small (close to zero), while at 90% reliability, they produce about 9.5 square feet per tenth-mile.

**Figure 137. Fatigue Cracking at SH 92 Delta (Eastbound) Showing Amount of Measured and PMED Predicted Cracking**

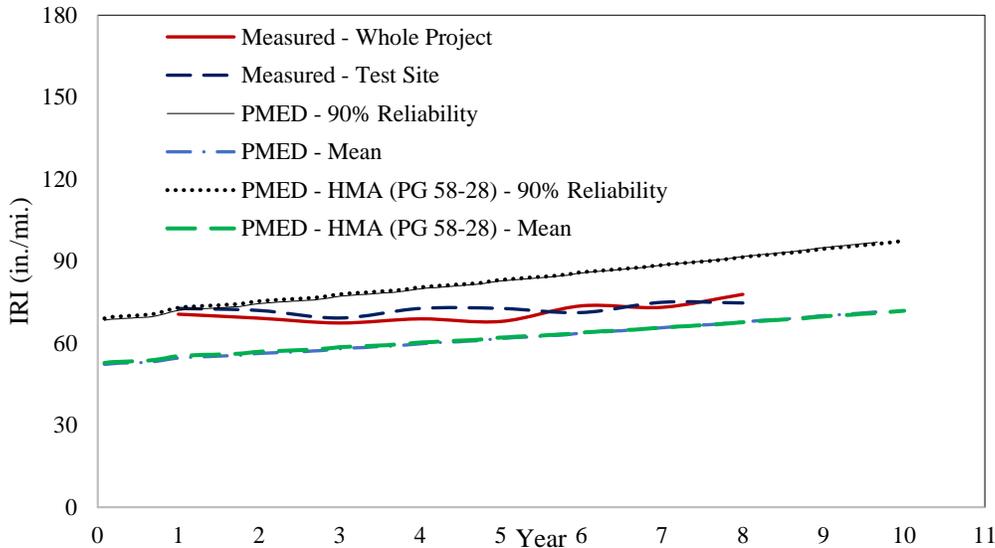
The measured and the PMED-predicted IRI of SH 133 Hotchkiss are presented in Figure 138 below. The PMED-outputs using the CIR and the HMA SX (75) PG 58-28 are almost the same. The measured IRI values are in between the PMED-predicted total IRI at mean level and at 90% reliability.

**Figure 138. IRI at SH 133 North of Hotchkiss Showing Amount of Measured and PMED Predicted IRI**

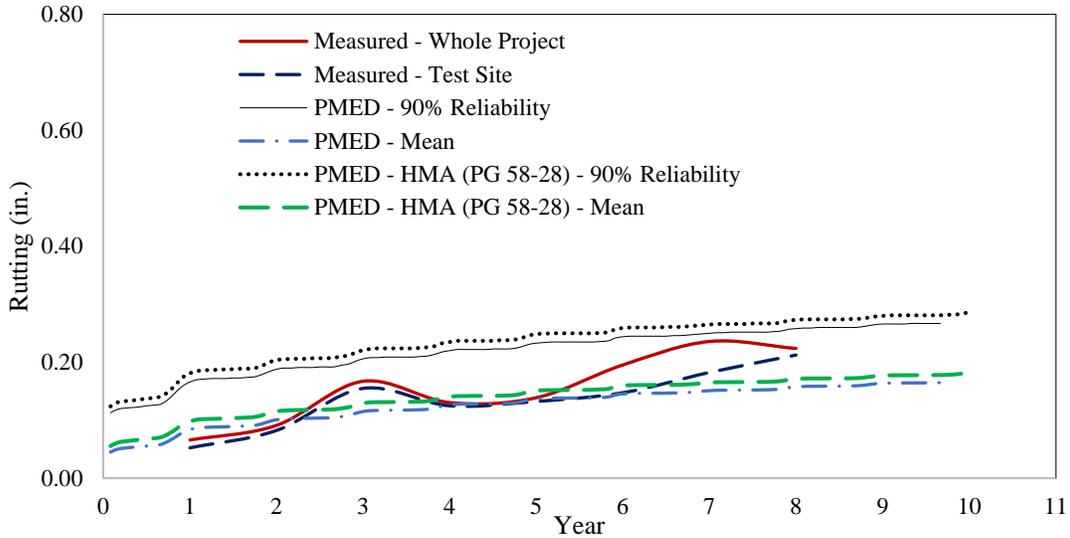
The measured and the PMED-predicted total rutting of SH 133 Hotchkiss are presented in Figure 139 below. The PMED-outputs using the CIR and the HMA SX (75) PG 58-28 are very close to each other. The PMED-outputs using the CIR and the HMA SX (75) PG 58-28 are very close to each other. The measured rutting values are in between the PMED-predicted rutting values.

**Figure 139. Total Rutting at SH 133 North of Hotchkiss Showing Amount of Measured and PMED Predicted Rutting**

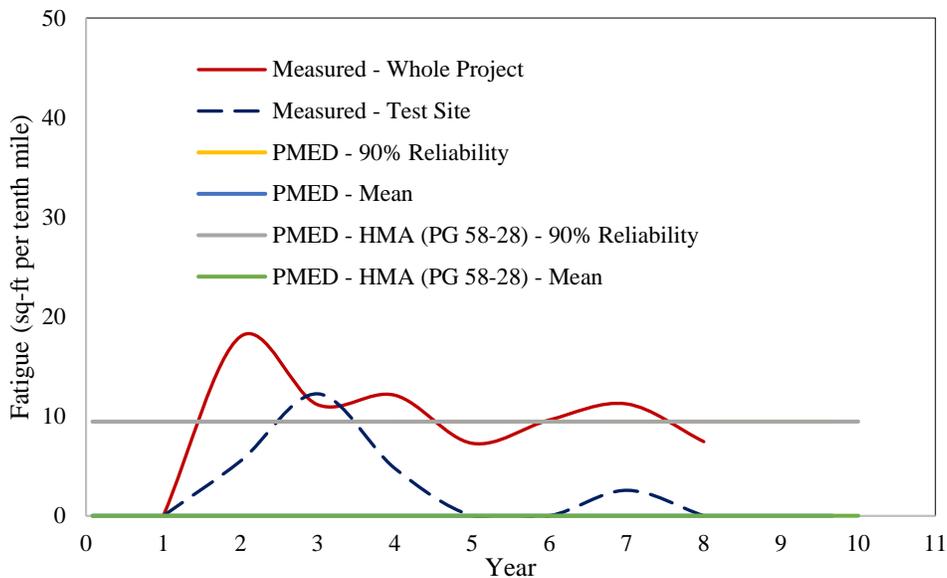
The measured and the PMED-predicted fatigue cracking of SH 133 Hotchkiss are presented in Figure 140 below. The measured fatigue cracking values are similar to the PMED-predicted fatigue cracking values at 90% reliability. The PMED-predicted fatigue cracking values by both HMA and CIR mix at mean level are very small (close to zero), while at 90% reliability, they produce about 9.5 square feet per tenth-mile.

**Figure 140. Fatigue Cracking at SH 133 North of Hotchkiss Showing Amount of Measured and PMED Predicted Cracking**

The PMED-predicted fatigue cracking values are less than the measured data at the CIR whole project and test site. There may be several reasons for PMED low prediction. One reason is that a local calibration coefficient used in the fatigue equation, BF1 ( $\beta_{f1}$ ) is 130.3674 which is 1.0 for global calibration. A lower value of this coefficient may be appropriate for CIR material. Since calibration of the PMED software for CIR overlay design was not performed in this study, a more rigorous study is required for recalibration of the PMED software so it is compatible with CIR materials. Recalibration of the PMED software for overlay design with CIR materials is necessary for better cracking prediction.
