# SAFETY REPORT

**EB I-70 Peak Period  
Shoulder Lane**  
CATEGORICAL EXCLUSION

**I-70 EASTBOUND PEAK PERIOD SHOULDER LANE (PPSL)**  
**SAFETY REPORT**

FHU Reference No. 11-111-09  
December 2013

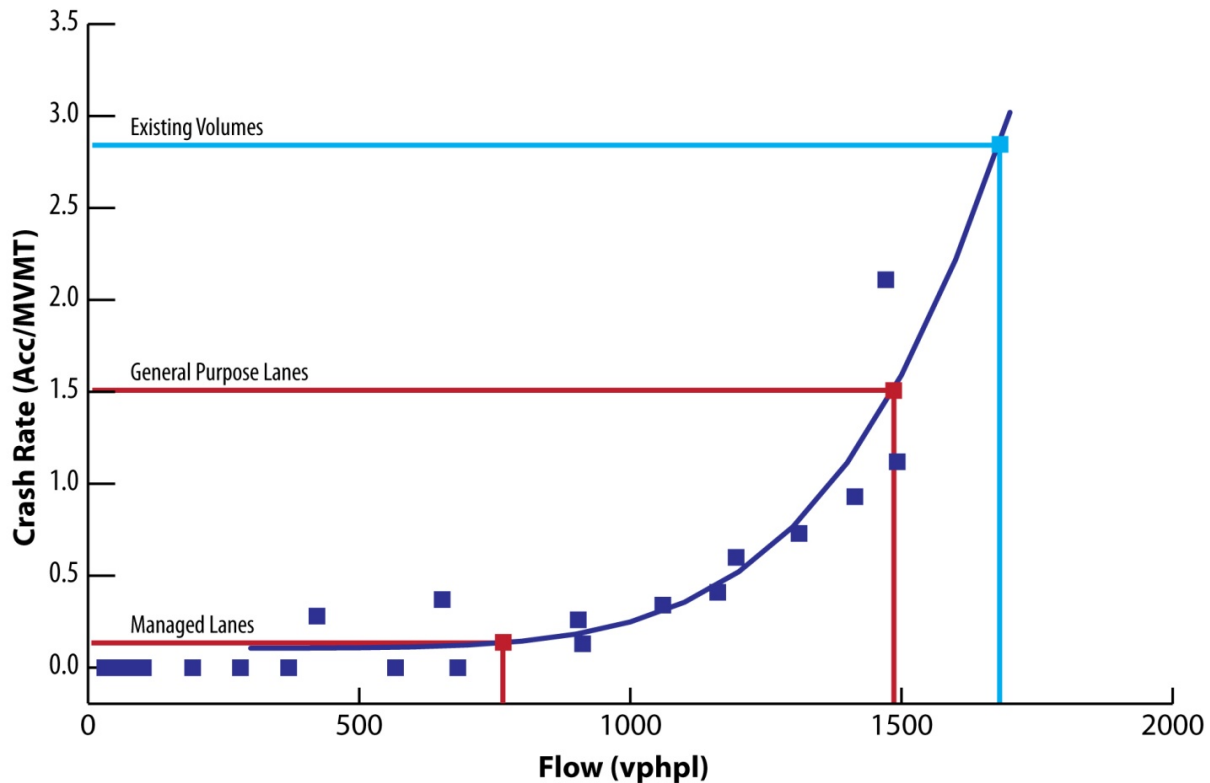
Figure 5. PPSL Corridor Volumes Superimposed on I-70 SPF

The result is a forecasted decrease of approximately 53 percent in the eastbound total crashes on Sundays from implementation of the PPSL project. According to the Safety Assessment (see Reference 1), the total annual crashes on Sundays in the eastbound direction is approximately 26 (128 over five years) and the annual number of rear-end crashes is approximately 19 (94 over five years). The calculation reveals that annual decrease in crashes due to congestion reduction would be between 9.4 (47 over 5 years) and approximately 12.8 (64 over 5 years).

Thus, when the forecasted decrease in crashes due to congestion relief is compared to the increase related to geometric changes, the analysis show an annual decrease of between 1.8 (9 over 5 years) and 5.2 crashes (26 over 5 years).

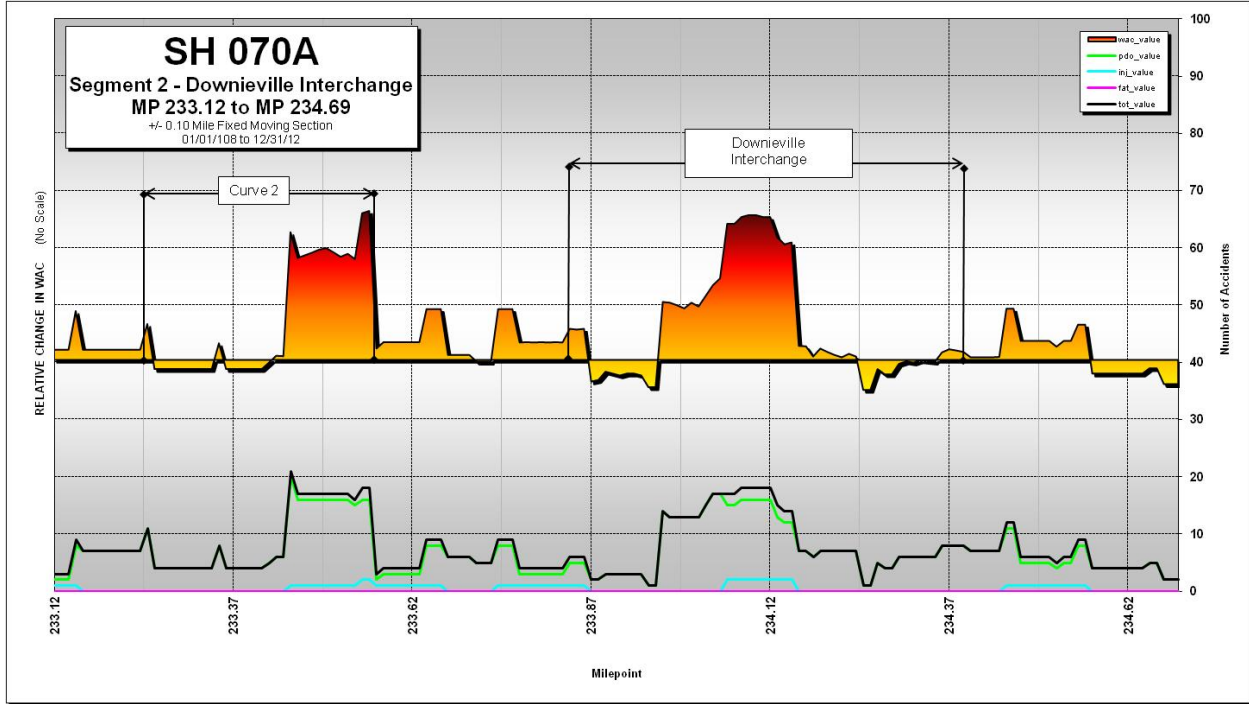
**Figure 10** shows the change in weighted accident concentration throughout this segment of I-70. As shown, the largest concentration of crashes occurred on Curve 2 in the segment and within the limits of the interchange.

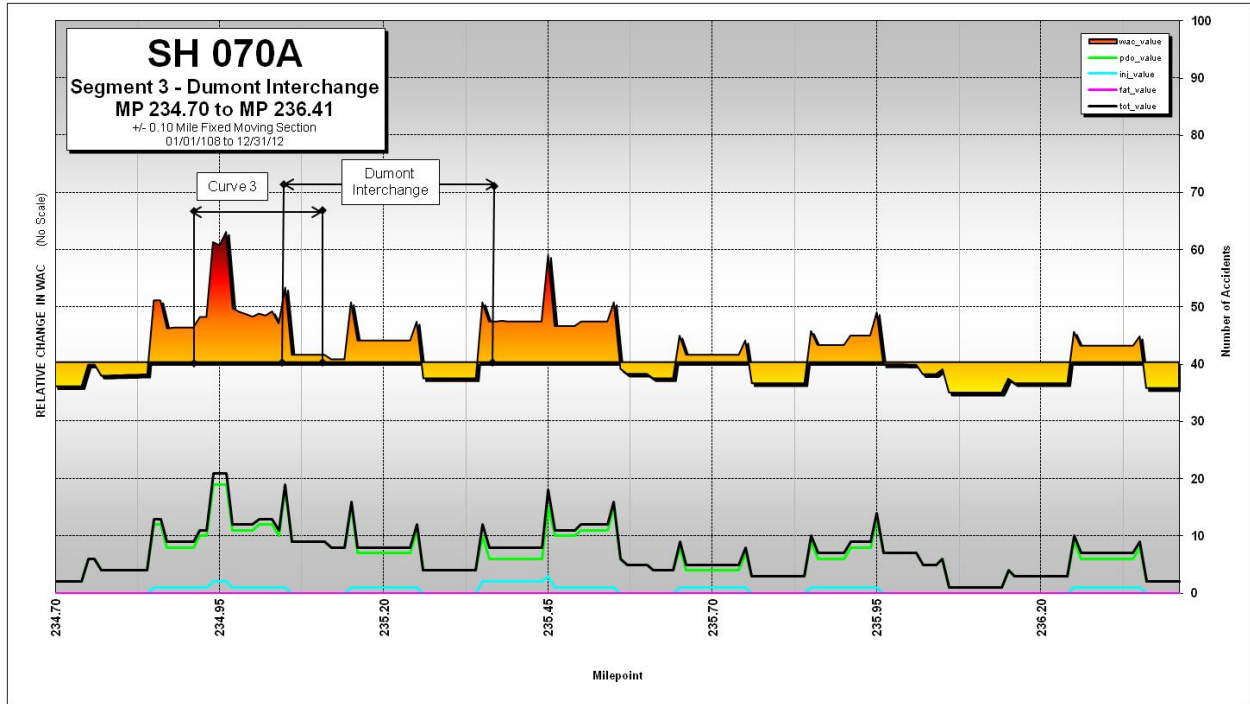
**Figure 14** shows the change in weighted accident concentration throughout this segment of I-70. As shown, the largest concentration of crashes occurred on Curve 3 in the segment.

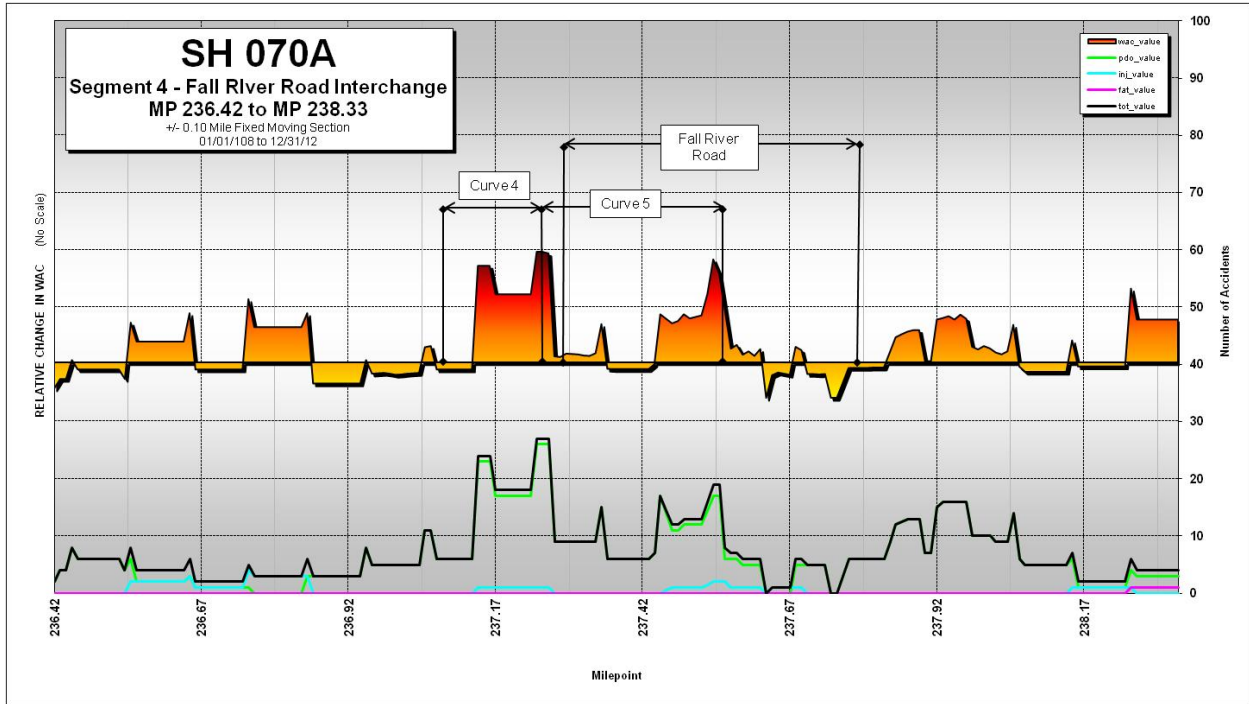
**Figure 18** shows the change in weighted accident concentration throughout this segment of I-70. As shown, the largest concentration of crashes occurred on Curves 4 and 5 in the segment.

As can be seen in this table, the majority of the eastbound fixed object crashes occurred at night in dry road conditions, while the westbound crashes were split between day and night during dry road conditions. There was a large concentration of these crash types along Curve 5 (see **Figure 18**). Most of the crashes at this location occurred in the eastbound direction. Based on a review of the crash reports, many of these crashes occurred when a driver lost control due to the road conditions or excessive speed. The driver was generally driving too fast for the given conditions and hit the guard rail. However, it is worth noting that the rail involved in the crashes generally prevented a more serious crash from occurring.

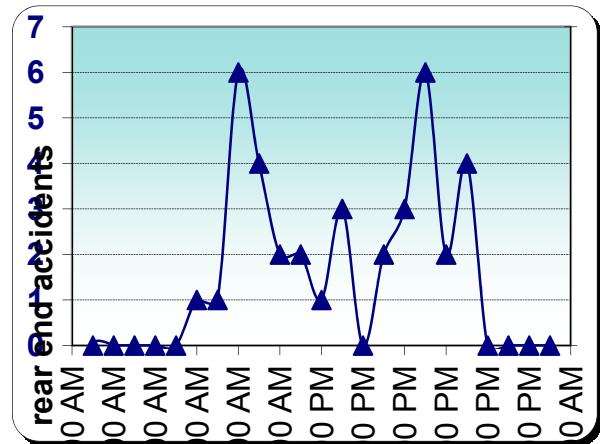
**Figure 20**  
Rear End Crashes by Time of Day

The proportion of rear end type crashes was higher than expected. Similar to the barrier type crashes, the majority of rear end type crashes occurred in the westbound direction (22 of 37) in Segment 4. Approximately half of these crashes occurred in dry / daylight conditions (19 of 37). Of the rear end crashes, most occurred on a weekday (19 of 37) and/or in the winter months (22 of 37). **Table 15** provides details of the road conditions, season, and day of the week. **Figure 20** shows the numbers of crashes by time of day. As shown, the majority of crashes took place around 8 AM and 5 PM. All of the crashes that took place around the morning peak occurred in the westbound direction and this coincides with the westbound peak hour of traffic. Most of the afternoon accidents occurred in the eastbound direction. The eastbound peak hour occurs around 3 PM, so these accidents occurred slightly later than the peak hour of traffic in this direction. It should also be noted that the roadway congestion is worst during the weekends, which coincides with when many of the accidents occurred. Based on a review of the crash reports, the majority of the rear end type crashes were related to congestion on I-70. Many of the westbound rear end crashes occurred within Curve 4. The lack of visibility of the stopped traffic ahead due to the curve may play a role in the crashes along Curve 4.

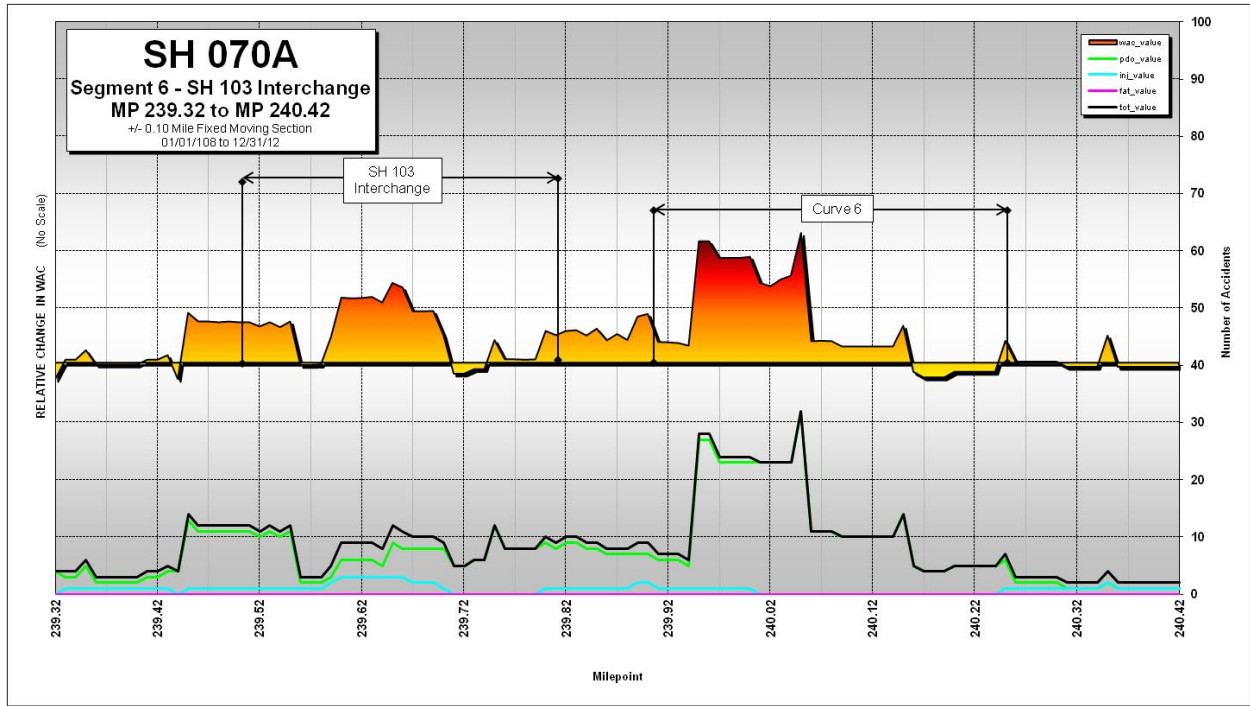
**Figure 25** shows the change in weighted accident concentration throughout this segment of I-70. As shown, the largest concentration of crashes occurred on Curve 6 in the segment. It should be noted that there is an uphill grade in the eastbound direction along Curve 6. Most of the other locations of large spikes in the graph are within the limits of the interchange.

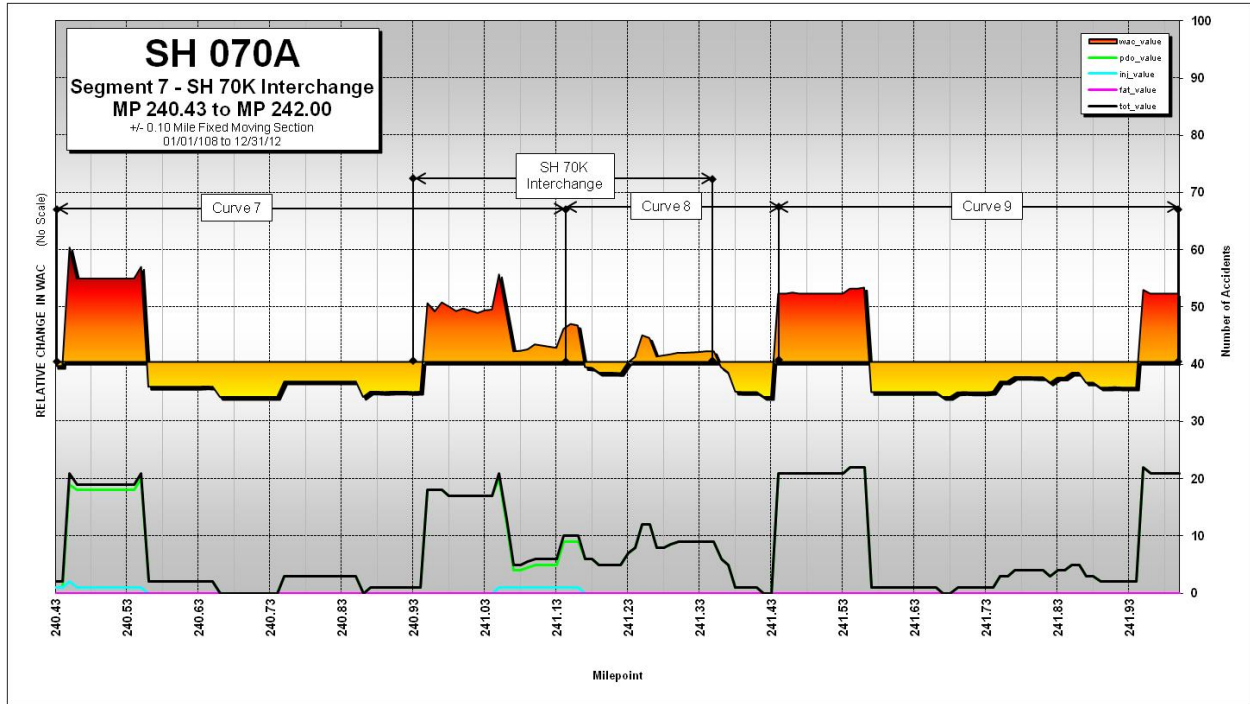
**Figure 28** shows the change in weighted accident concentration throughout this segment of I-70. As shown, there is a large concentration of crashes on each curve in the segment.

There was a large concentration of these crash types around MP 241.5, at the western edge of Curve 9, which coincides with a spike in the weighted accident concentration graph (See **Figure 28**). Based on a review of the crash reports, all the crashes at this location occurred on inclement road conditions with more occurring in the westbound direction. In most cases the driver lost control due to the road conditions and/or excessive speed and hit the barrier. The driver was generally driving too fast for the given conditions. However, the rail and barrier involved in the crashes generally prevented a more serious crash from occurring.

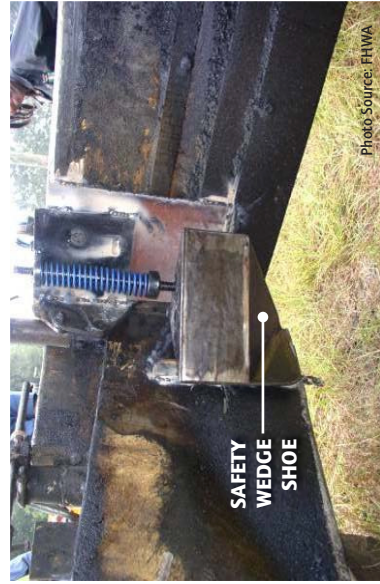
The Safety Wedge Shoe is a special edging device that asphalt paving contractors can install on new or existing resurfacing equipment to shape the Safety Edge.

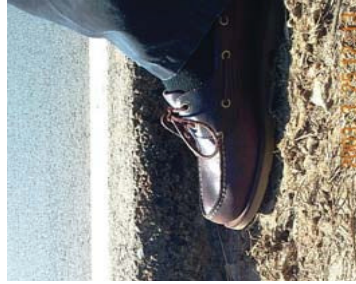
**Sharp, steep pavement edge dropoffs can contribute to crashes.**

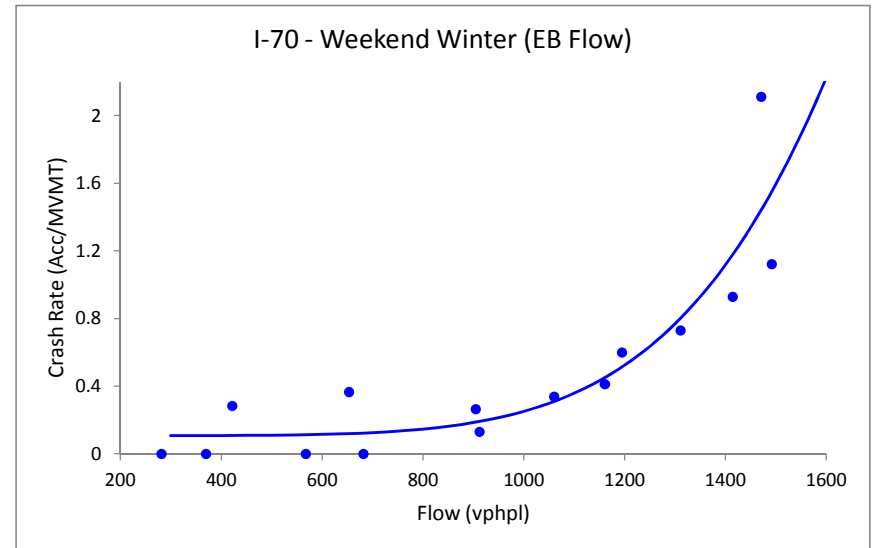
**Fitted Curve for I-70 Mountain Corridor**  
**Relationship between Traffic Density, Speed and Safety and Implication on Setting Variable Speed Limits on Freeways, Kononov, et. al., TRB 2012.**

EB Flow (vphpl)	Model EB Crash Rate	DS^2	Model DS2	Vmax	n	Km	D	Model Formula
300	0.107319998		30000	0.163894127	23.5354	5.917004	2366.321	0.107204 (D+((Vmax*(x^n))/((x^n)+(Km^n))))
400	0.107840363		35000	0.163894726	A	B	C	D Model Formula
500	0.109586809		40000	0.163897296	216.5955	11.32497	196049.1	0.163894 (D+((Vmax*(x^n))/((x^n)+(Km^n))))
600	0.114210795		45000	0.16390651				
700	0.124640166		50000	0.163935255				
800	0.145592598		55000	0.164015407				
900	0.184145132		60000	0.164219235				
1000	0.250316923		65000	0.164699149				
1100	0.35758609		70000	0.165757653				
1200	0.523208542		75000	0.167964925				
1300	0.76814074		80000	0.172348906				
1400	1.116307137		85000	0.180692346				
1500	1.592935113		90000	0.195983444				
1600	2.221766607		95000	0.223081576				
1700	3.021210073		100000	0.269677174				
1800	3.999932633		105000	0.347644417				
1900	5.152900919		110000	0.474904902				
2000	6.459196108		115000	0.677935337

EB Flow (vphpl)	Model EB Crash Rate
300	0.107319998
400	0.107840363
500	0.109586809
600	0.114210795
700	0.124640166
800	0.145592598
900	0.184145132
1000	0.250316923
1100	0.35758609
1200	0.523208542
1300	0.76814074
1400	1.116307137
1500	1.592935113
1600	2.221766607
1700	3.021210073
1800	3.999932633
1900	5.152900919
2000	6.459196108
