## 1.1 PURPOSE AND NEED STATEMENT

## 1.2 PROPOSED ACTION

The proposed project is located in La Plata County, Colorado. The project length on US 160 would be 16.2 miles, extending from milepost (MP) 88.0, located east of Durango, to MP 104.2, located east of Bayfield. The project length on US 550 would be 1.2 miles, extending from MP 16.6, located at the US 160/US 550 (south) intersection, to MP 15.4, located south of the US 550/County Road (CR) 220 intersection.

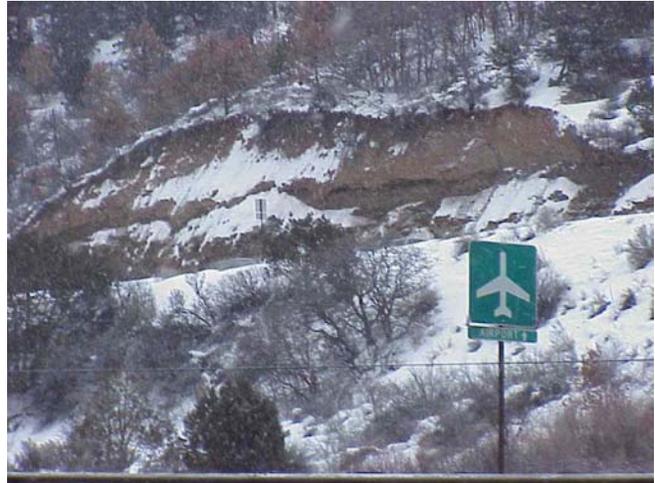
**Photo 1.4.1**  
**Farmington Hill**

(Photo 1.4.1). The roadway is cut into the side of the Farmington Hill embankment and follows the sharp horizontal curves of the hillside at a steep grade, rising over 200 feet in approximately 0.66 mile. There are minimal paved shoulders of 2 feet or less. The traversable ground surface outside the roadway is as narrow as 5 feet in many places, and only one-third of the section has guardrail along the downward slope embankment, leaving little room for driver error or emergency stops. Outside the traversable area, the embankment both above and below the roadway is steep: approximately 34 degrees. The embankment below the roadway ranges from 46 to 290 feet in height. The north-facing slope of the road surface makes this area prone to winter icing. The steep embankment above the roadway comprises decomposed shale overlain by sandy cobbles and boulders, which are prone to sloughing onto the roadway surface, creating hazards for drivers. Because of the sharp horizontal curves, driver visibility along the road is short—as little as 100 feet at some locations; hence, assuming a 30-miles per hour (mph) travel speed, drivers have only 2 seconds to react to roadway hazards.

The roadway conditions are factors in the type and severity of accidents occurring on Farmington Hill (Figure 1.4.5, US 550 Accident Histogram CR 220 to US 160). The steep winding roadway, icing conditions, and roadway obstructions contribute to drivers losing control of their vehicles. If drivers lose control, the narrow shoulders, lack of guardrails, and steep embankments make it difficult for them to regain control once their vehicles leave the roadway. Accidents on Farmington Hill generally fall into two categories: drivers lose the ability to slow or stop their vehicles due to the steep grade and either strike vehicles located in front of them or run out into

the US 160/US 550 (south) intersection, or drivers lose control and run off the roadway surface and down the steep embankment below the roadway.

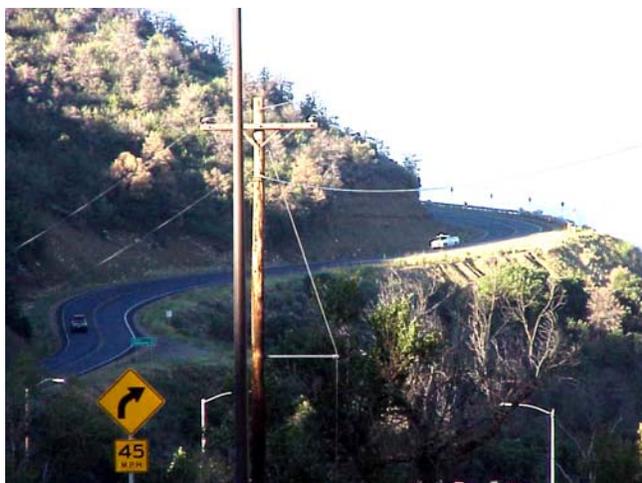
**Photo 1.4.2**  
**Farmington Hill's north-facing slope**

These grades also present a safety hazard in winter months when roads are snow-packed or icy. This is of particular concern at Farmington Hill, where vehicles traveling north on US 550 descend on a 6 percent grade for approximately 1 mile to the intersection with US 160. The last 2,000 feet of this 6 percent grade just before entering the intersection is on a north-facing slope prone to icing, making it difficult to stop (Photo 1.4.2). Steep grades are also a concern through Grandview where portions of US 160 westbound are on a 6 percent downgrade.

The horizontal alignment is deficient in several locations. Curve radii in some sections need to be increased to meet current CDOT and AASHTO standards for a highway of this type. The horizontal alignment of US 550 at Farmington Hill has significant deficiencies. The last 4,600 feet of US 550 as it approaches the intersection with US 160 include a series of seven curves with an average degree of curvature of approximately 12 degrees, equating to a design speed of

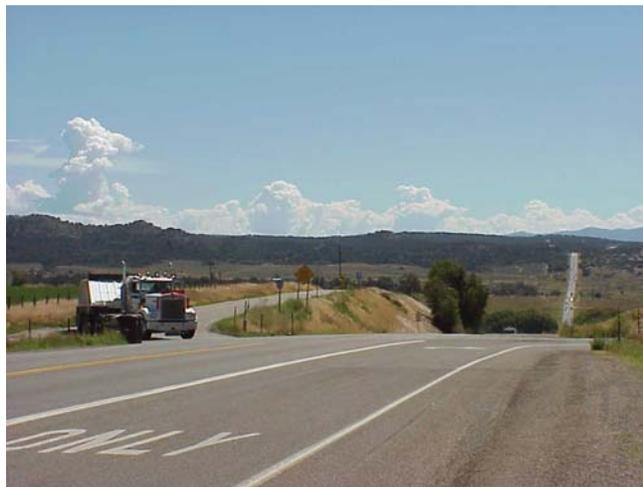
**Photo 1.4.3**  
**CR 222/CR 223 (west) intersection,**  
**looking east**

- **CR 222/CR 223 (west)**– This intersection is located near the crest of a 6 percent grade. Sight distance to the east at the intersection is less than 200 feet (Photo 1.4.3).
- **CR 223 (east)** – This intersection is located along a horizontal curve at the base of a steep hill. Sight distance to the east around the curve is less than 500 feet.
- **CR 502** – This intersection is located just west of the Los Pinos River on a 4 percent grade near the crest of a vertical curve. Sight distance to the west is less than 600 feet.

Other geometric elements contribute to the inadequacy of several of the county road intersections. Intersections should not be located at a skew angle of less than 60 degrees. The most severe example of poor intersection skew is the CR 222/CR 223 (west) intersection. CR 223 intersects US 160 at an angle of 25 degrees, and CR 222 intersects US 160 at an angle of 55 degrees. These low skew angles do not accommodate certain turning movements and greatly decrease the already poor sight distance at the intersection.

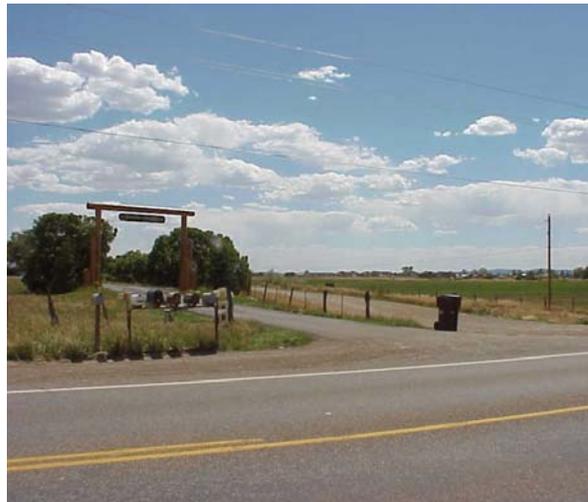
**Photo 1.4.4**  
**Two of the hundreds of uncontrolled**  
**accesses along US 160**

This situation is due in part to the extensive development in the urban areas along US 160 over the past 20 years. Numerous roads and driveways intersect US 160. Most of these driveways and roads are unsignalized intersections. The most developed area along the US 160 project corridor is the area between the US 550 (south) and SH 172/CR 234 intersections, known as Grandview. In this 3-mile stretch of the highway, there are 57 access points. One is a US highway, one is a state highway, five are county road connections, five are private road connections, and 45 are private driveways (Photo 1.4.4). Development in this area is residential, commercial, and industrial.

This 3-mile road segment is a Non-Rural Principal Highway (NR-A) access category in the State Highway Access Code. The Code states that for this category, direct access service to abutting land is subordinate to providing service to through-traffic movements, and the minimum spacing for intersecting streets or other accesses that are full movement is 0.5 mile.

Uncontrolled access is one of the contributors to accidents in the project corridor. There are almost 200 access points on this segment of US 160, creating a situation where unsafe movements are a common occurrence. For example, drivers have been observed traveling on the shoulder and on the wrong side of the highway, and passing left-turning vehicles on the right shoulder.
