## 4.15 MINERAL RESOURCES, GEOLOGY, AND SOILS

This section discusses the geologic setting along the United States Highway 36 (US 36) corridor and impacts to minerals, geology, and soils. Information was gathered on geologic conditions, geologic hazards, and geologic factors that could potentially affect the design of any of the build packages. Although several geologic constraints have been identified, no significant impacts to geology, soils, or mineral resources are expected due to the implementation of any of the proposed packages. Conditions that have been identified along the US 36 corridor that may require mitigation during construction include expansive soils and bedrock, steeply dipping bedrock, collapsible soils, soil erosion, and mine subsidence (collapse of an underground mine causing movement to the surface above). The results of this analysis indicate that coal beds located under the Superior/Louisville and Boulder segments would not impact construction on US 36.

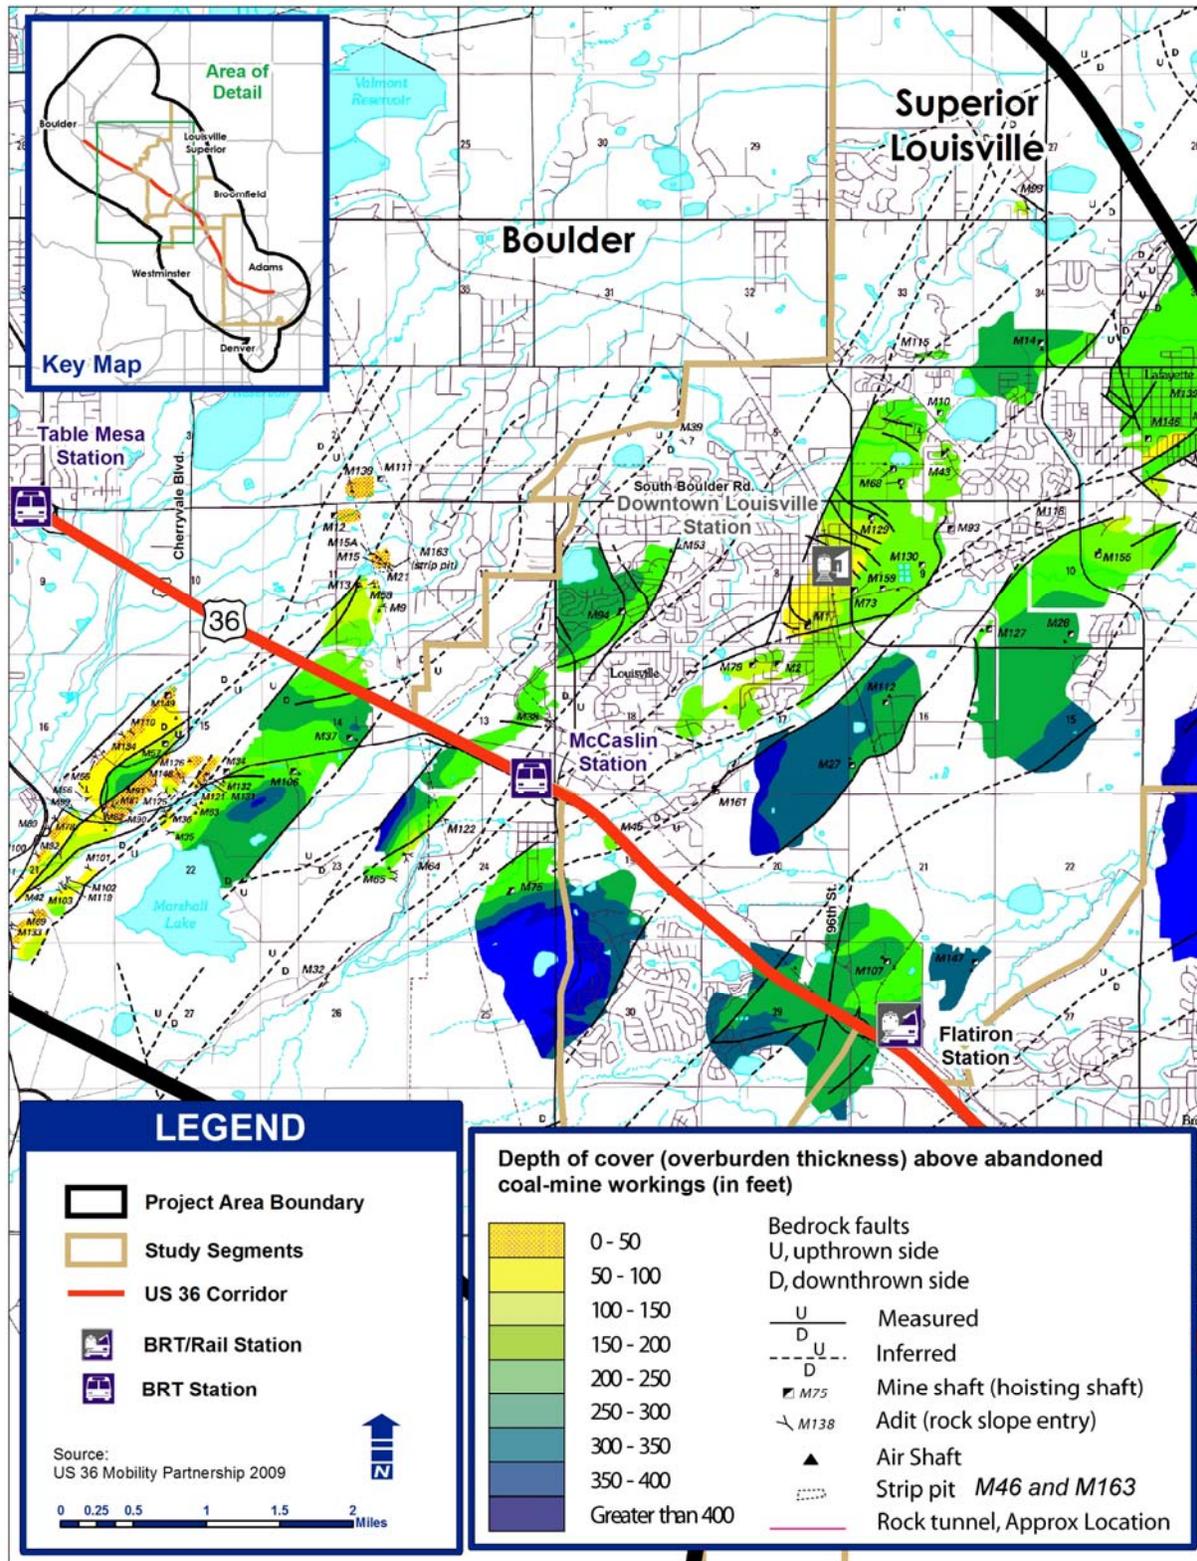
Figure 4.15-1: Abandoned Coal Mines

Figure 4.15-1, Abandoned Coal Mines, illustrates the areas of abandoned coal mines with associated depths of overburden that underlay the US 36 corridor. No known areas of underground abandoned coal mine fire areas have been identified within the US 36 corridor.

Mine subsidence occurs when a void at depth collapses and causes vertical displacement (settlement) to the surface. Mine subsidence occurs at depth, rather than near the surface, as with collapsing soils. Coal was mined along the corridor starting in the 1860s and continued locally into the 1970s, using a room-and-pillar technique in which a coal seam was mined into “chambers.” Unmined coal pillars were left at the corners of rooms to help support the mine roof. Over time, the mine roof and coal pillars collapsed, and the empty void space left by mining is destroyed. Because the rock units in and surrounding the coal seams do not resist stress well, subsidence typically occurs relatively soon after mining ceases. In addition, in many of the mines, the pillars were removed when mining was completed to encourage collapse of the void space.

Some mine void space probably remains today. Therefore, the potential for subsidence and possible damage to structures at the surface also exists.
