# **Safety Assessment - I-270 Corridor Improvements**

## **Environmental Impact Statement**

Federal Project No.: STU 2706-046

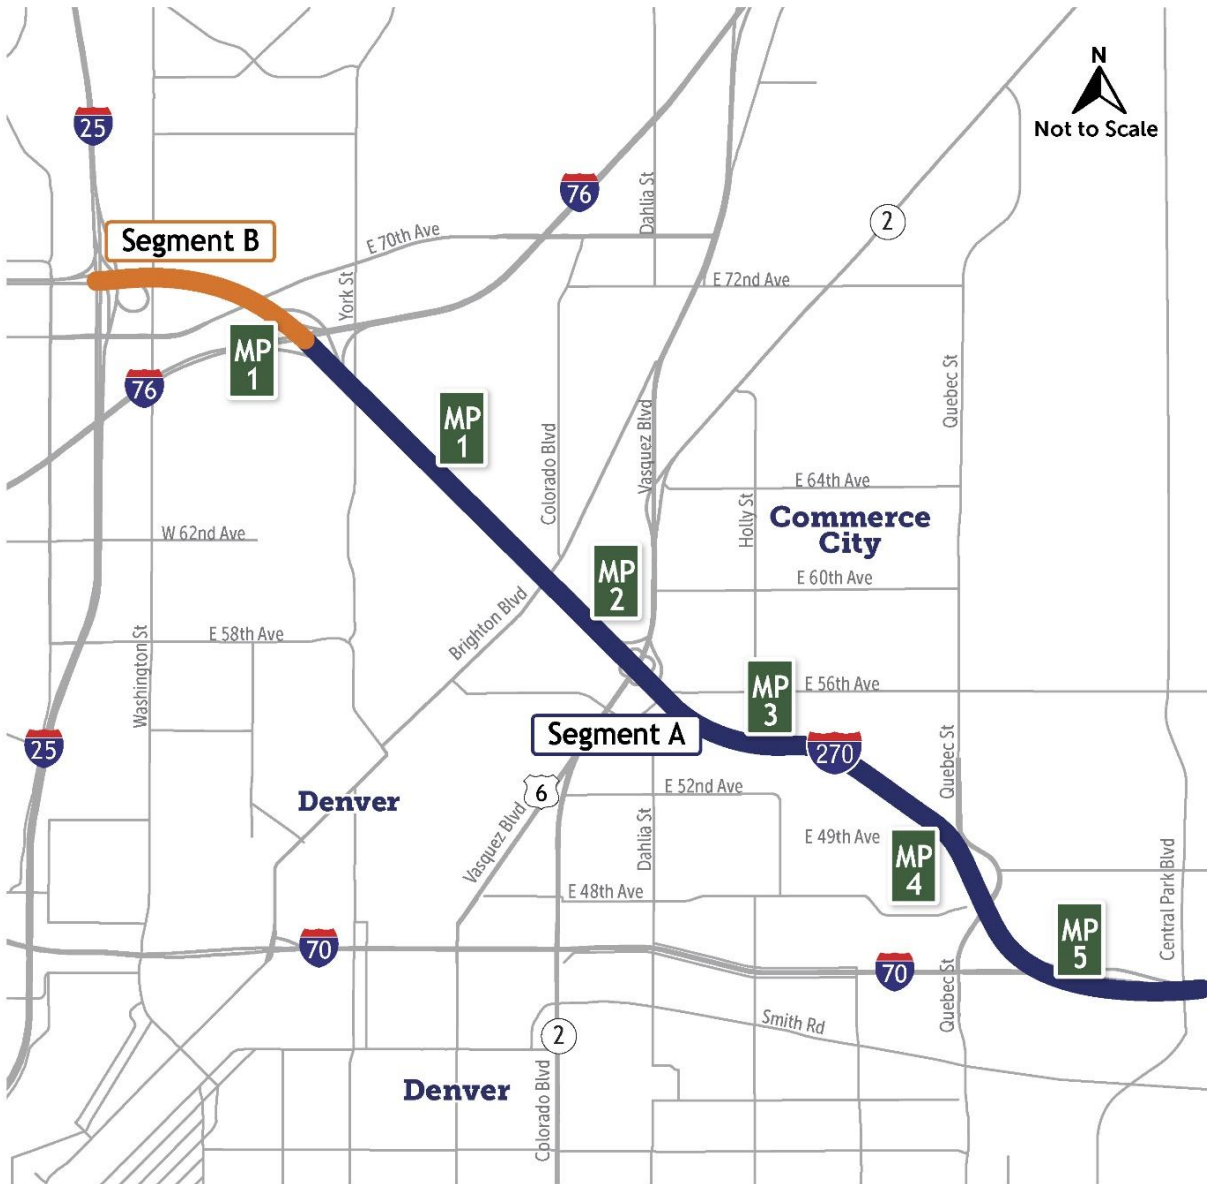
**Figure 6. I-270 Corridor Segments and Mile Markers**

Location specific crash data is referenced in this technical report by segment and mile marker. Corridor-wide crash metrics and statistics have been summed across both segments. Figure 6 illustrates the corridor segments and mile markers.
