3.7 Geologic Hazards

This section summarizes the initial investigation of impacts on the geologic resources found in the natural and man-made settings in the Corridor area. The highly complex and varied ground conditions include a wide range of active physical and chemical processes with the potential to pose hazards during construction and operation of the transportation system. I-70 is located along a corridor influenced by numerous faults, adverse rock structure, landslides, rockfalls, debris flows, avalanches, and collapsible soil. Many of these naturally occurring hazards have affected previous projects and continue to affect the mobility of the existing transportation system.

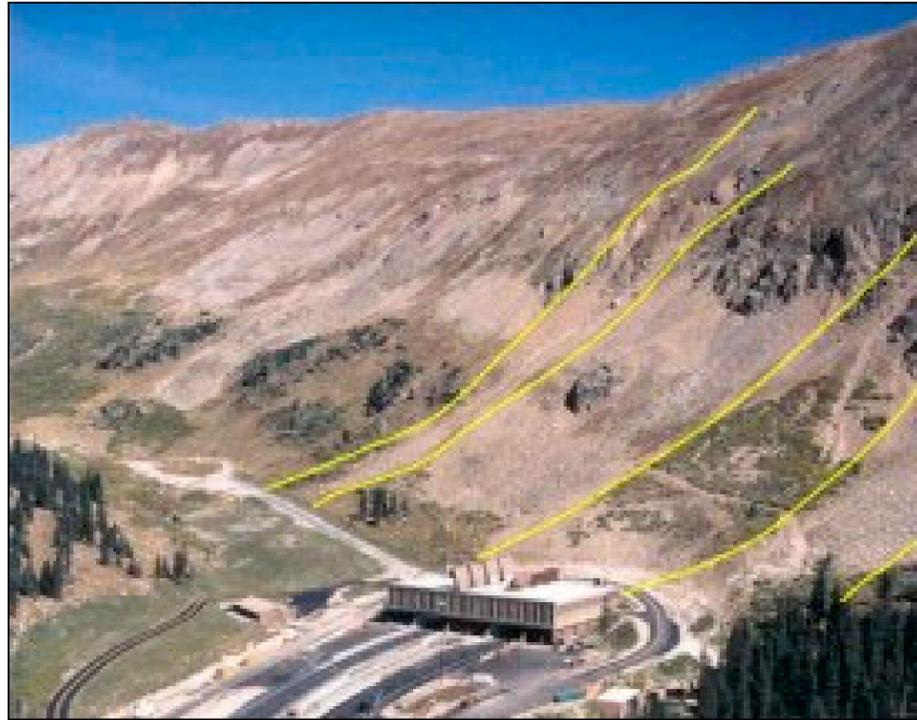
Figure 3.7-3. Avalanche Chutes, EJMT West Approach

Runout zones of several avalanches are located along the western approach to EJMT. The chutes on the mountainside above the west portals (as shown on Figure 3.7-3) are more active, and could potentially reach the interstate. (I-70 has been closed in the past due to avalanche hazard here.) Avalanches originating from the southern flank of Mount Bethel east of EJMT have been mitigated by installing a snowdrift fence and constructing a detention basin in the runout zone. Charges dispensed from helicopters are used to activate snowslides that could potentially threaten I-70 and appear to be an effective means of mitigating such hazards.

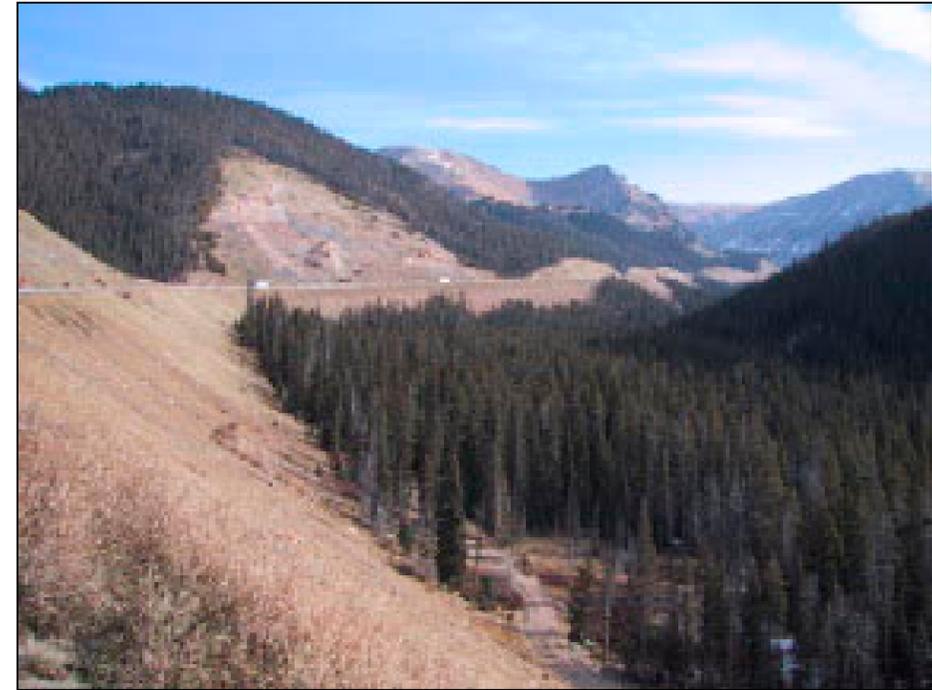
In Figure 3.7-4, cut-and-fill sections are obvious from the poorly vegetated slopes left after construction of I-70. Recently, this area has been part of an aggressive revegetation and erosion control program implemented by CDOT to mitigate many of the effects of previous I-70 construction.

Figure 3.7-4. Cut-and-Fill Slopes Along I-70

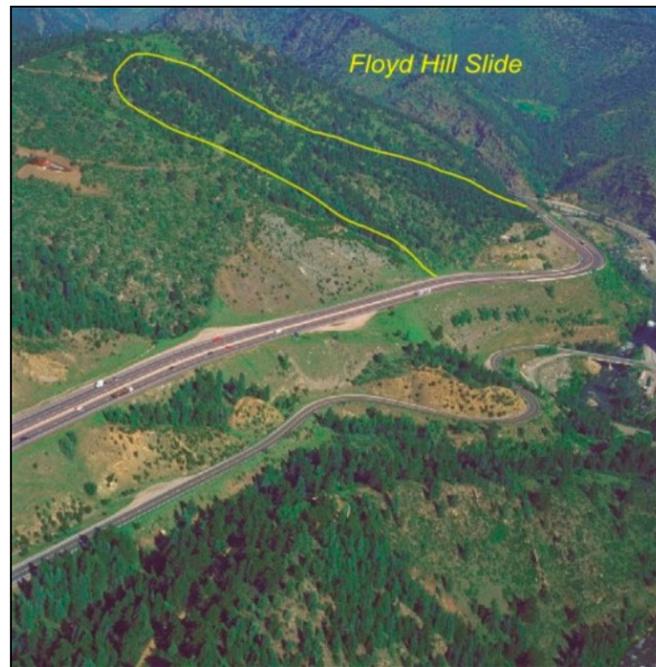
Figure 3.7-6. General Boundary of Floyd Hill Rockslide
