1.0 PURPOSE AND NEED

This Environmental Assessment (EA) for the State Highway (SH) 82 Grand Avenue Bridge in Glenwood Springs, Colorado, describes the alternatives being considered for improvements within the study area, including the Proposed Action identified by the Federal Highway Administration (FHWA) and the Colorado Department of Transportation (CDOT). It also identifies potential impacts of the Proposed Action and mitigation for those impacts. This EA has been prepared in accordance with National Environmental Policy Act (NEPA) provisions and applicable regulations. As the lead agency for this Proposed Action, the FHWA is responsible for supervising the NEPA analysis. CDOT, as the project sponsor and co-lead agency, prepared the EA and documentation. The City of Glenwood Springs is a cooperating agency.

SH 82 GRAND AVENUE BRIDGE

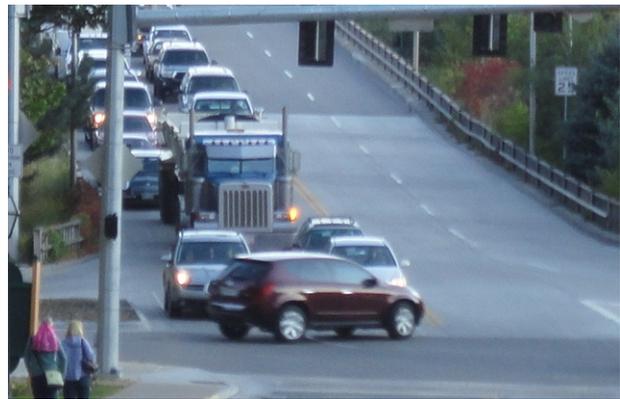
A truck taking up both lanes on the bridge worsens traffic congestion.

On the bridge, the lanes are a substandard width (9 feet 4 inches instead of the standard 12 feet) and there are no shoulders. These conditions impair the ability of the bridge to provide connectivity. Vehicle safety and mobility are impaired because they:

- ❖ Force larger vehicles (transit buses, emergency service vehicles, oversized passenger vehicles, etc.) to cross over into the second lane, occupying two full lanes of traffic.
- ❖ Create an unnerving environment for drivers.
- ❖ Limit drivers' ability to make emergency maneuvers.
- ❖ Hinder the response time of emergency service vehicles. The narrow lanes make it difficult for emergency response vehicles to pass other vehicles on the bridge without entering into oncoming traffic. Narrow lanes also delay emergency response times because there is limited space for vehicles to pull to the side of the bridge and yield.

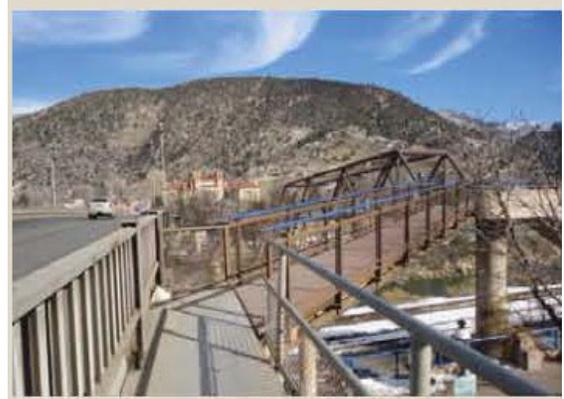
The existing pedestrian bridge does not meet the requirements of the Americans with Disabilities Act.

The pedestrian bridge was completed in the mid-1980s, and was not built to be accessible according to current Americans with Disabilities Act (ADA) standards. A 250-foot-long ramp is the only non-stair access to the pedestrian bridge, which is located to the east of the roadway bridge. The width of the ramp is generally 4 feet except where light posts narrow the width to 3.5 feet in several locations, the slope exceeds 5 percent for more than half of the bridge length, and there are no landings.

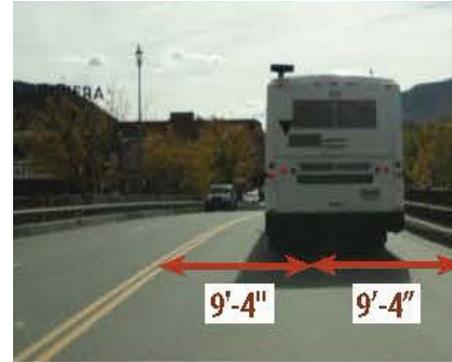
Converting the bridge to four lanes narrowed the lanes to a substandard width.

Bridge Width. When the bridge was converted to four lanes, the lane widths had to be narrowed. The existing lane widths are 9 feet 4 inches that narrow down from 11-foot-wide approach lanes at the south end of the bridge. Standard state highway lane widths are 12 feet. In addition, there are no shoulders on the bridge. The bridge inspection rating for bridge width is 2 out of 9.

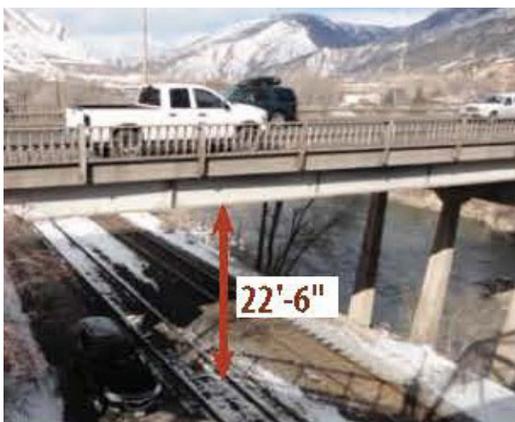
UPRR standards and federal regulations require an additional 10 inches in vertical clearance over railroad tracks.

The existing bridge crosses over the UPRR with a vertical clearance of 22 feet 6 inches. While some crossings exist and operate acceptably with less vertical clearance, the minimum vertical clearance for a grade-separated crossing of a railroad, per federal regulations, is 23 feet 0 inch. The existing vertical clearance over the UPRR is 6 inches less than required, which makes it substandard according to both the federal and American Railway Engineering and Maintenance of Way Association (AREMA) requirements, along with being 10 inches less than the UPRR minimum guidelines. The existing impaired clearance restricts the movement of specific railcar types and high-wide loads, and impacts railroad maintenance activities.

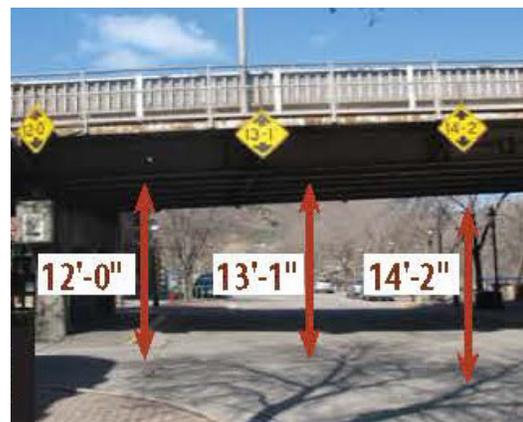
The bridge girders have been damaged by tall vehicles on 7th Street passing under the low bridge.

The existing bridge's vertical clearance from 7th Street to the bottom of the bridge girders varies from 12 feet to 14 feet 2 inches. Current standards require a bridge to have a clearance of 14 feet 6 inches over local streets. The combined rating for the two bridge vertical clearances is 3 out of 9.

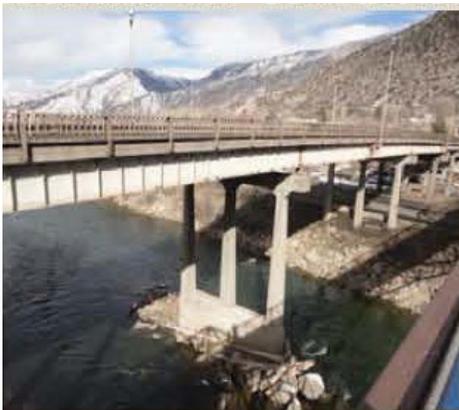
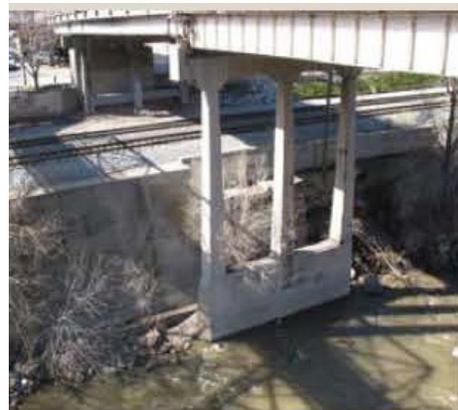
The bed material that supports the pier footings erodes, particularly in years of high water flows, compromising the piers over time.

Bridge Piers and Footings Susceptible to Scour. The predicted scour depth for a 100-year flood event for the pier in the river is over three feet below the footing. A recent hydraulic assessment found the bridge to be “scour critical,” meaning that the bridge foundations have been determined to be unstable for assessed, calculated, or observed scour conditions (AMEC, 2014). Specifically, erosion has been observed below the concrete footing that supports the piers in the river. The bridge needs to be monitored closely during and after a high water event or closed if monitoring is not feasible. In addition, the hydraulic analysis determined that the bridge is unstable at flow rates below a 500-year flood event. CDOT’s 2013 bridge inspection report (CDOT, 2013) rated the bridge’s piers and abutments a 6 out of 9 because the piers were showing deterioration, corrosion, and exposed reinforcing steel. Figure 1-3 illustrates the existing bridge pier scour.
