**TO: THE BRIDGE AND TUNNEL ENTERPRISE BOARD OF DIRECTORS**  
**FROM: JEFF SUDMEIER, CHIEF FINANCIAL OFFICER**  
**DATE: NOVEMBER 18, 2021**  
**SUBJECT: FOURTH SUPPLEMENT TO THE FISCAL YEAR 2021-22 BRIDGE AND TUNNEL ENTERPRISE BUDGET**

This month the Bridge Tunnel Enterprise (BTE) Board of Directors (Board) is being asked to approve a budget supplement to establish the construction phase for the replacement of E-17-GW and E-17-GV, I-76 over York Street.

**BE04S22 - ATTACHMENT A: PHOTOS OF E-17-GV EXISTING CONDITIONS**

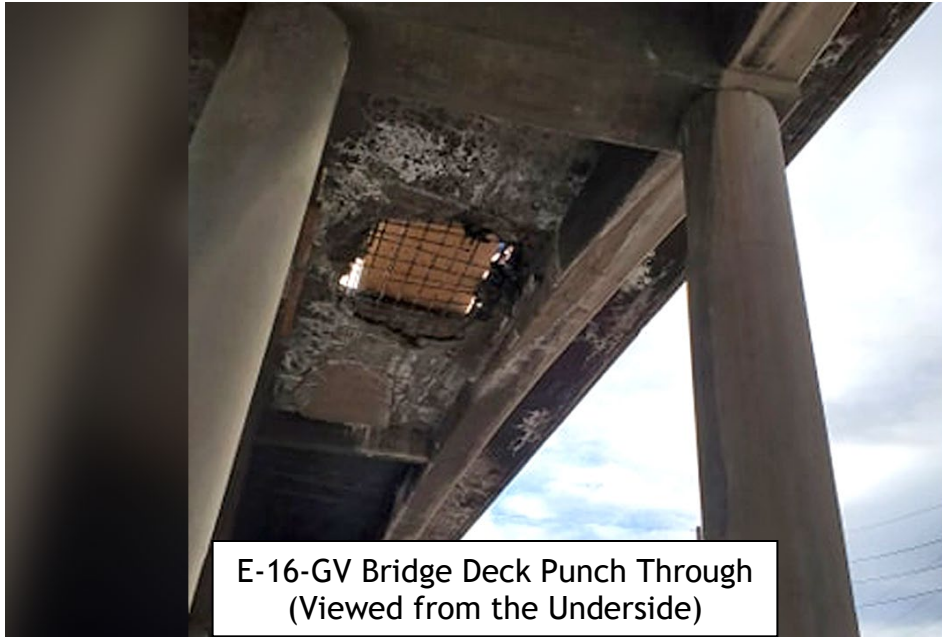
- In February of 2020, a large hole formed in the deck of the westbound structure after an existing full-depth patch repair fell onto York St. below (photos provided in Attachment A). The National Bridge Inventory (NBI) deck rating for both structures was subsequently downgraded to “poor” condition with a rating of “4”.

E-16-GV Bridge Deck Punch Through  
(Viewed from the Underside)

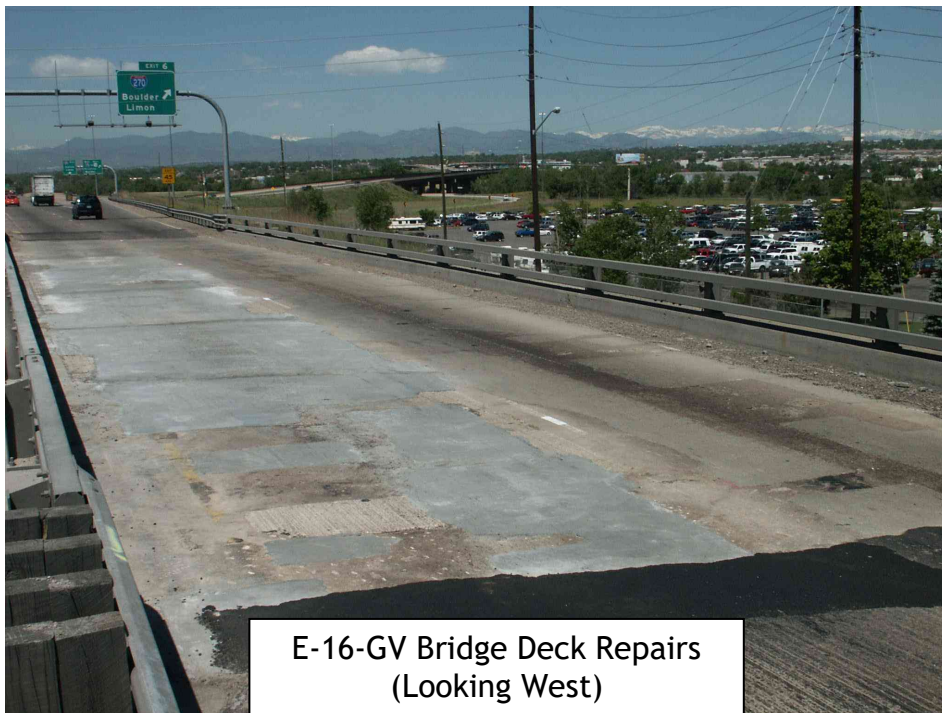
E-16-GV Bridge Deck Repairs  
(Looking West)

- The structures have had numerous repairs and retrofits during the last decade. The repairs have temporarily provided enhanced safety for the traveling public but do not address the underlying structural condition issues as evidenced by the falling concrete.
