# **Aquatic Resources Delineation Report**

Bridge O-19-D

FINAL

**January 2021**

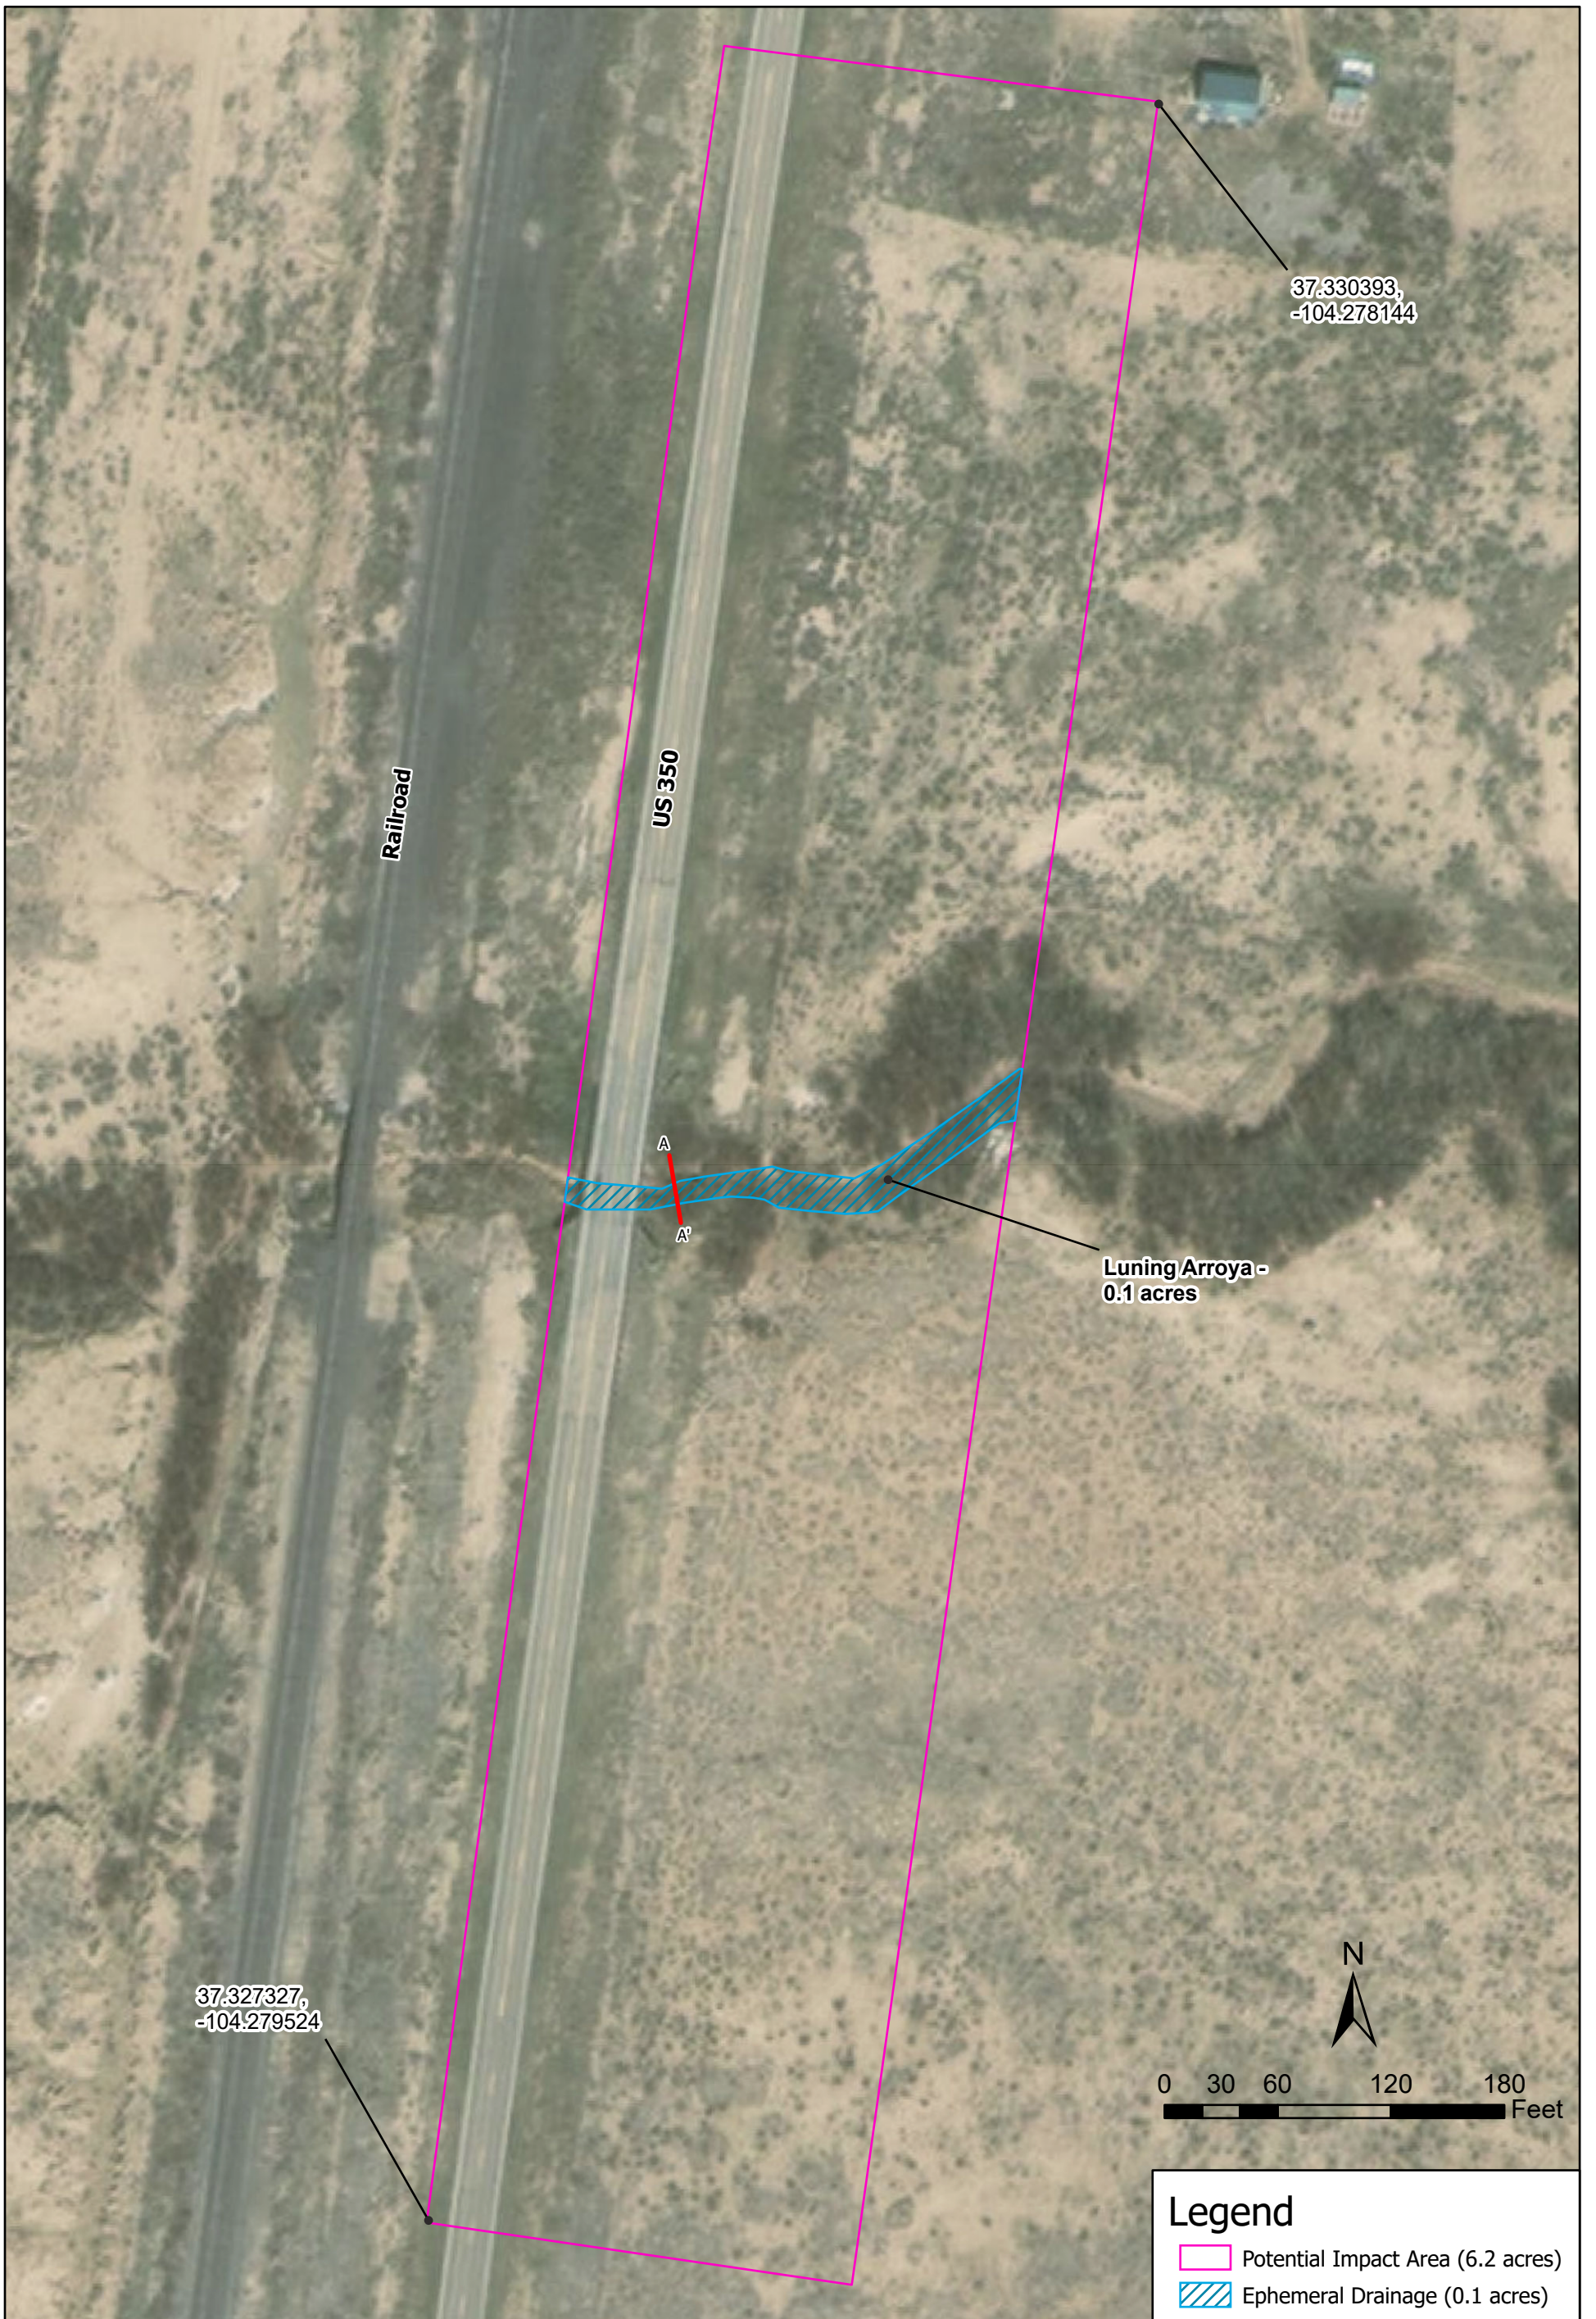
**Figure 2: Aquatic Delineation Map**

The Luning Arroyo is an ephemeral drainage (0.1 acres and 245 linear feet) flowing through the PIA from west to east. The watershed for the drainage is a shallow valley west of US 350 and is approximately 0.69 mi<sup>2</sup> in size (based on USGS Streams Stats calculation – USGS 2020). Approximately 1,900 feet upstream of the bridge crossing is the Model Ditch, which crosses over the drainage. After crossing under the O-19-D bridge, the Luning Arroyo flows east and then into an area where the channel appears to become indistinct and perhaps becomes more of a shallow basin approximately 1,600 feet to the east, according to aerial imagery. However, about 1,300 feet later the channel appears to reform and continue east and into the Purgatoire River approximately 19 miles later. The Purgatoire River flows northeast until its confluence with the Arkansas River in approximately 63 miles at Las Animas.

The channel area is highly incised in places, with near vertical banks, suggesting some high flows in a highly erodible soil. Dense vegetation lines much of its banks though this reach of the arroyo with a variety of arid and riparian shrubs and small trees (see above in Section 4.4 Plant Communities). The OHWM was observed as a fully developed bed and bank with scour, soil cracking, stained leaves, and debris wracking. The channel varies some and is a little wider under the bridge and farther downstream (See Figure 2: Luning Arroyo, and Appendix D: Photo Inventory). The channel was very dry at the time of investigation, but likely has flows seasonally and/or after storm events.

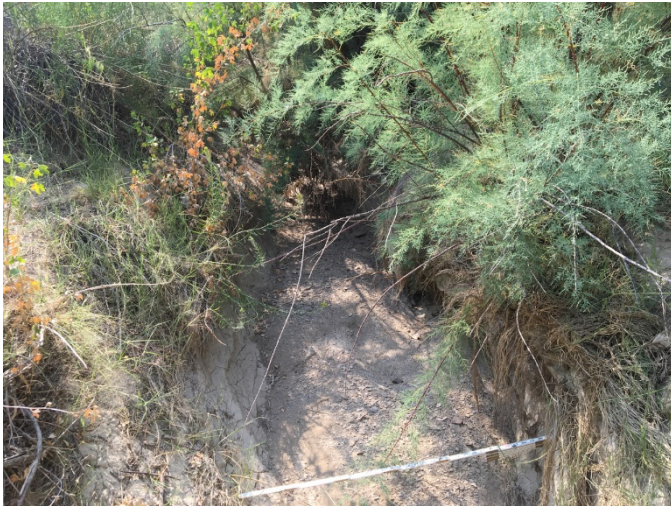
**Photo 1.**  
**Luning Arroyo**, looking east and downstream from bridge, at cross section A. Ruler near bottom of channel, OHWM at top of incised channel at base of vegetation.

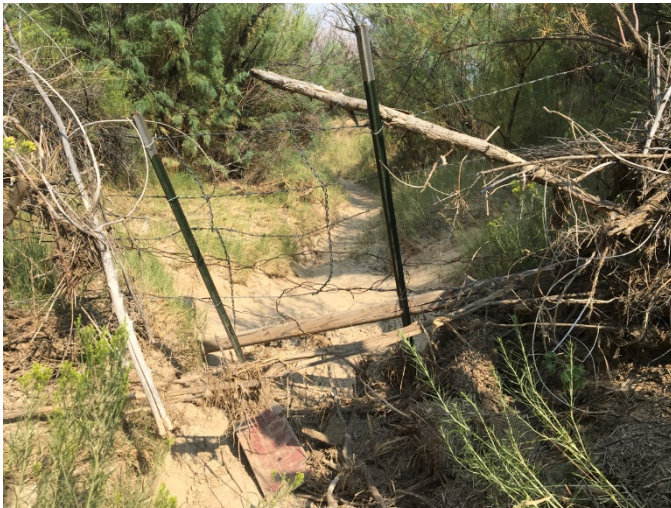
**Photo 2.**  
**Luning Arroyo**, looking east and downstream from bridge, farther east from cross section A, at ROW fence boundary.

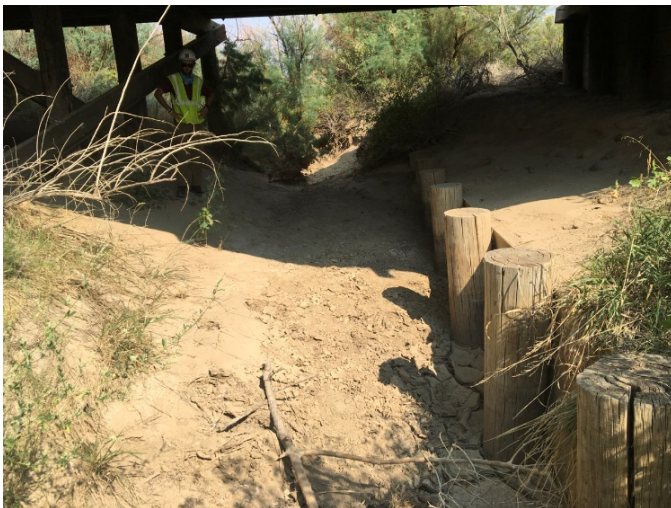
**Photo 3.**  
**Luning Arroyo**, looking east and under bridge structure. OHWM widens out some due to bridge structure, from pilings on the right to approximately where field person is standing.

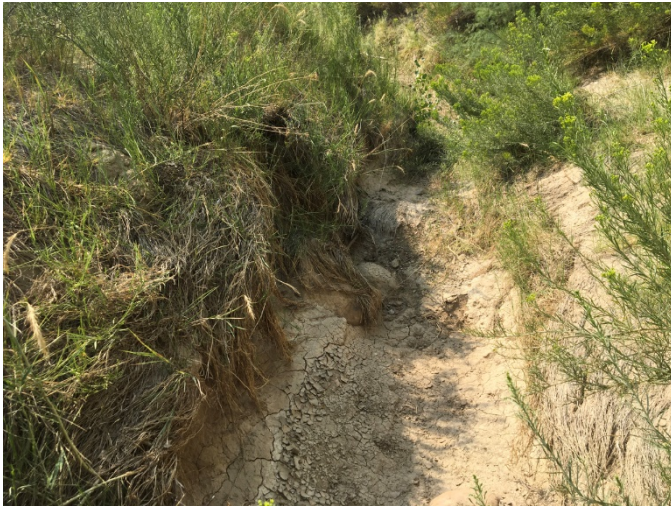
**Photo 4.**  
**Luning Arroyo**, looking west and upstream of bridge. Incised channel with soil cracking and water stained leaves can be seen.

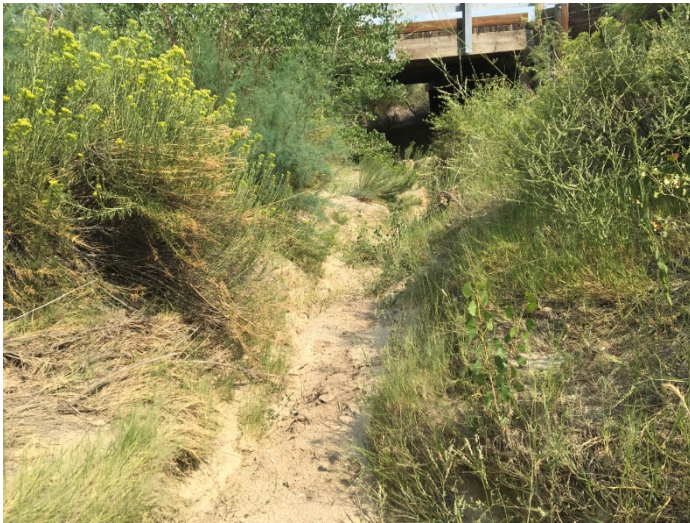
**Photo 5.**  
**Luning Arroyo**, looking east and upstream of bridge. Banks widening out some here, soil cracking, water stained leaves, and wrack can be seen.
