COLORADO

Department of Transportation

RE: Asbestos and Lead-Based Paint Inspection Report for Bridge M-22-U located at US Highway 350 over Otero Ditch at MM 69.817 Southwest of La Junta, Colorado

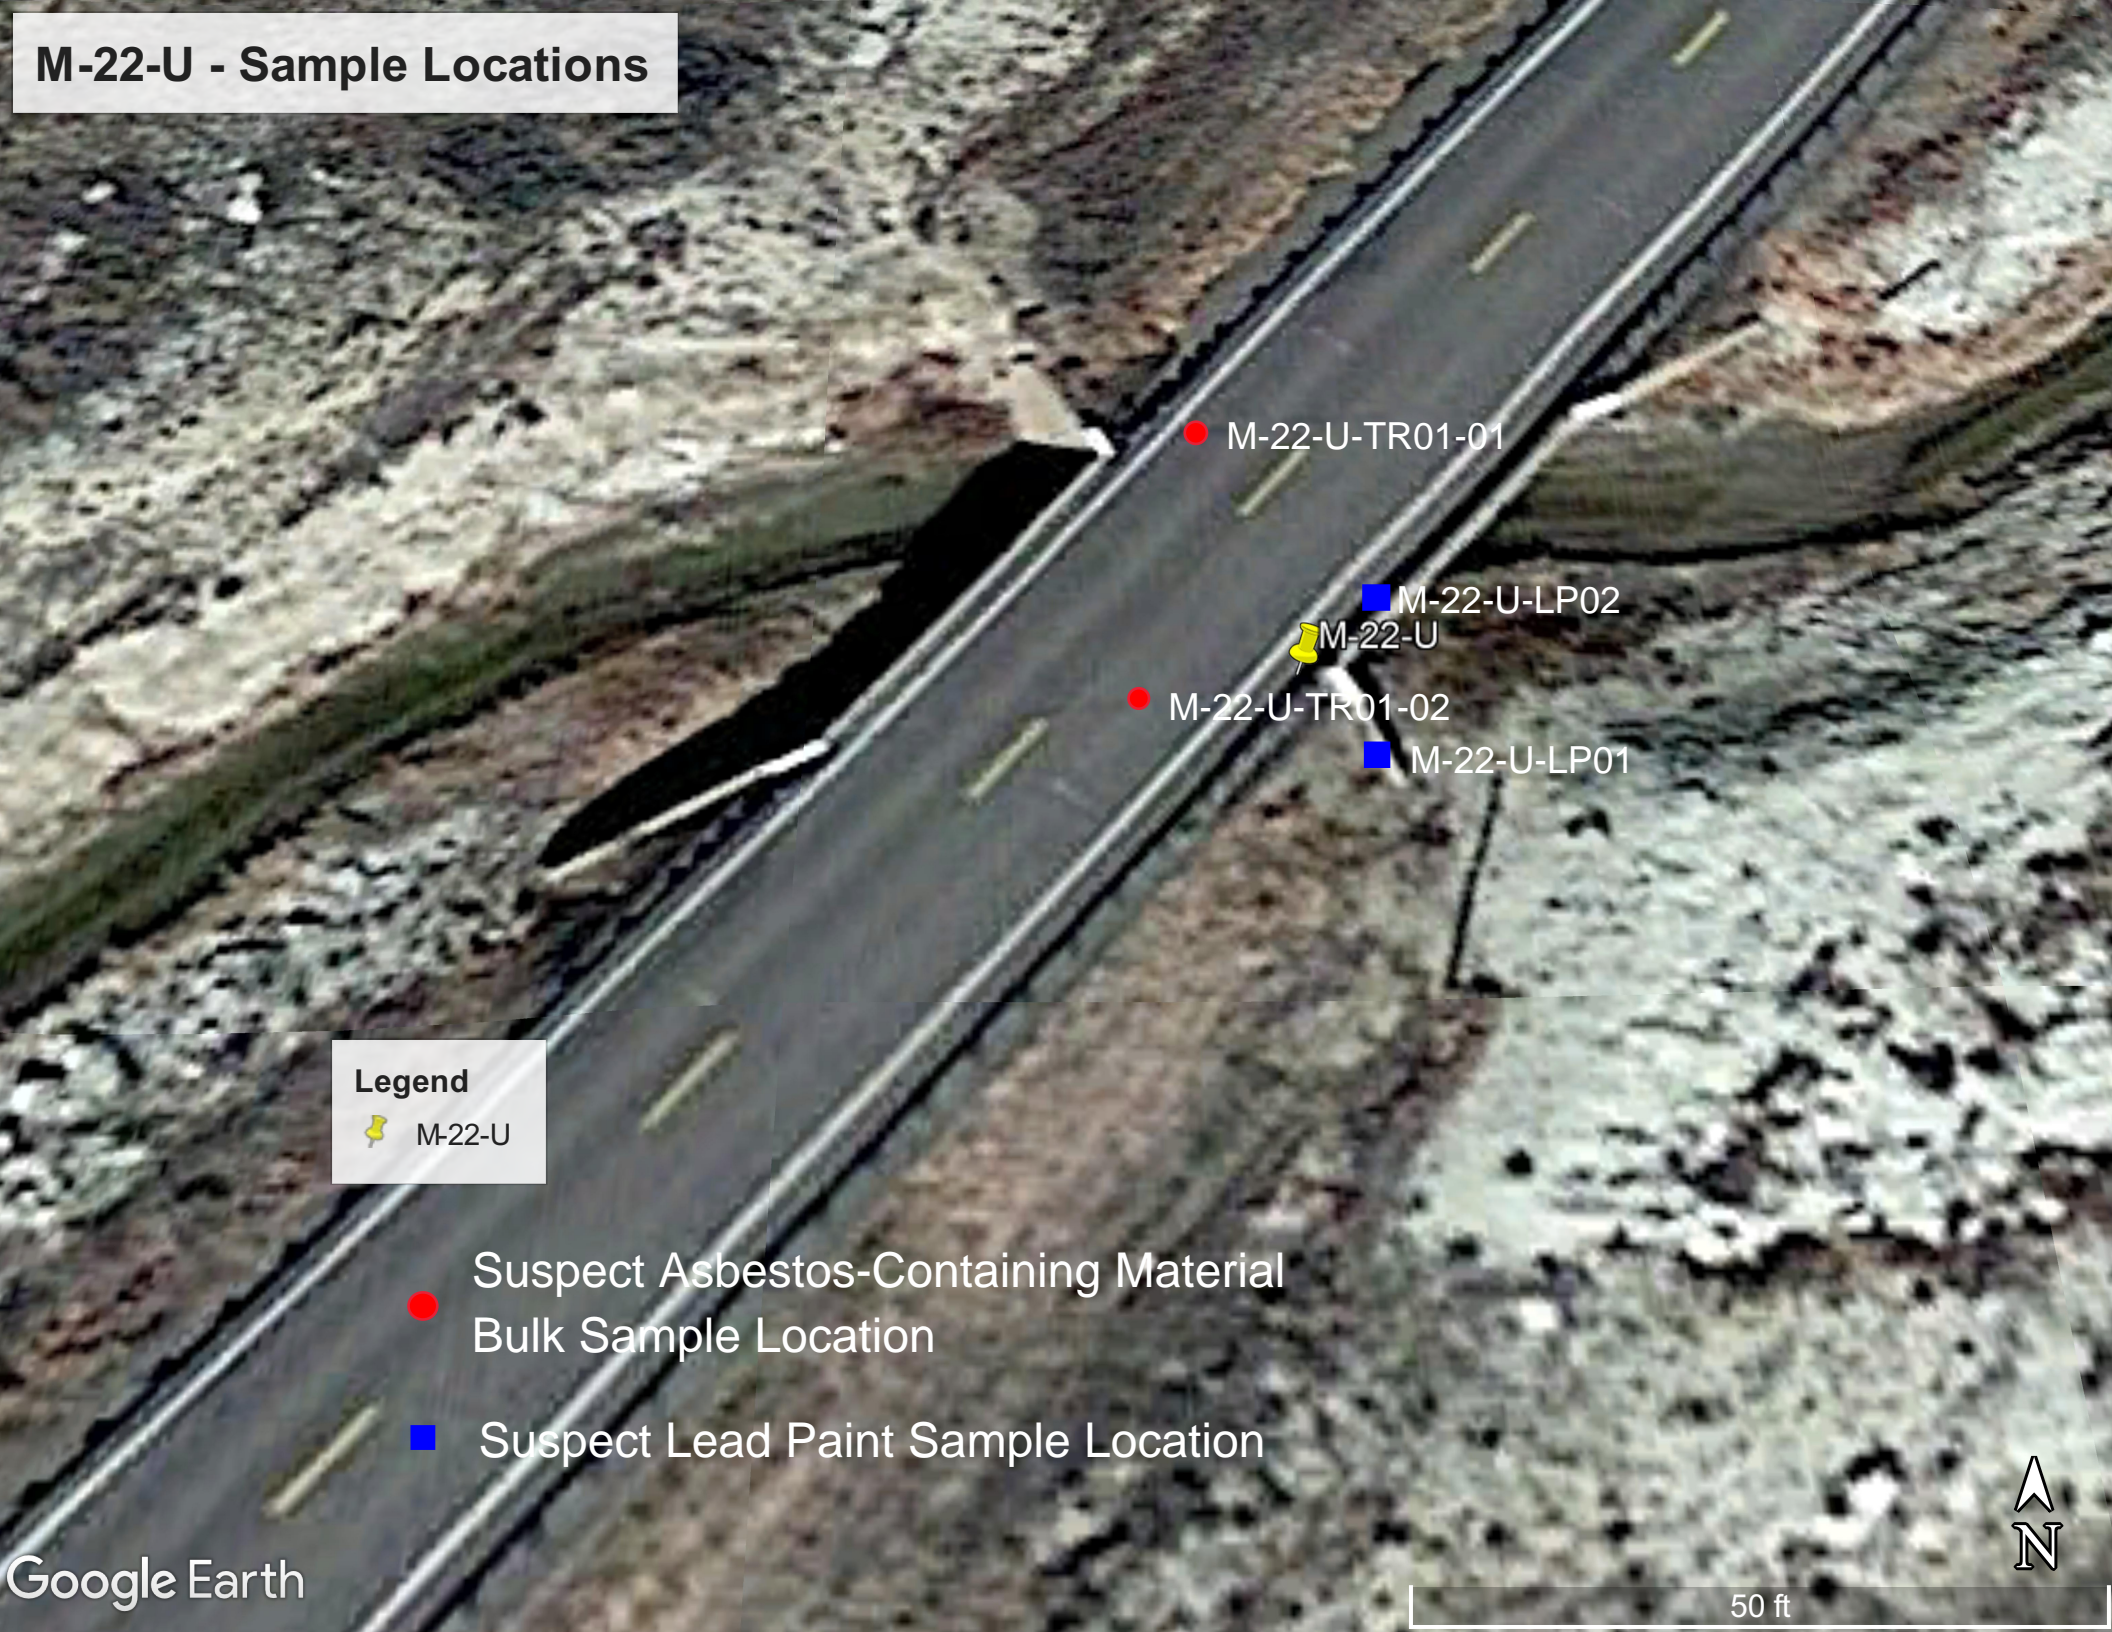
M-22-U - Sample Locations

Suspect Asbestos-Containing Material Bulk Sample Location

Suspect Lead Paint Sample Location

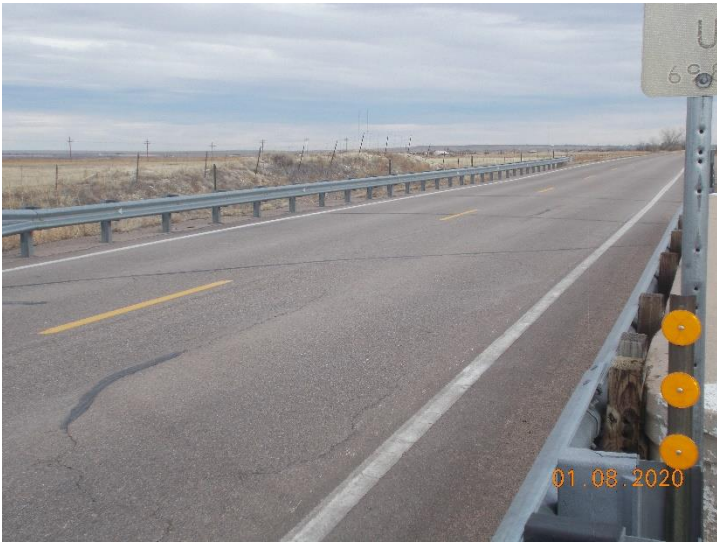
View of bridge M-22-U looking north.

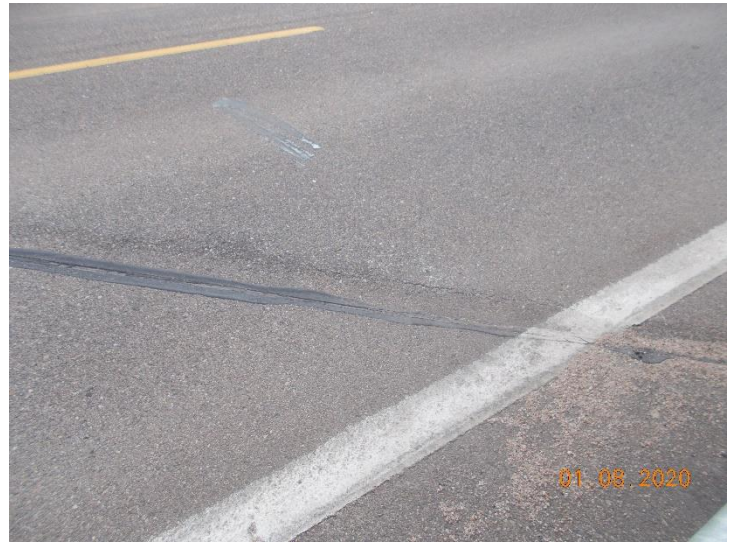
One suspect asbestos-containing material (ACM) was identified during the inspection. Two bulk samples of a black tar expansion joint material were collected from the deck of the bridge. The two bulk samples were non-detect for asbestos.

Suspect asbestos-containing material M-22-U-TR01. The tar expansion joint material is non-detect for asbestos.

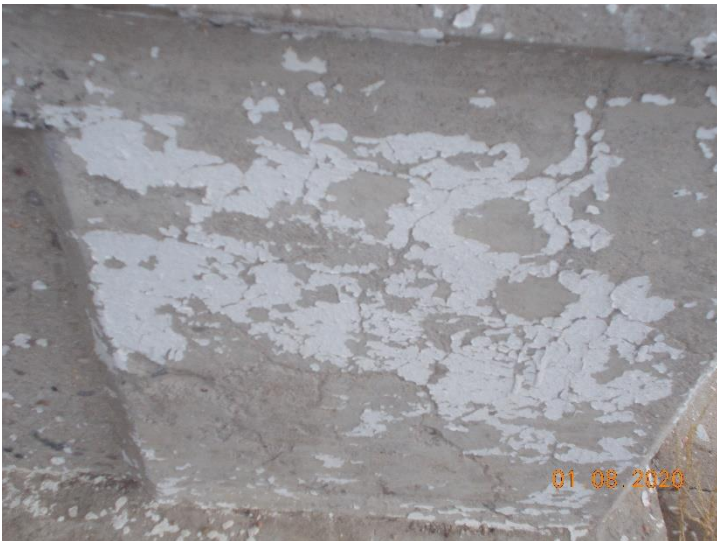
Two paints were sampled from the bridge structure. A white paint chip sample was collected from a concrete wing wall from the southeast of the bridge (sample M-22-U-LP01). The white paint was below the threshold of 0.5% as a lead-based paint but is considered as a lead containing paint. A second paint sample was collected from a black paint, from beneath the deck off a metal girder (sample M-22-U-LP02). This black paint was also on a portion of the concrete abutment adjacent to the girders. This paint contains 38.5% lead and is considered a lead-based paint.

Paint sample M-22-U-LP01. The white paint is considered lead-containing paint.

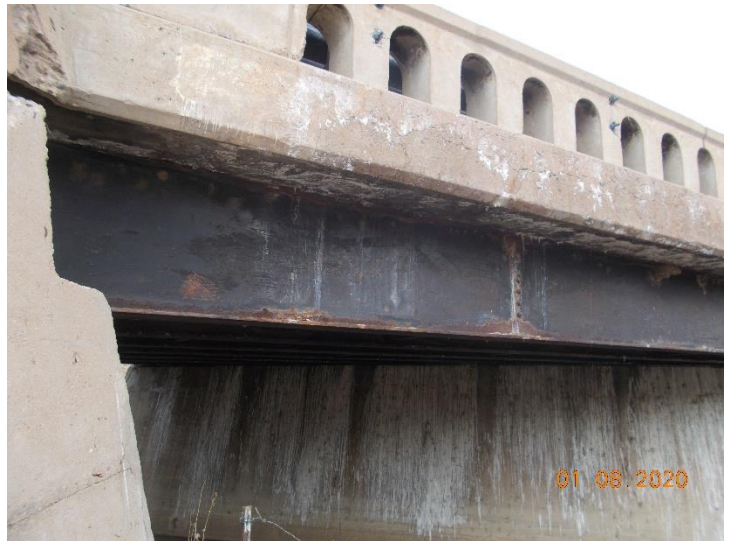
As the lead-based paint was observed on a substrate other than metal, a composite sample of bridge components, including the black lead-based paint, was collected and submitted for Toxicity Characteristic Leaching Procedure (TCLP) analysis. The sample was collected to determine if the components of the bridge structure would be considered as hazardous waste. The TCLP laboratory result for this bridge structure revealed a result

of 0.27 milligrams per liter (mg/l) of lead. The debris from the bridge is therefore classified as solid waste (and not hazardous waste) as the TCLP result was less than the regulatory limit for lead of 5.0 mg/l.

Paint sample M-22-U-LP02. The black paint on the metal girders is considered lead-based paint.

The black paint located on the metal girders and concrete is a lead-based paint. If the paint will be disturbed by repair or removal activities, it is recommended that paint removal and waste disposal work be performed in accordance with 29 CFR 1926.62 and Section 250.04 of the 2017 CDOT Standard Specifications for Road and Bridge Construction Handbook. ACMs were not identified on the structure during the bridge inspection. Please contact (720) 582-0694 with any questions or concerns regarding this report.
