## Colorado Procedure 58-07

### Detecting and Measuring Temperature Segregation of HMA

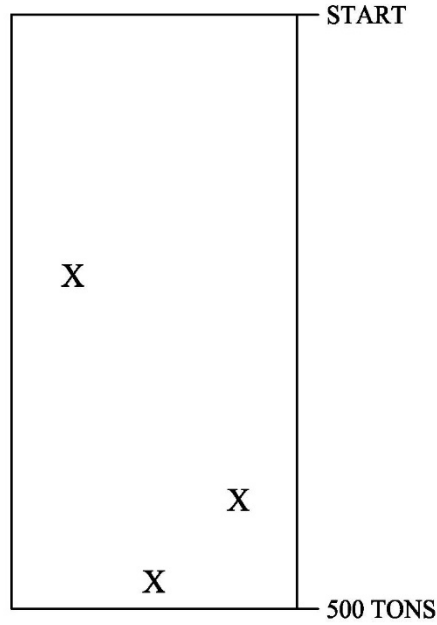
**Figure 58-1: Temperature Segregation Study Done Correctly**

In Figure 58-1 below, the tester performed the temperature segregation check correctly. A start was established and 500 tons were checked for temperature segregation. Three cool areas were found in the 500-ton temperature segregation check.

- 4.1 Mark the start of the area that will be examined. The tonnage of the area can be calculated in length by using 110 lbs/yd<sup>2</sup>/inch or can be found by tracking asphalt tickets. See Figure 58-1.

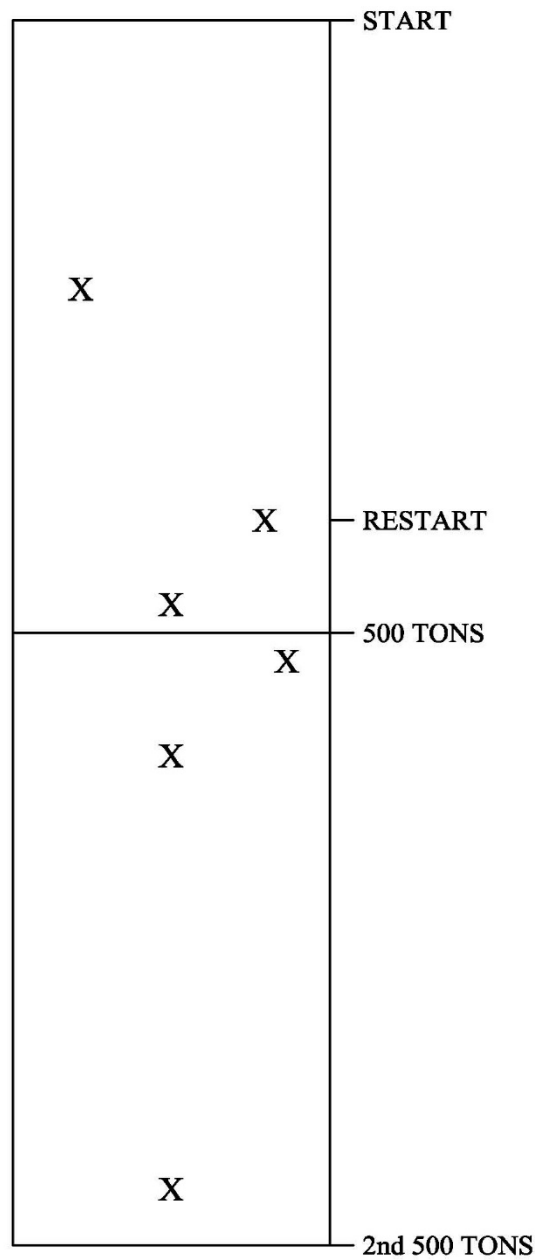
**Figure 58-2: Temperature Segregation Study Done Incorrectly**

In Figure 58-2 below, the tester did not perform the temperature segregation check correctly. A start was established and the tester went about 400 yards finding just two cool areas. He then restarted the temperature segregation check at the second cool area by establishing a new 500-ton test section. This resulted in finding five cool areas over the next 500 tons. This is incorrect.
