**Regarding: Notice of Intent & Request for Quick Release for flooding and road damage in Southwest Colorado**

### **Overview of Damages**

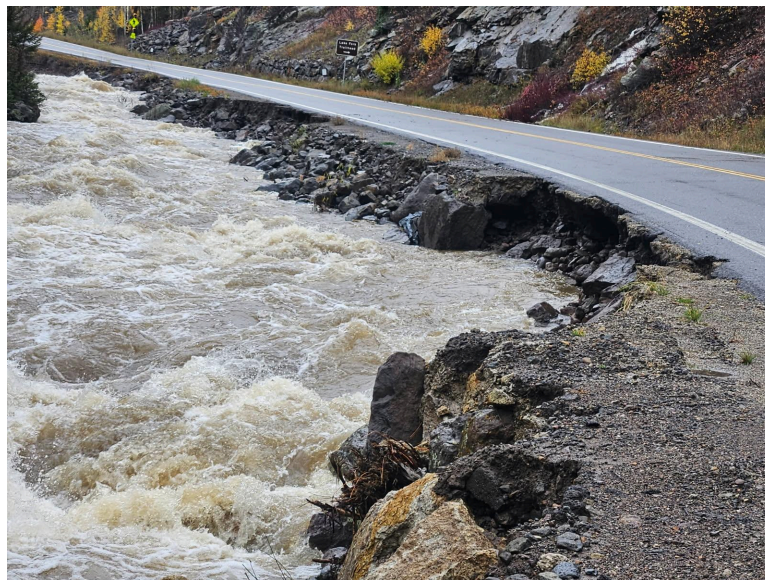
- **Damaged highway, MP 176 to 183 (Narrows):** Flooding of the South Fork of the Rio Grande has caused shoulder damage and undercutting of the roadway along a three to four-mile stretch of the highway. The undercutting extends approximately six feet into the travel lane, about half of the eastbound lane. Floodwater levels within the river channel

next to the highway have been high, covering the road in some sections and making stabilization work difficult.

Shoulder damage and undercutting of the roadway on US 160 at MP 177

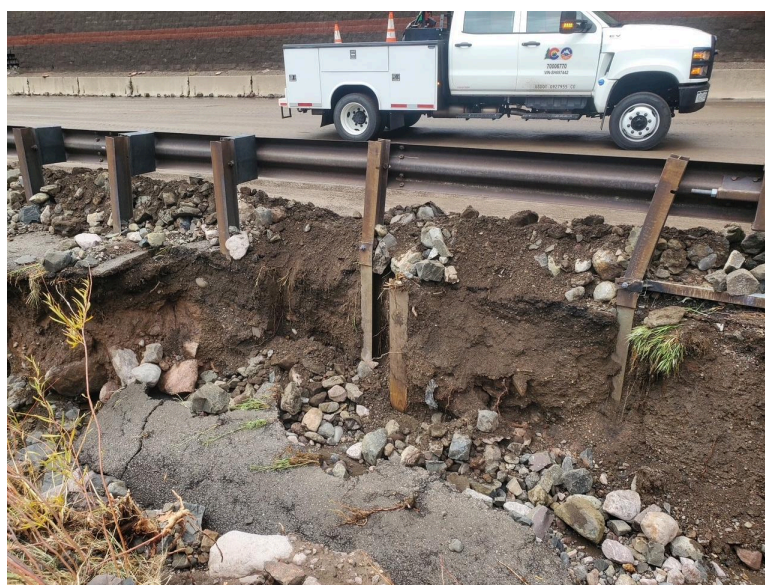
- **Various damage to highway structures, MP 160-165:** Torrential rains and heavy runoff have damaged a retaining wall that supports the highway. Significant repairs are needed at this location near the Wolf Creek Valley Scenic Overlook. Two rock walls that protect the highway from debris falling from the cliffs uphill of the highway were undercut, further towards the summit from the overlook. These rock walls will need to be stabilized. Significant cutting to the roadside ditch in this stretch has also been identified.

Retaining wall damage on US 160 at MP 161

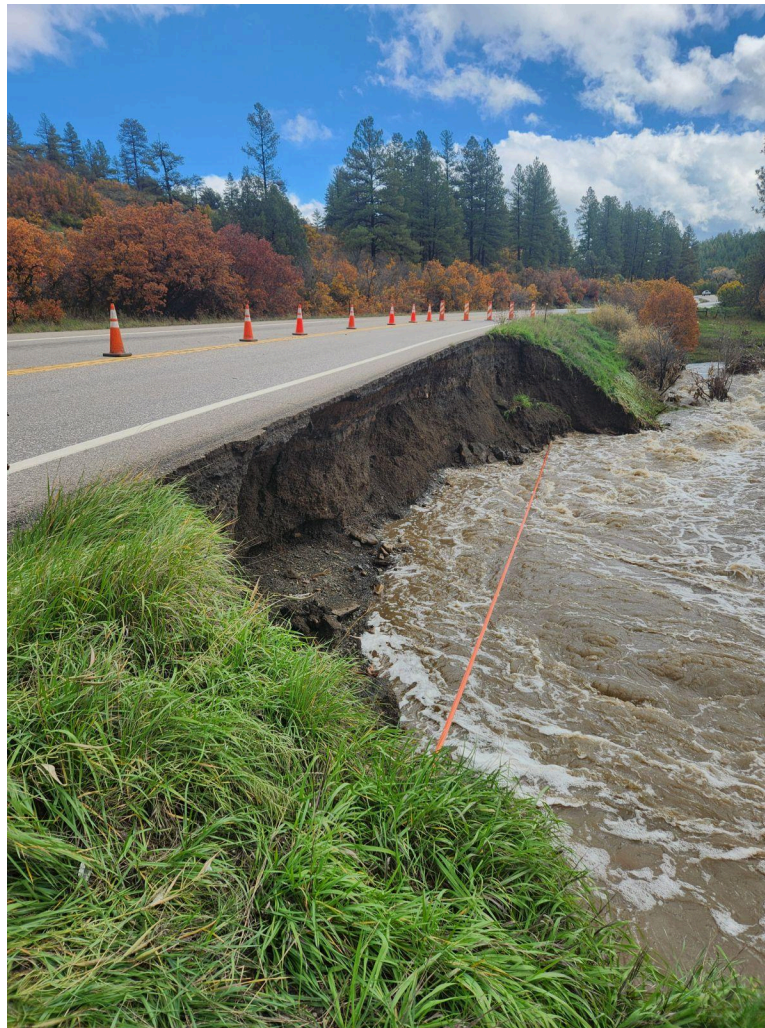
October 24, after flooding caused significant damage to the eastbound travel lane between Deer Trail Road and Elk Canyon/Hersch Avenue. Crews opened the highway to one-way alternating traffic, but motorists continue to experience delays, and a temporary signal and pilot truck are guiding traffic through the impacted area. Expected repair and reconstruction needs include:

Significant shoulder damage and undercutting of travel lanes on US 160 at MP 135

- Approximately 500 feet undercutting of the eastbound travel lane;
- Repairs to shoulder areas approximately 1,500 feet long on both sides of the highway;
- Up to a mile of major highway reconstruction (two to 12 foot travel lanes, and two foot shoulders);
- Culvert replacement and stream channel rehabilitation.

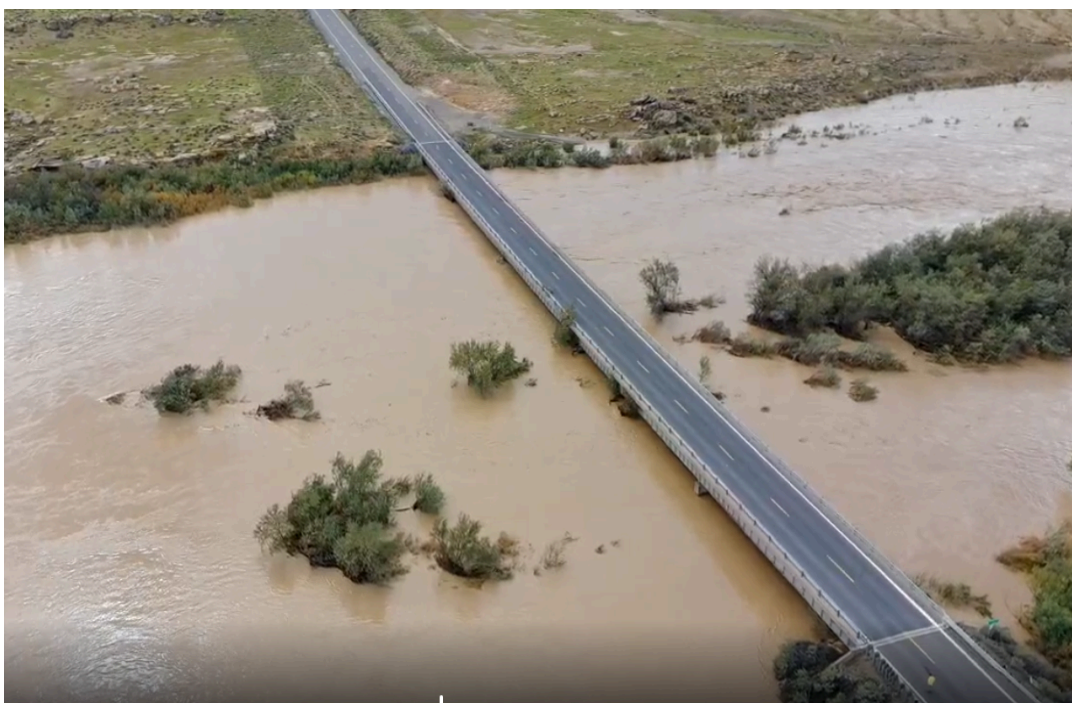
- **US 160 Four Corners Bridge (MP 1):** This bridge has been closed since October 24 due to rising floodwaters and will remain closed until flood flows decrease and inspections can confirm the bridge structure is stable and safe for the traveling public. At this time, CDOT is not estimating full replacement costs for this bridge. Water gauges at this bridge confirmed that the high flow reached the 500-year event level. CDOT is estimating that major scour protection will be required for the majority of the substructure, with high end estimates at approximately \$9 million.

San Juan River Bridge and floodwaters reaching the bridge girders on US 160 at MP 1

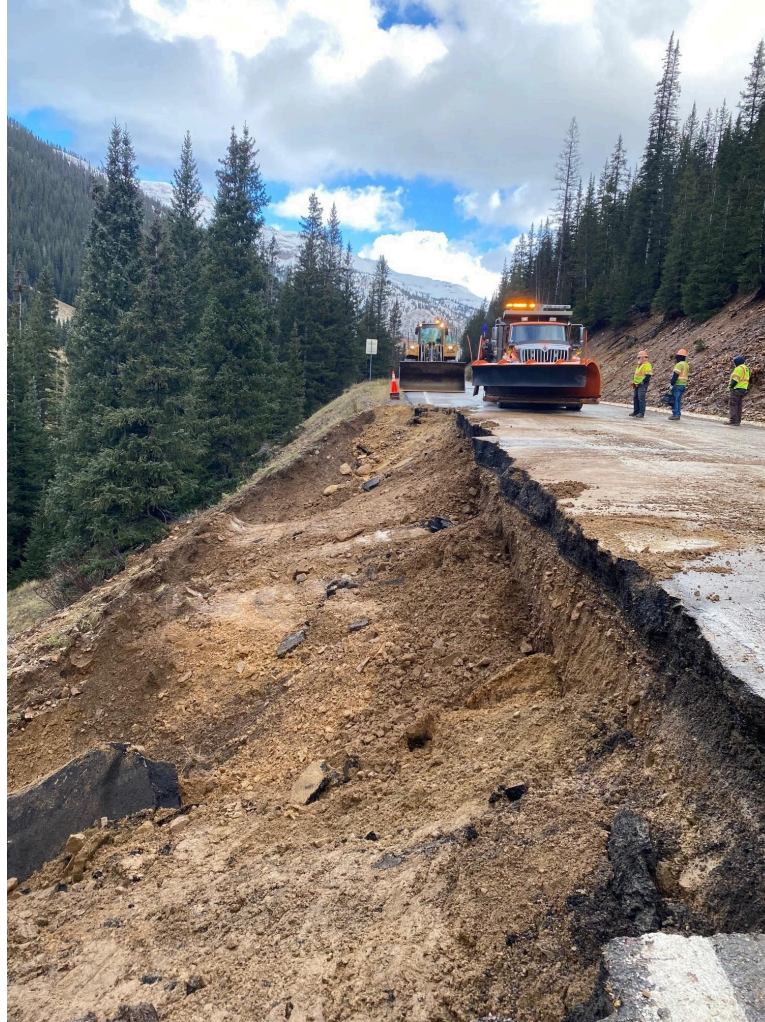
US 550, Red Mountain Pass, is a critical route for the communities of Durango, Silverton, Ouray, Ridgway and Montrose. US 550 at MP 75 was closed on October 22 due to mountainside flooding concerns and roadway damage. Due to the storm, two culverts were plugged by debris and water flowed over the highway and damaged the downhill embankment. The shoulder embankment and a portion of the southbound travel lane was washed away. The area of downhill embankment damage was approximately 100 feet (along the edge of the roadway) and 10 feet down the hillside. Crews were able to begin stabilization work at the area and open the highway to one-lane alternating traffic, controlled by a portable light signal on the

Damage to shoulder and southbound travel lane on US 550 at MP 75

evening of October 23. However, two culverts will likely need to be replaced, and the surrounding embankment stabilized.

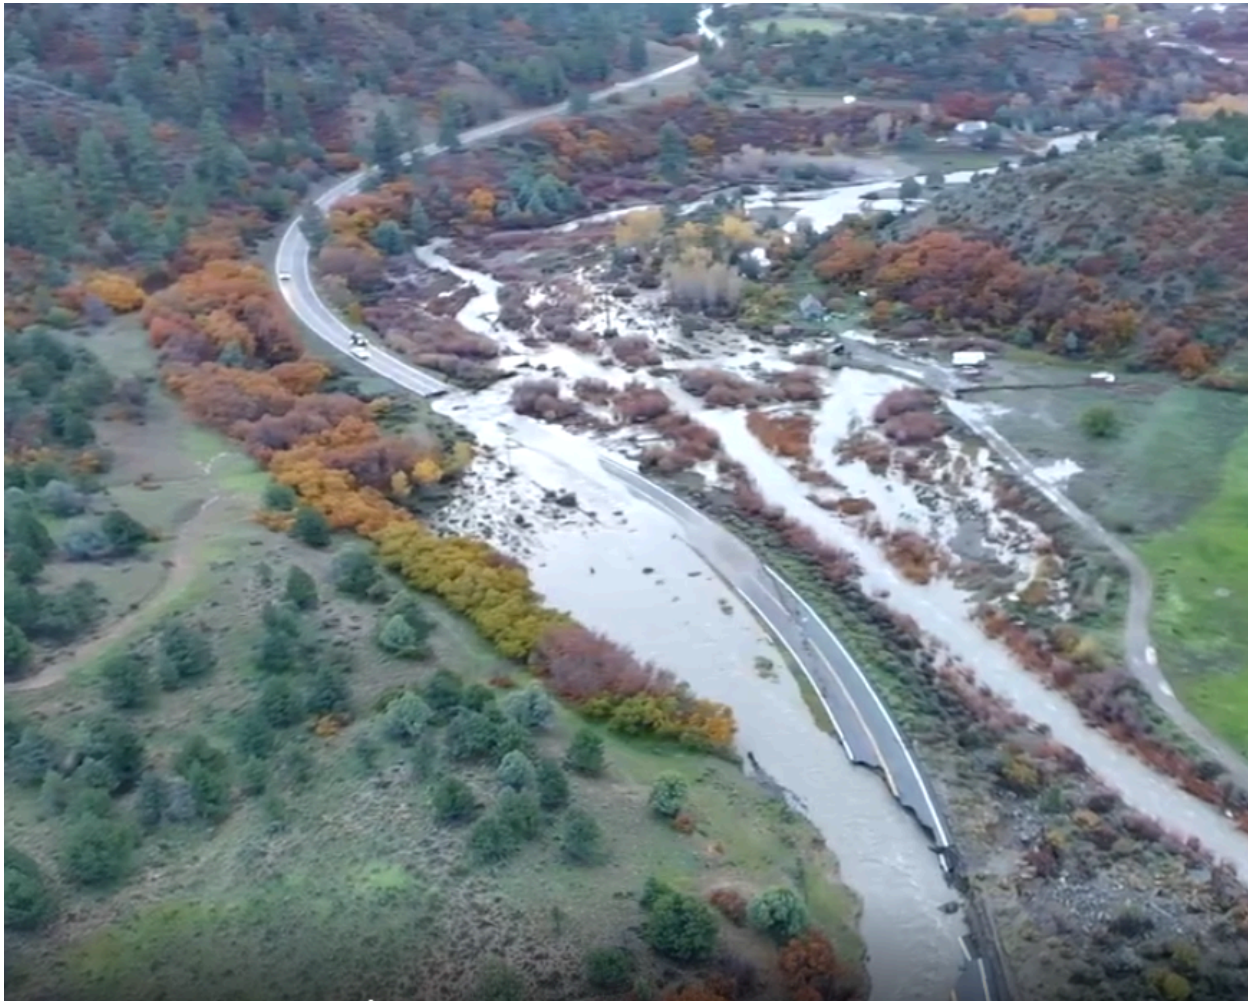
Floodwaters destroyed and washed away this segment of roadway, about seven miles south of the road's junction with US 160 in two locations. The first location is near MP 27, where the entire highway has been washed out, and Stollsteimer Creek is running down the highway alignment for approximately 1,200 feet. At MP 30, Stollsteimer Creek ran over the highway for 48 hours and undermined both sides of the highway for approximately 300 feet.

Highway destroyed by flood on CO 151 at MP 27

CDOT has begun planning for emergency reconstruction, which first includes the installation of a temporary access road for local residents and emergency responders. Permanent total reconstruction will require assessment and site preparation, subgrade stabilization and rebuilding, culvert replacement, side ditch building and surface treatment of asphalt overlay.
