**Biological Assessment
For the
Colorado Department of Transportation State Highway 83 Castlewood Canyon
Bridge Reconstruction Project
Douglas County, Colorado
7 January 2003**

Lead Agency: Colorado Department of Transportation

Cooperating Agency: Federal Highway Administration

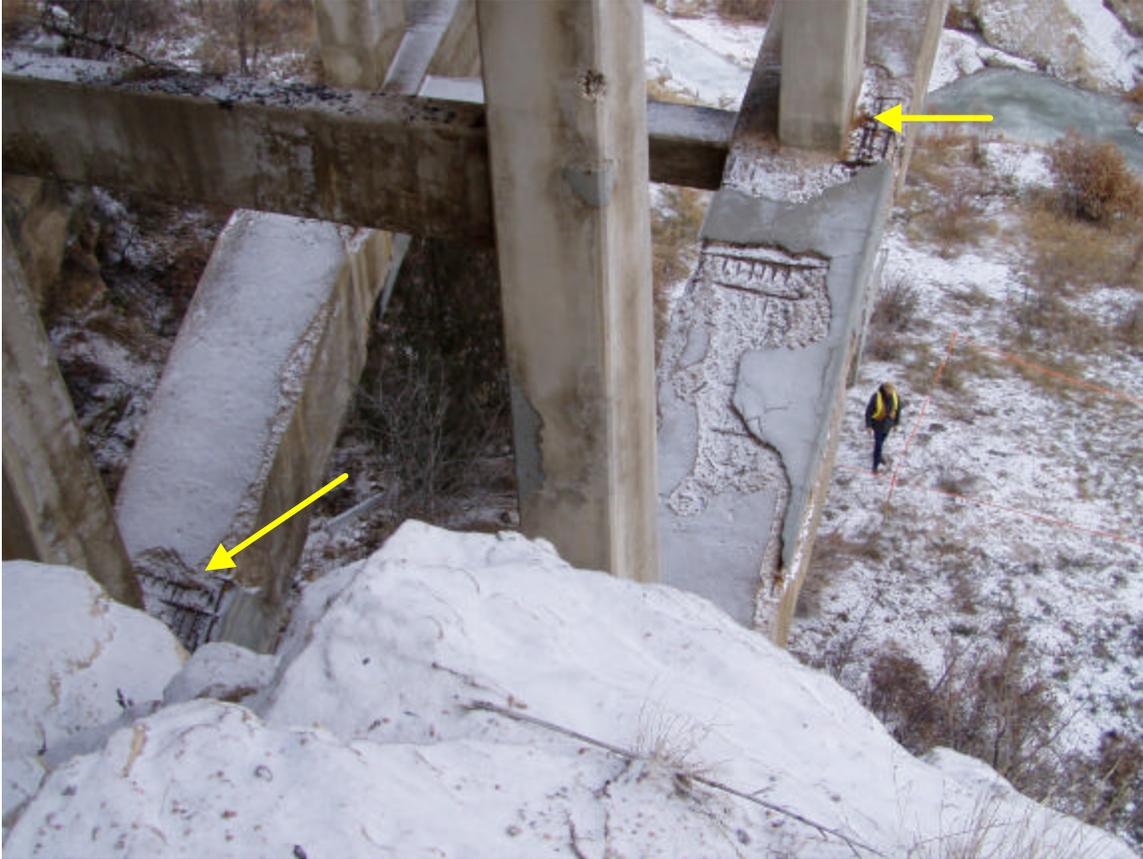
Photo 1: The arrows point to examples of the deterioration that has and is occurring on the bridge structure.

The project is located in Douglas County approximately 5 miles south of Franktown on SH 83. Bridge structure G-18-BL spans Cherry Creek on the eastern edge of Castlewood Canyon State Park. The Cherry Creek Bridge (G-18-BL) is a concrete two-rib open-spandrel arch that was completed in 1948. It was listed on the National Register of Historic Places in October 2002 (NRHP 2002) for its role in the development of transportation in the region, and for its structural configuration. The open-spandrel concrete arch is one of the most distinctive of highway bridge types. Despite their appeal, open spandrel arches were used infrequently on Colorado's highways and today only six remain in use. With its 70.5-meter (232-foot) span, the Cherry Creek Bridge is by far the longest of the concrete arch bridges in Colorado. Exposure to

the environment has lead to the concrete on the structure becoming weathered and deteriorated. Continued deterioration of the structure would make it unsafe for use. The structure has been patched in the past but these areas are now in need of additional repair (Photo 1). Because of the historical nature of this structure repairs instead of replacement is necessary.

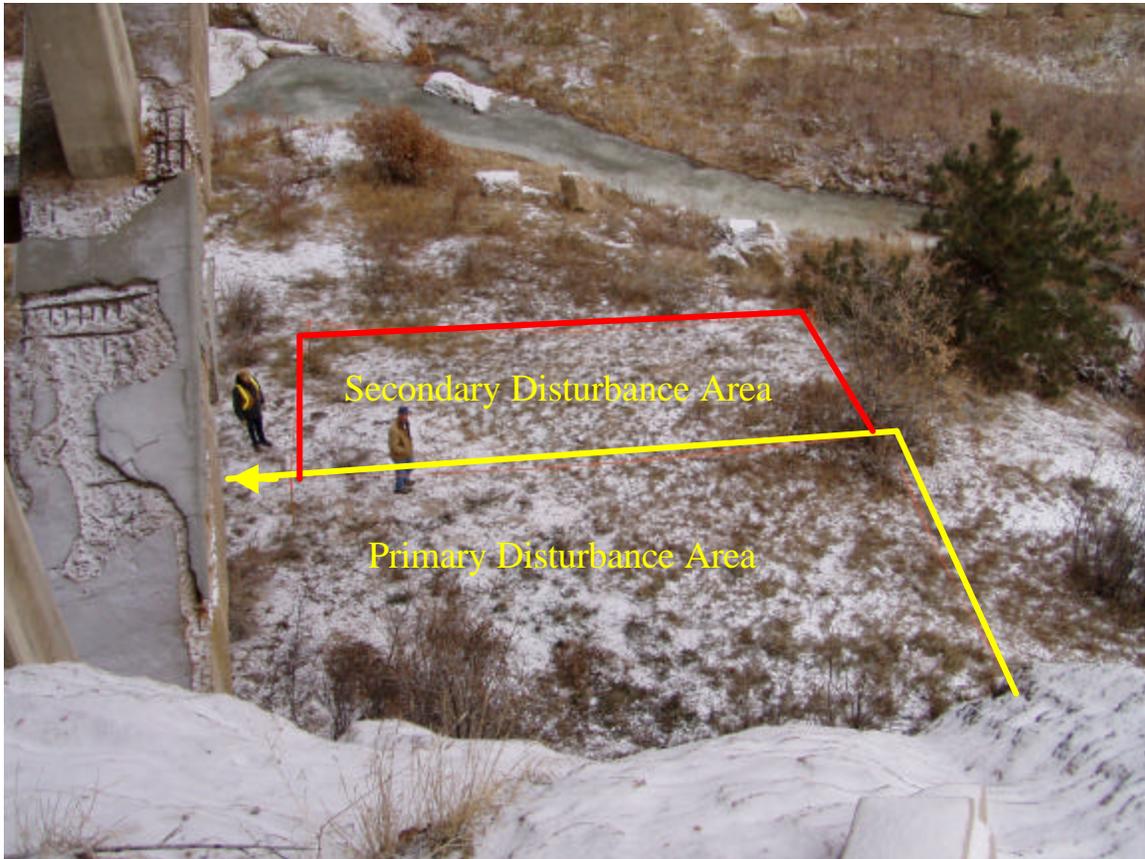
Photo2: This photo shows the primary and secondary disturbance areas at the south footer. The arrow is intended to show that the primary disturbance area continues west to the canyon wall. For additional clarification please refer to the attached disturbance area diagram.

The top of the south arch foundations are buried approximately 3.6 meters (12 feet) deep. The required excavation will be approximately 306 cubic meters (400 cubic yards) of material. To limit impacts two

areas were delineated for use on the south side; these are noted as primary and secondary disturbance areas (Photo 3). The primary area will be the main work zone on the south side. This is where the backhoe will be lowered into the canyon and also where fill material shall be stockpiled until placed back in the area from which it was excavated. The secondary impact area will only be used if there is more fill material excavated than what can be stored in the primary area. The estimated area of the primary disturbance area is 290 square meters (3150 square feet) and the secondary area is estimated at 56 square meters (610 square feet) (see attached site diagram). The existing topography around the south arch foundations is generally flat with a slight slope adjacent to the arch and does not have the large boulders found at the north footing location.

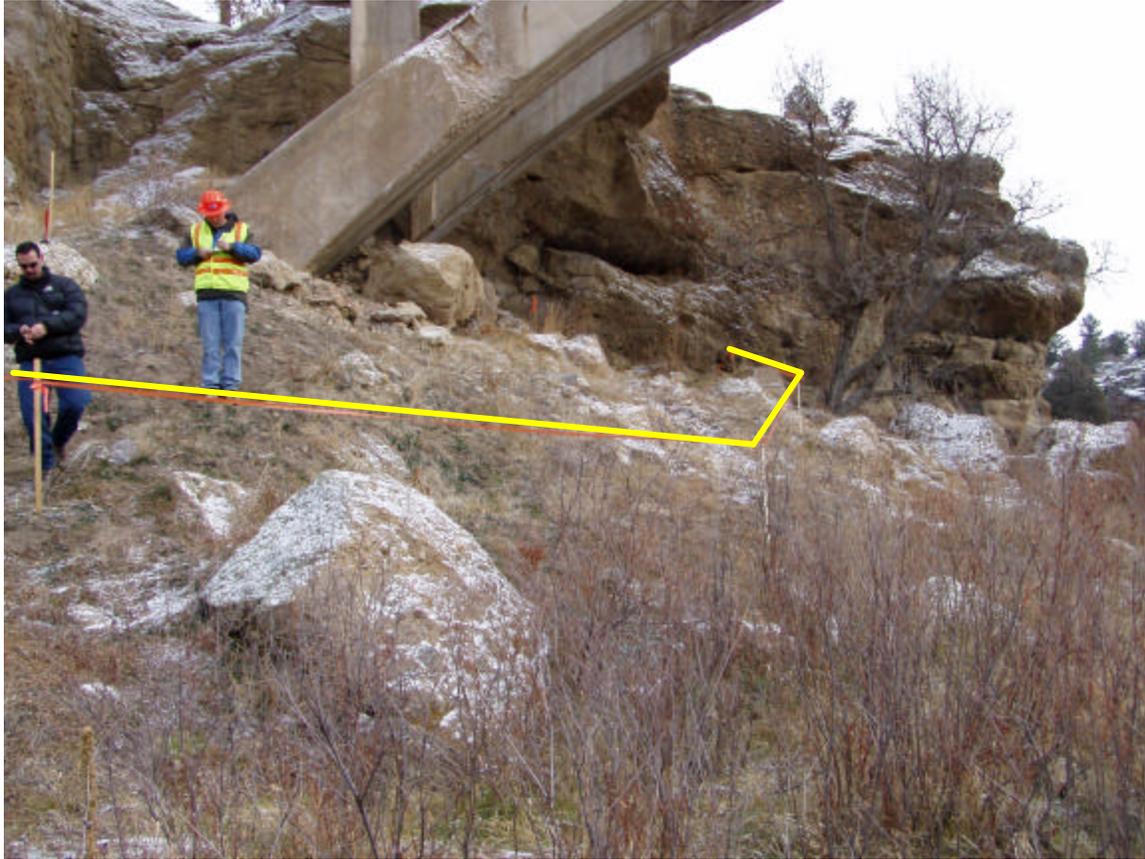
Photo 3: This photo shows the maximum disturbance area for the north footers.

The north arch foundations are partially exposed and as such will not require significant excavation. The estimated amount of material excavated is approximately 153 cubic meters (200 cubic yards). A small tracked backhoe will be lowered from the bridge deck to the canyon bottom using a large crane. Bare, rocky areas exist directly adjacent to the arch foundations; however, the existing topography slopes rapidly away from the foundation and does not permit a platform for a small tracked backhoe to operate on. The ground immediately west of the foundation will be leveled for use as a work pad. This requires that a disturbance area large enough to operate the tracked backhoe needs to exist. The disturbance area will be used for the maneuvering of the backhoe on the west and south sides of the structure and also as storage for the removed fill material. The estimated area of disturbance is 299 square meters (3250 square feet) (Photo 2 and attached site diagram). The existence of large boulders on the surface adjacent to the arch will necessitate a requirement in the plans for the contractor to develop a procedure to contain the excavated material. This will ensure that these boulders do not roll into the bottom of the canyon. This could be accomplished by utilizing portable pre-cast concrete barrier or by creating an earthen berm.
