**Report No. CDOT-DTD-R-2002-5  
Final Report**

## **Cost of Sanding**

**Prof. Nien-Yin Chang  
Adj. Prof. Brian Brady  
University of Colorado at Denver**

**June 2002**

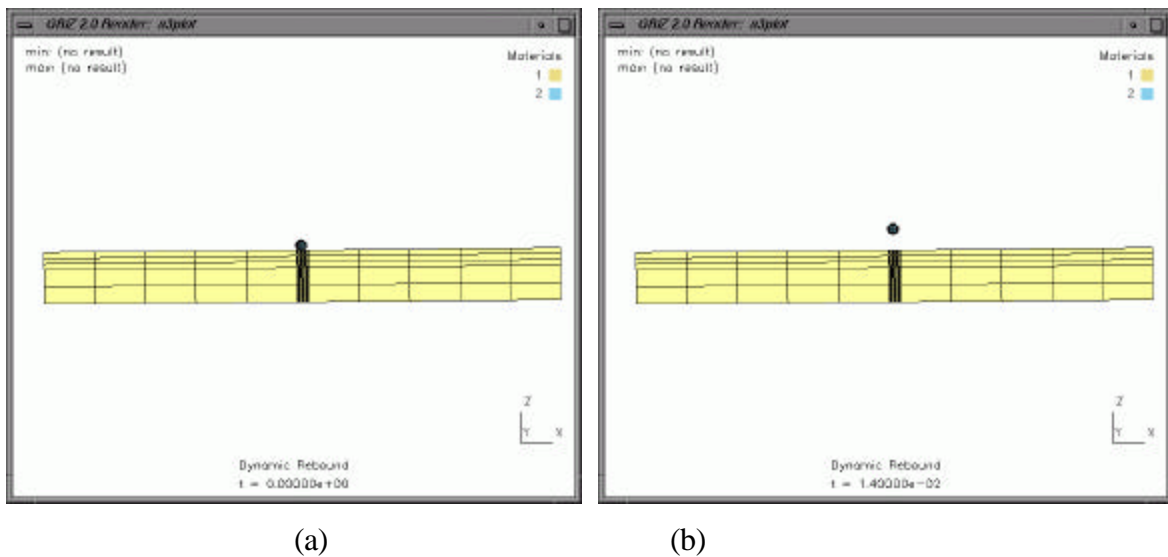
**Figure 6.3.3 FEM Mesh before(a) and after(b) Impact Load Applied on the Particle**

In the FE model, a portion of the pavement with dimensions of 9x9x1 ft and 0.066 ft diameter soil particle was modeled as solid parts using 8 noded brick elements. The FE mesh was generated using TrueGrid© software. Fixed boundary condition is assumed at the bottom of the pavement (X, Y, and Z motion is constrained). Lateral movements of pavement boundaries are restricted. The particle is assumed to move freely only in Z (vertical) direction. Figures 6.3.3 (a and b) show FE Mesh before and after impact loading respectively.
