**IN-SITU MONITORING OF INFILTRATION-INDUCED
INSTABILITY OF I-70 EMBANKMENT WEST OF THE
EISENHOWER-JOHNSON MEMORIAL TUNNELS, PHASE III**

**APPLIED RESEARCH &
INNOVATION BRANCH**

Alexandra Wayllace, CSM
Ning Lu, CSM
Benjamin Mirus, USGS

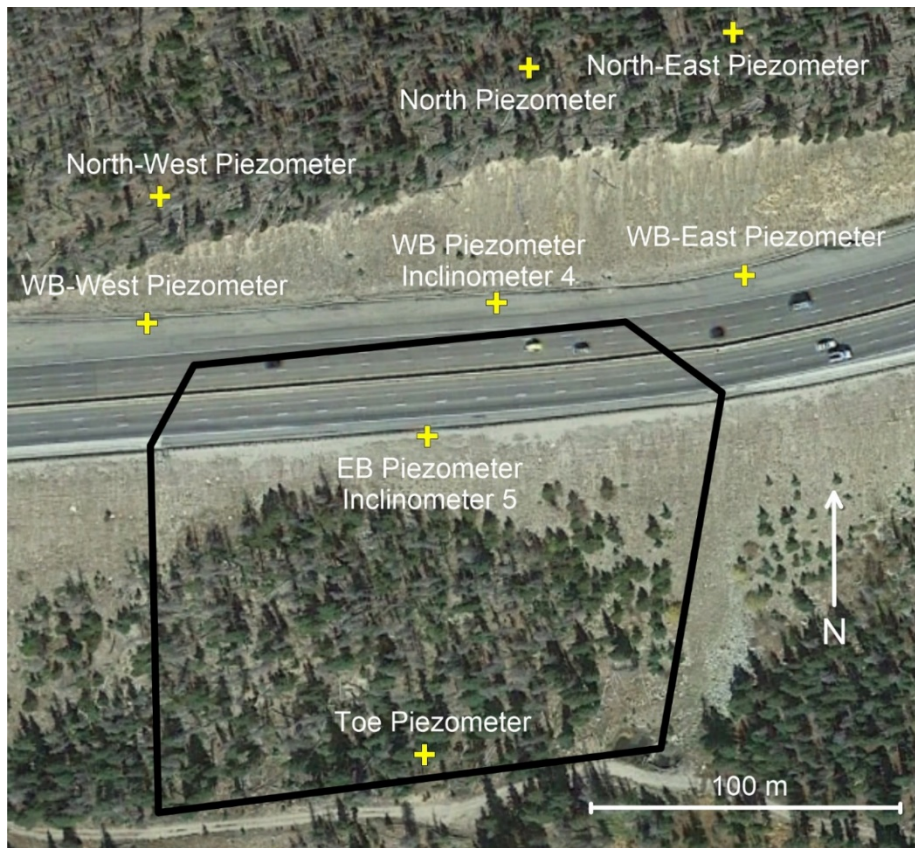
Figure 1. (a) Straight Creek slide location and extents; approximate slide area is shaded in red, approximate watershed area is outlined in blue and A-A' transect shown in subsequent figures. (b) Piezometer locations with approximate slide extents shown in black (from Hinds, 2018).

temporary measure to maintain a road leveled surface was asphalt capping; however, this measure was not efficient because it had to be done several times per year, causing partial road closures. In 1996, CDOT commissioned Kumar & Associates to perform a more detailed investigation. Their report indicates an ongoing slide failure, identifies the shear zone, and provides stratigraphic information from six boreholes drilled on the west and eastbound shoulders of the highway, as well as near the toe of the slide. In 2007 and 2008, CDOT installed inclinometers in the east and westbound shoulders of the affected I-70 stretch; the sensors maxed out within a year, measuring over 5 cm of lateral displacement. In 2011 and 2012, Shannon & Wilson, Inc. installed lightweight caissons in the highway, and ten horizontal drains near the slide toe, to decrease normal stresses on the failure plane and pore water pressures in the hillslope. Figure 1a portrays the slide location and extents.

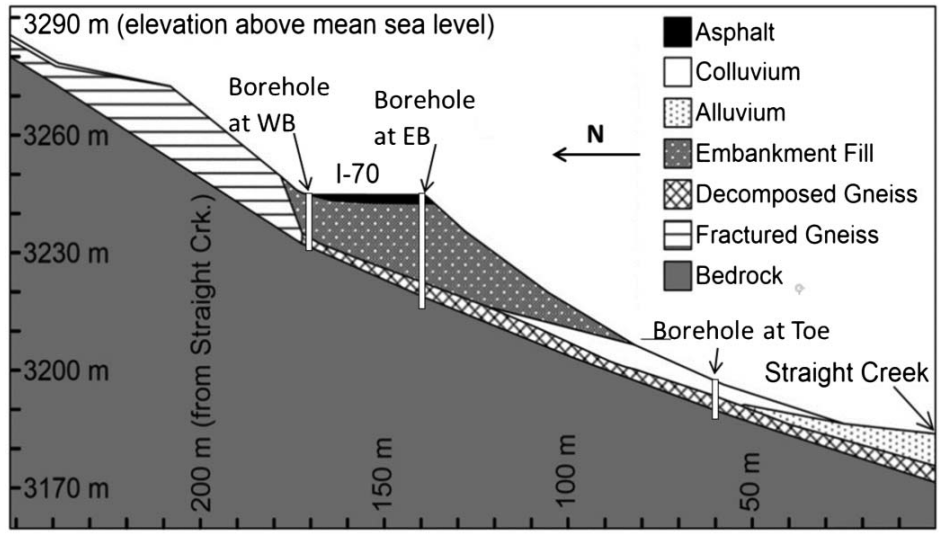
Figure 2. Transect showing subsurface material distribution along the slide centerline shown in A-A' transect in Figure 1 (from Hinds, et al., 2019).

Model geometry was based on the transect in Figure 2, with the north boundary extended 740 m up to the watershed boundary (Figure 1); this large extent of northern slope is needed to generate the high lateral subsurface flux caused by infiltration over the entire slope up to the drainage divide. The south boundary is also extended 100 m to reduce boundary effects in stress calculations. The mechanical boundary conditions at both the north and south boundaries are no horizontal displacement but free vertical displacement. The mechanical boundary conditions at the bottom are no vertical displacement but free horizontal displacement. Based on site geologic and hydrologic conditions, the hydrologic boundary conditions are set to no flux at (1) the bottom and north boundaries due to the relative low hydraulic conductivity of the bedrock and intact rock, and (2) the highway surface due to the relative impermeable layer of asphalts. A specified flux boundary condition is used at the slope surface to allow applied infiltration for both rainfall and snowmelt precipitation. A constant head is applied at the south boundary to reflect the modulating effect of Straight Creek, which approximately coincides with that boundary. Although the water level of Straight Creek may vary, the annual fluctuation is less than a few feet or a meter. The effect of such change has a minimum effect on the groundwater table variation within the slope, as indicated in the recorded data nearby at the toe of the slope shown in Figure 3. Material properties reported in Table 2 were used.

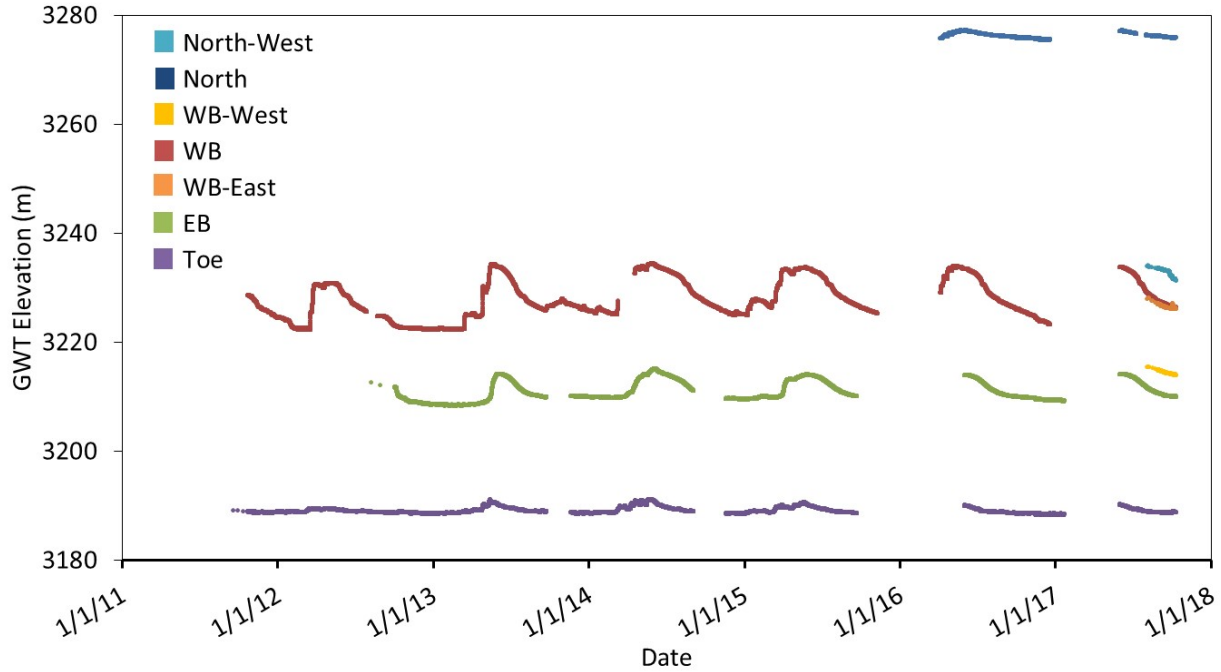
Figure 3. Groundwater level monitored at seven locations at the study site.

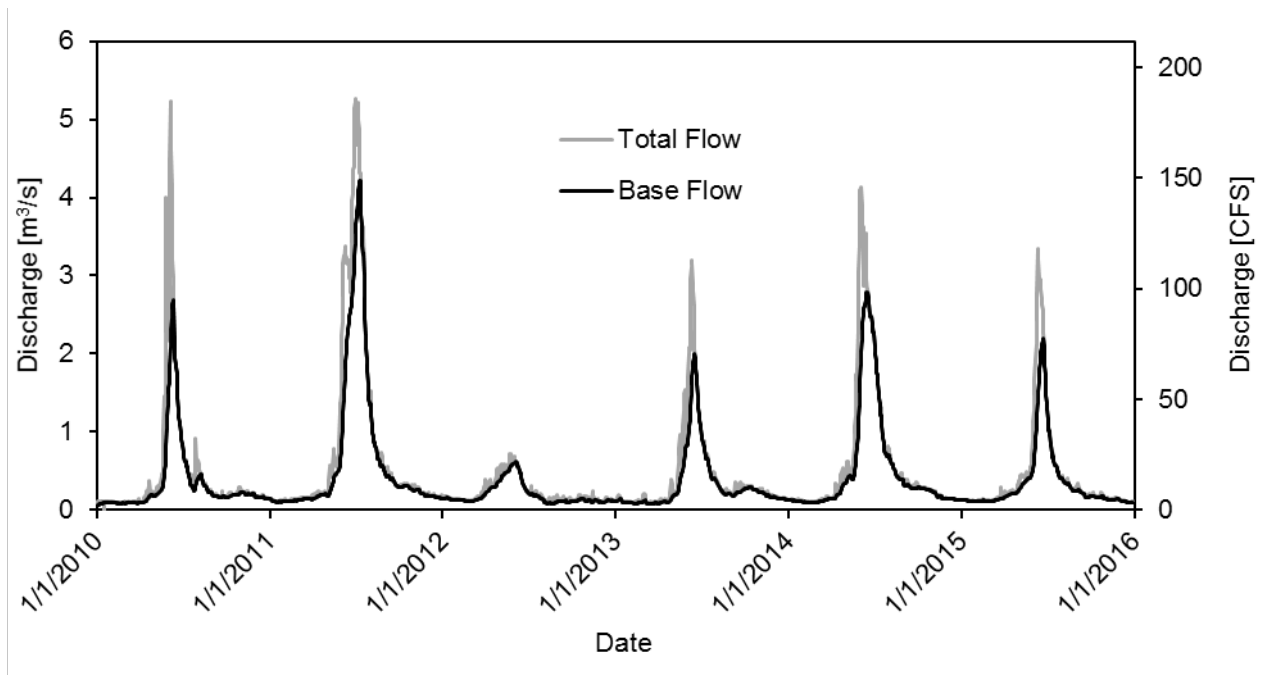
Figure 5. Total flow and filtered base flow at USGS stream gage 09051050, 2010 through 2015 (from Hinds, 2018).

where q_t is the filtered direct runoff (i.e., the portion of stream flow that is not base flow) at time t , Q is the total stream flow, and α is the filter parameter, for which a value of 0.925 was used based on the findings and recommendations of Nathan and McMahon (1990). This filter method is sometimes referred to as the BFLOW filter, due to its use in the popular BFLOW software produced by the USDA Agricultural Research Service. Raw stream flow data and the filtered base flow for 2010 through 2015 are shown in Figure 5.

The annual peak base flow levels fluctuate in a similar pattern to peak groundwater table elevations recorded by the CSM piezometers. In addition, as it is observed below, this pattern also matches the annual cumulative snowmelt infiltration amounts (Figure 6). The annual peak values for total (unfiltered) flow suggest that peak levels for 2010 and 2011 are equal, despite the fact that the cumulative snowmelt infiltration in 2011 is twice as high as in 2010. This suggests that the filtering method is achieving its purpose of extracting groundwater-derived flow from the discharge data, and that the calculated base flow is in fact a useful and valid proxy for groundwater levels.

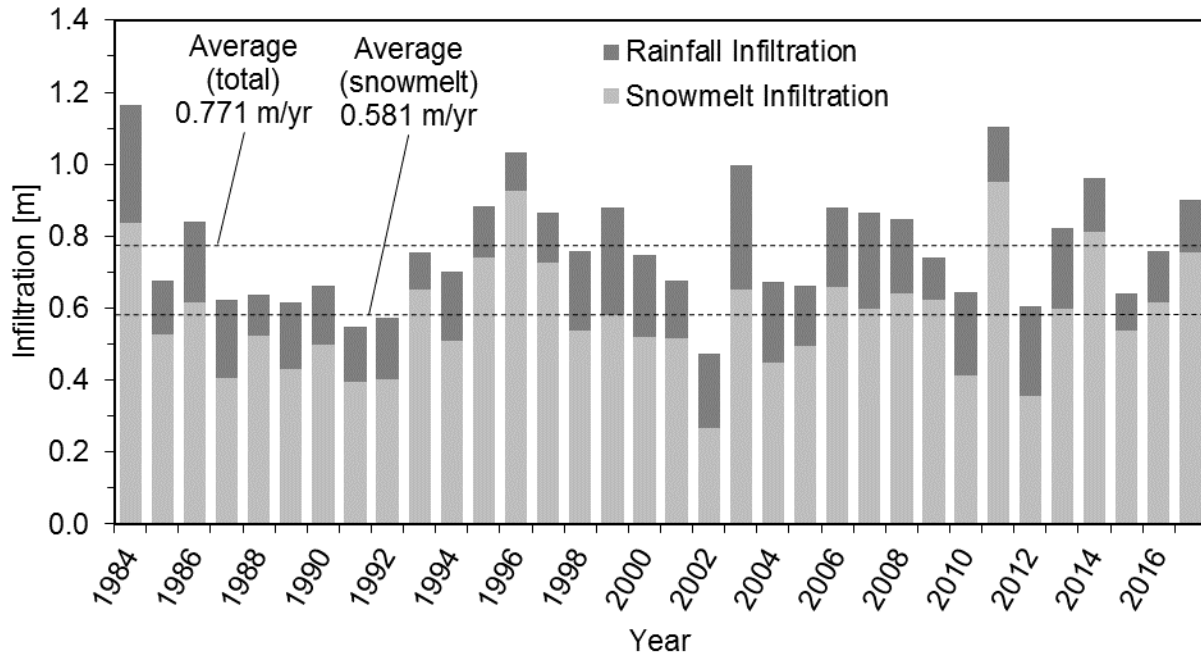
Figure 6. Infiltration totals calculated from SNOTEL data, 1984 through 2017 (from Hinds, 2018).

SNOTEL data for infiltration due to rainfall and snowmelt for the years 1984 – 2017 is presented in Figure 6 and used to develop numerical model atmospheric inputs, to characterize the infiltration seasons, and to correlate with observed hydrologic response and slide activation. In general, infiltration cycles of an approximately 10-year period are observed, but also there are isolated years of elevated infiltration (2003, 2011). In addition, snowmelt infiltration exhibits greater magnitude and variation than precipitation infiltration, which lead to the hypothesis that the former is more important in causing slide activation.

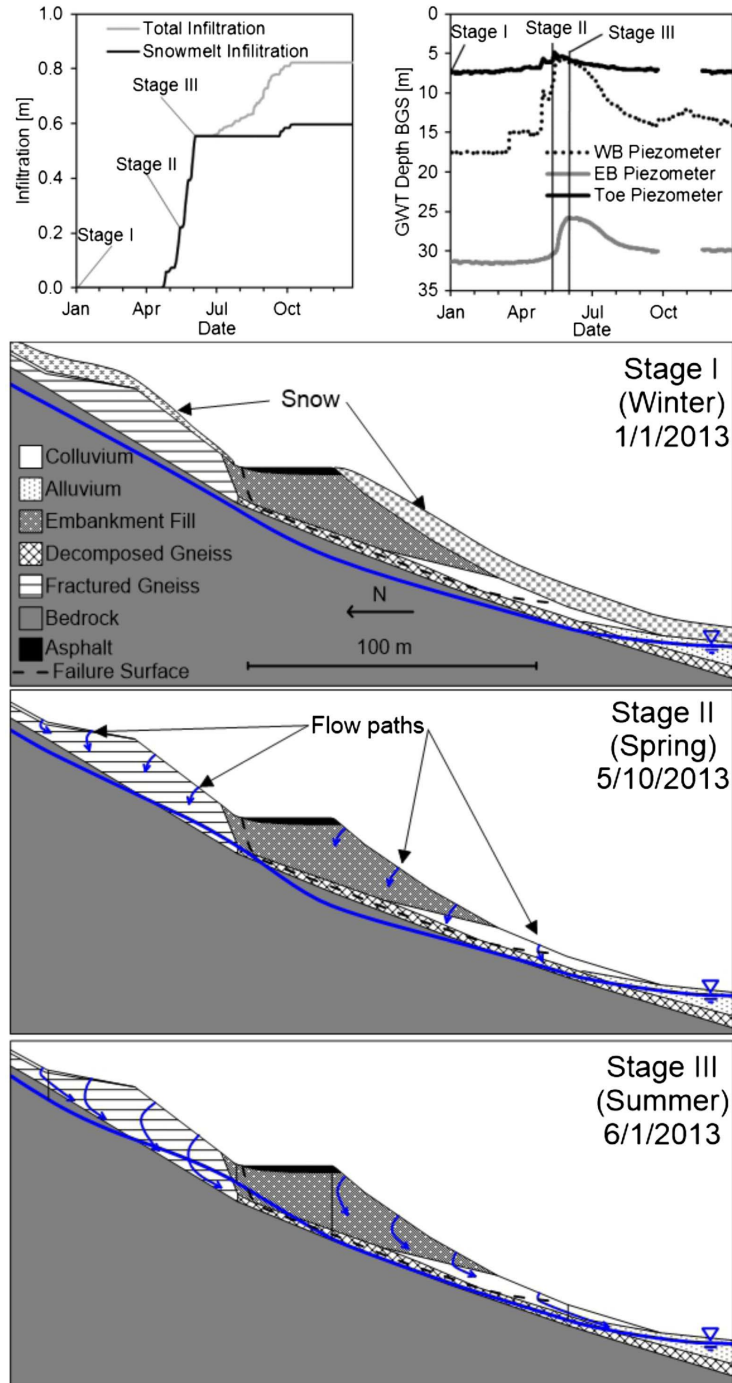
Figure 8. Infiltration data (top left) and piezometer data (top right) from 2013 linked to the conceptual model for seasonal hydrology: Stage I the water table (blue line) is initially below the failure surface; Stage II spring snowmelt infiltration causes the water table on the north side of the highway to rise, but it remains below the failure surface; Stage III continued infiltration causes the water table to rise further and intersect the failure surface (from Hinds et al., 2019).

The following conceptual model was presented in Phase II and consists of three seasonal stages (Lu et al., 2013). Stage I coincides with winter; in this stage the groundwater table is at its lowest level, resting along the surface of the competent bedrock. During this stage snowpack accumulates with essentially no melting or other infiltration occurring. Stage II corresponds to the spring; during this stage rapid melting of the snowpack occurs, and the meltwater begins to infiltrate into the hillslope. In most years, an initial fast increase in groundwater level is observed, probably due to snow plowed onto the WB shoulder melting as the temperatures warm up. Subsurface flow is initially perpendicular to the slope during this period because moisture gradients control flow direction more than gravity (simulated pathlines near the slope surface in Figure 8); as the slope becomes wetter, vertical flow predominates (simulated pathlines in the middle of the slope in Figure 8). Stage III corresponds roughly to summer and fall, when the hillslope has higher saturation and there is slower surface infiltration rate due to rainfall.

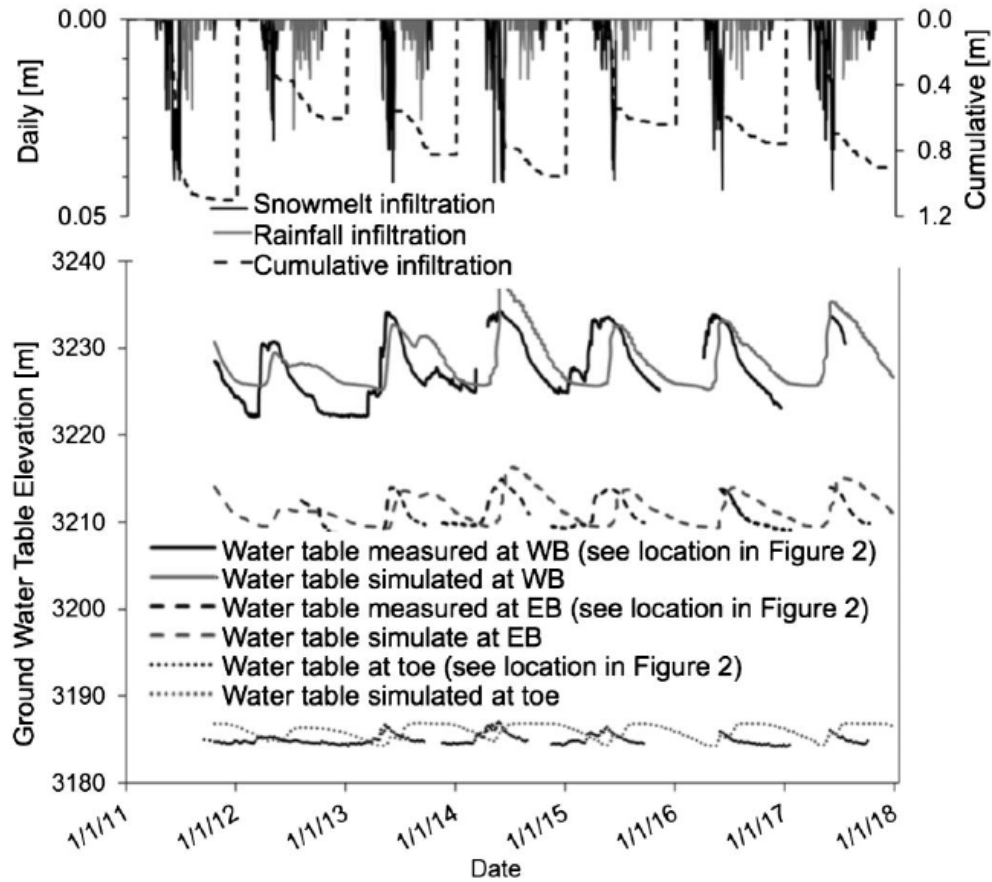
Figure 10. Measured and simulated groundwater table elevations and infiltration data, 2011-2018 (from Hinds et al., 2019).

The model was calibrated using the multiyear water table variation and the 2-week shift of infiltration boundary condition. Infiltration data for the years over which piezometer data are available; soil hydrologic properties and spatial distribution are then calibrated within ranges constrained by the literature, previous laboratory testing programs, and interpretation of borehole logs to match observed piezometer data as closely as possible. The hydrological simulation results are shown in Figure 10 indicating that the use of the SNOTEL infiltration with the two week shift is reasonable; the simulation and field measurements are closer to each other for the WB piezometer than for the piezometers at the EB and near the toe of the slide. Annual peak pressure heads, which are considered the most critical hydrologic result because they directly cause peak instability, generally match piezometer data very well, as do annual minimum pressure heads; the timing of pressure head change does not. Some discrepancy may be explained by differences between the Straight Creek slide site and the SNOTEL station site, which is 14 km away in a different (although similar) watershed, and in a location that is topographically flatter, more heavily forested, and more distant from roadways than the Straight Creek slide. These differences may be sufficient to cause the persistent disparity in timing and occasional disparity in magnitude of groundwater level peaks.

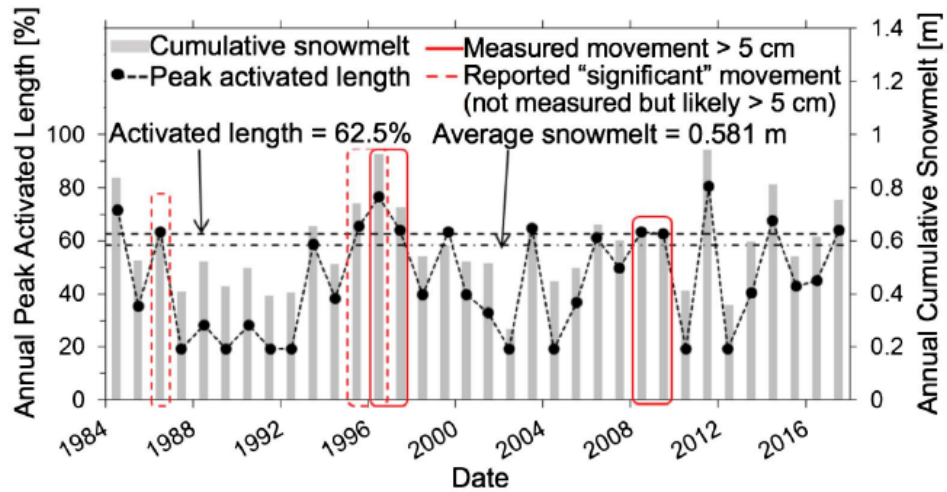
Figure 12. Annual cumulative infiltration, modeled annual peak activated length, and periods of known pronounced movement, 1984-2018 (from Hinds et al., 2019).

Annual cumulative infiltration from 1984 to 2018 is presented in Figure 12, and general infiltration characteristics are reported in Table 3. In every year on record, cumulative snowmelt infiltration is both much greater in magnitude (average of 0.581 m annual cumulative snowmelt infiltration versus 0.190 m annual cumulative rainfall infiltration) and occurs over a much shorter timescale (average duration of 45 days for snowmelt season versus 116 days for rainfall season). This suggests that snowmelt characteristics likely have a larger effect on embankment stability than rainfall. Years of above-average annual cumulative snowmelt infiltration coincide with known periods of pronounced slide movement and with higher modeled instability (Figure 12). There are years of above-average annual cumulative snowmelt infiltration and high-modeled instability for which pronounced movement is not noted (1984, 1993, 2003, 2006, 2007, and 2011); however, these years all occur during periods without inclinometer or continuous piezometer data. It is possible that little movement occurred despite high infiltration and pore pressures; informal interviews may have simply failed to record pronounced movement during these years, or extensive roadwork in 2011 may also have obscured pronounced movement during that year.

of the full failure surface is potentially enough to substantially reduce or even eliminate movement in 2009 (Figure 12); this effect from the preceding year's infiltration is greater than that of annual cumulative rainfall infiltration for the Straight Creek site. The duration of the peak in activated length is also affected by the preceding year; for a year in which peak activated length will exceed 62.5% regardless of infiltration in the previous year, the period of time for which it will exceed this threshold will be responsive to this infiltration history. It is reasonable to expect that a longer period above this threshold will result in greater magnitude of slide movement. It was found that infiltration during the preceding year has a moderate but clear carryover effect on the hydrology and stability of the Straight Creek slide. Years of above-average annual cumulative infiltration increase groundwater levels at the onset of snowmelt in the following year, increasing the resultant peak pressure heads. Meanwhile, years of below-average annual cumulative infiltration have the opposite effect. The ability of the numerical model to simulate the importance of antecedent infiltration also corroborates the validity of the identified threshold of the failure length for landslide reactivation.

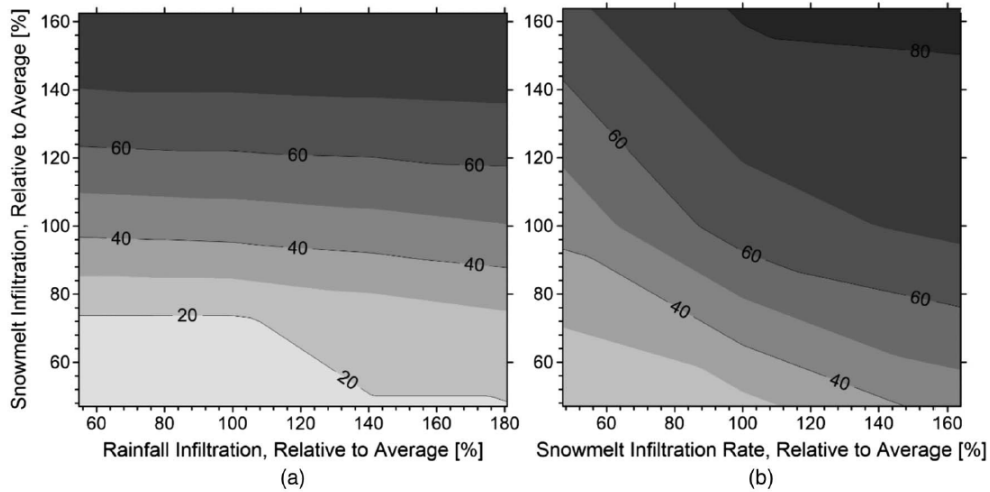
Figure 14. Contour plots of activated length modeled for various combinations of annual cumulative snowmelt infiltration and (a) rainfall infiltration; or (b) snowmelt infiltration rate (from Hinds et al., 2019).

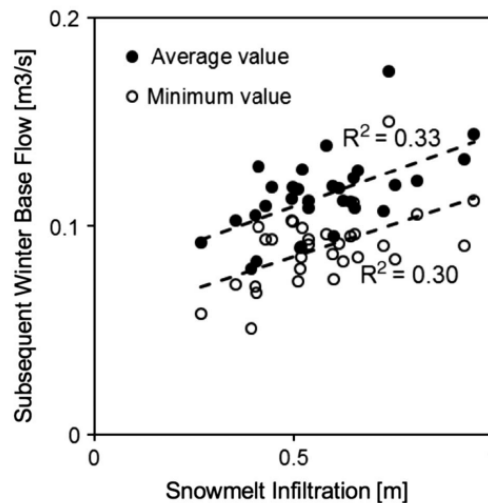
Figure 15. Correlations between infiltration and base flow in the subsequent winter season (from Hinds et al., 2019).

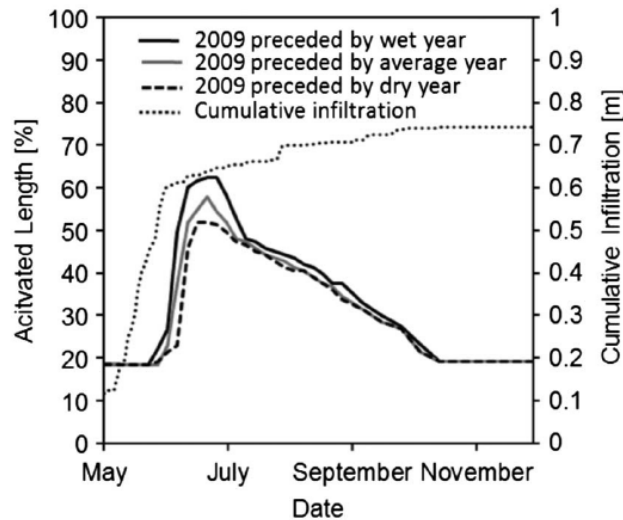
Figure 16. Activated length time series from 2009, modeled as preceded by different years (from Hinds et al., 2019).

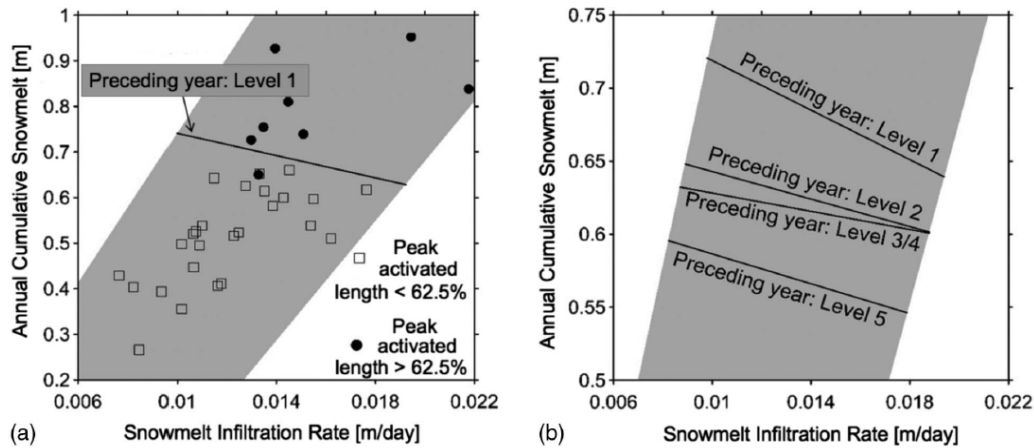
Figure 17. (a) Predictive framework development; and (b) final thresholds. Shaded area indicates region of observed data (from Hinds et al., 2019).

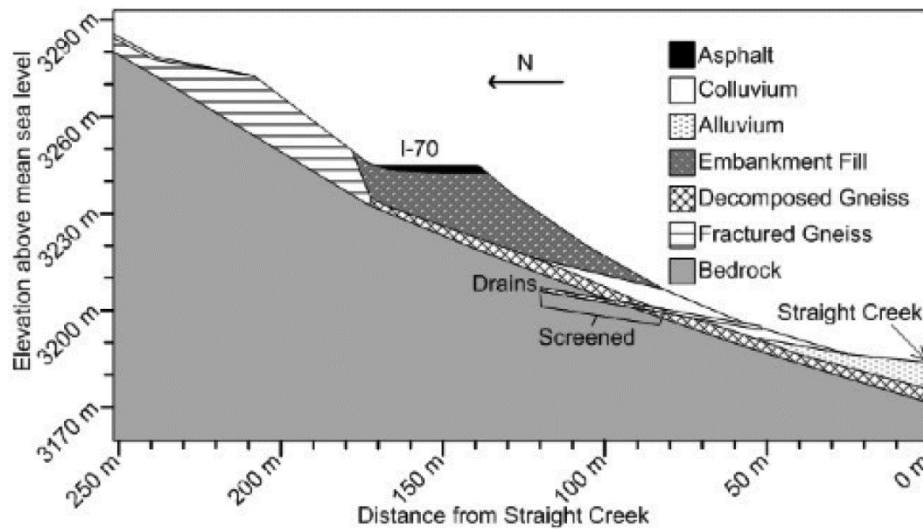
Figure 18. Position of horizontal drains (from Hinds et al., 2021).

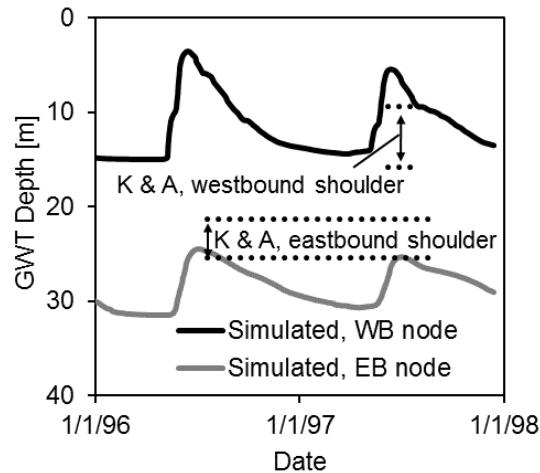
Figure 19. Groundwater table observations from Kumar & Associates, with simulated results from the same time period.(from Hinds, 2018).

between the westbound and eastbound shoulders, the Kumar & Associates data indicates a flatter groundwater table than is both observed at the piezometers after drain installation and predicted by the model that has been calibrated to those piezometers. This could indicate that the drains have been partially successful in lowering groundwater levels downslope from the embankment, and in causing faster dissipation of elevated pore pressures beneath the eastbound shoulder and slide toe area.

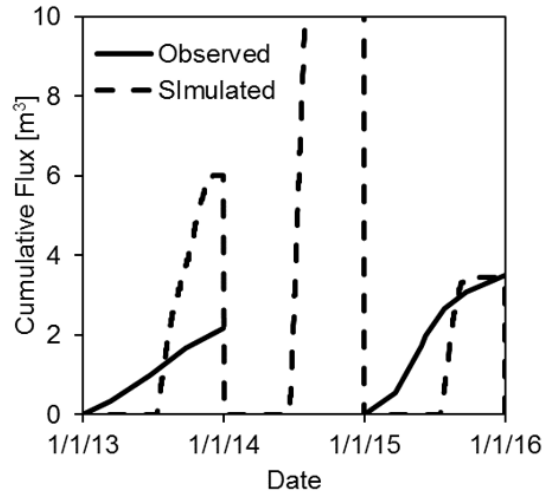
Figure 21. Observed and cumulative drain flux (from Hinds, 2018).

2015; because the simulated results reflect this and the observations do not (Figure 21), it seems likely that the flow rate measurements missed a peak in 2013, and the calculated cumulative flux is an underestimate. There is a 3.5-month gap in drain flux measurements in 2013 from mid-March to late June, which corresponds to the timing of the observed peak in 2015. Based on 2015, the one year of data that is likely to be free from substantial gaps, the model appears to adequately capture annual cumulative drain fluxes.

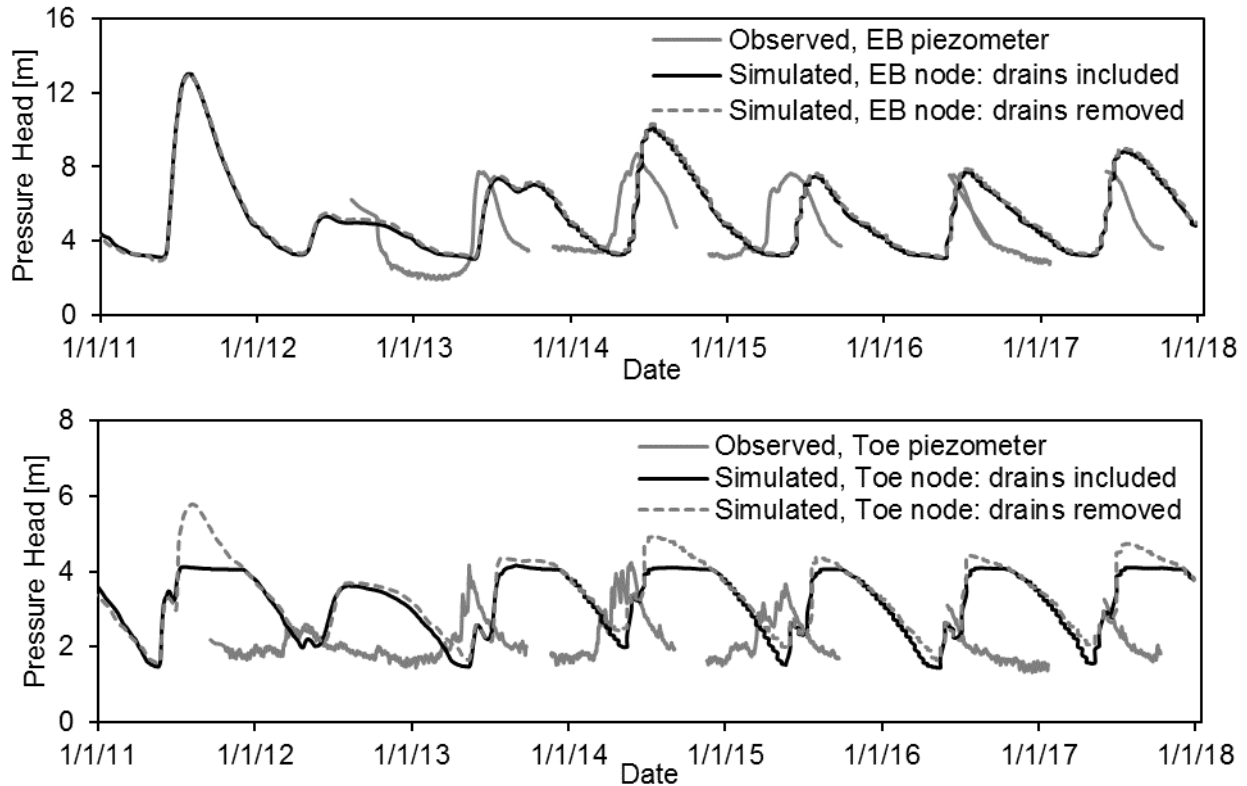
Figure 22. Observed and simulated (with and without toe drains) pressure heads at the EB and Toe nodes.(from Hinds, 2018).

The observed pressure head time series in the EB and Toe piezometers is presented in Figure 22 with the corresponding simulated pressure heads at observation nodes for the model with and without drains. Since the modeled drains have essentially no effect at all on the WB and North nodes, those results are not presented. The effect at the EB node is a slight lowering of pressure heads at all times; the difference is approximately 0.2 m. Compared to a typical peak value of about 8 m and typical winter-summer differential of 5 m, this is a small but not necessarily unimportant difference. The effect at the Toe node is more pronounced; the removal of the modeled drains increases peak pressure heads by about 0.5 m for years of average infiltration (2013, 2015 through 2017) and almost 2 m for 2011, a year of particularly high infiltration. These differences are substantial relative to a typical peak value of 4 m and typical winter-summer differential of 2.3 m. The toe drains act as a cap on pressure heads above 4 m at this node; above this level, any additional groundwater is removed by the drain. Winter-season and transitional values are also lower with the drains than without.

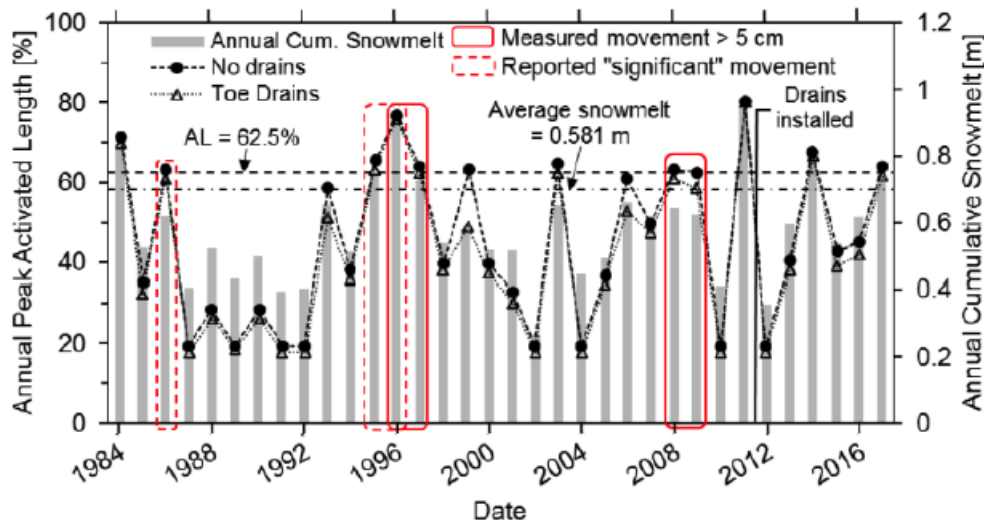
Figure 24. Annual peak activated length for different years, for cases with and without horizontal drains near the toe (from Hinds et al., 2021).

when modeled with the toe drains, and that peak activated length is only 4.4% above this threshold. If the model is slightly underestimating the drains' effect on embankment stability, the combination of toe drains and hydrologic variability could explain the reduced movement rate.

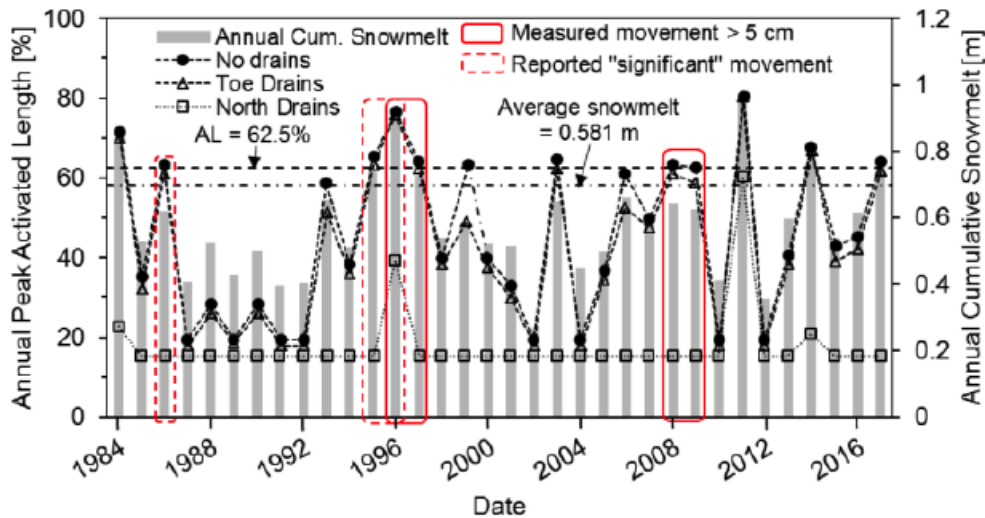
Figure 30. Annual peak activated length for no drains (circles), toe drains (triangles), and North drains (squares) (from Hinds et al., 2021).

The proposed north slope drains network is just one possible effective remediation. They have the potential to substantially change the stability of the Straight Creek slide, possibly eliminating slide movement altogether. They could accomplish this for a smaller cost than has already been spent on remediation for this site, eliminate the expenditure on annual asphalt capping operations that are currently necessary to maintain roadway serviceability, and not require any traffic lane closures. We conclude that a Phase IV study to engineer an optimum upslope drain system would result in a long-term solution to the Straight Creek slide problem.

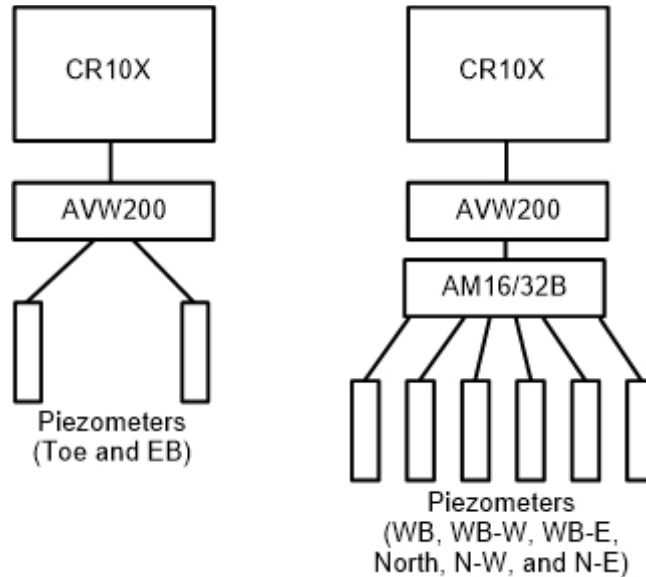
Figure B.1. Datalogger setup; eastbound (left) and westbound (right).

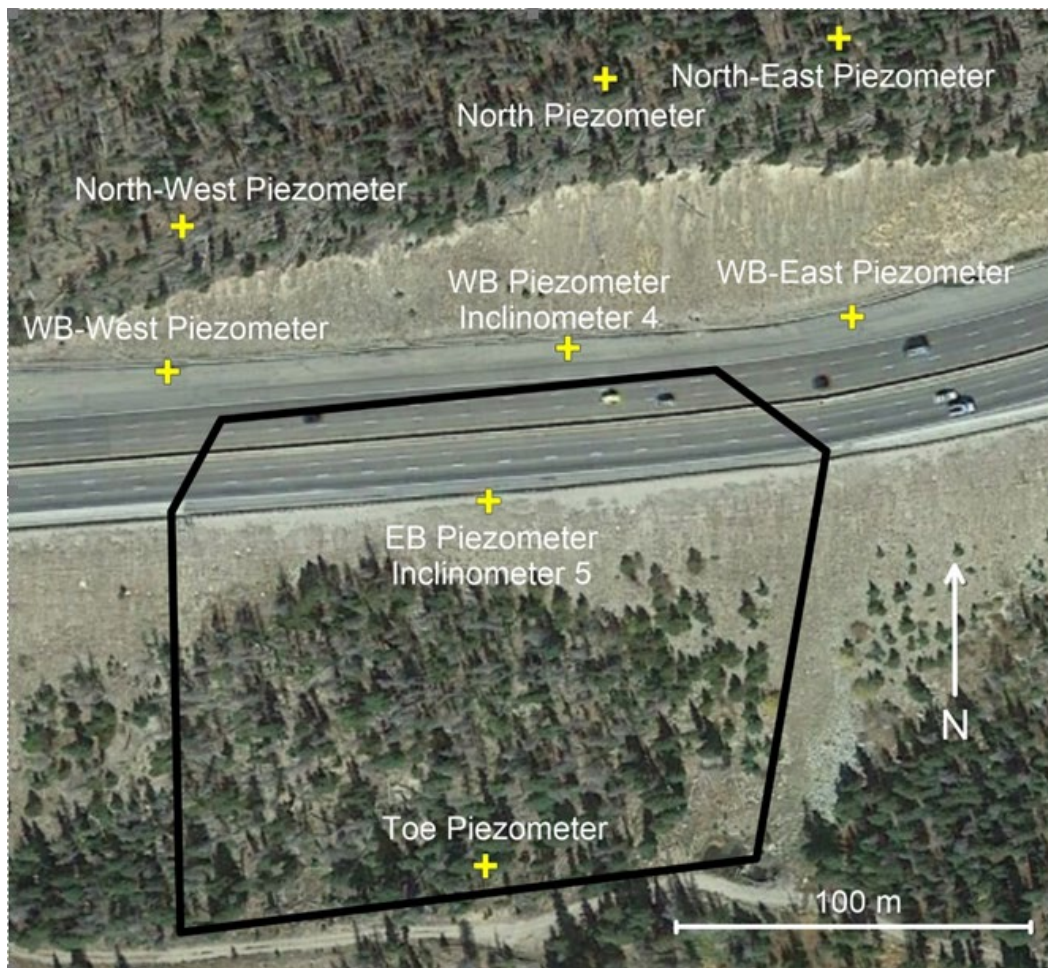
Figure C.1. Piezometer locations with approximate slide extents shown in black (from Hinds, 2018).
