COTTONWOOD PASS CONCEPT DESIGN (EAGLE AND GARFIELD COUNTIES)

DRAFT FINAL REPORT AUGUST 2023

DAVID EVANS
AND ASSOCIATES INC.

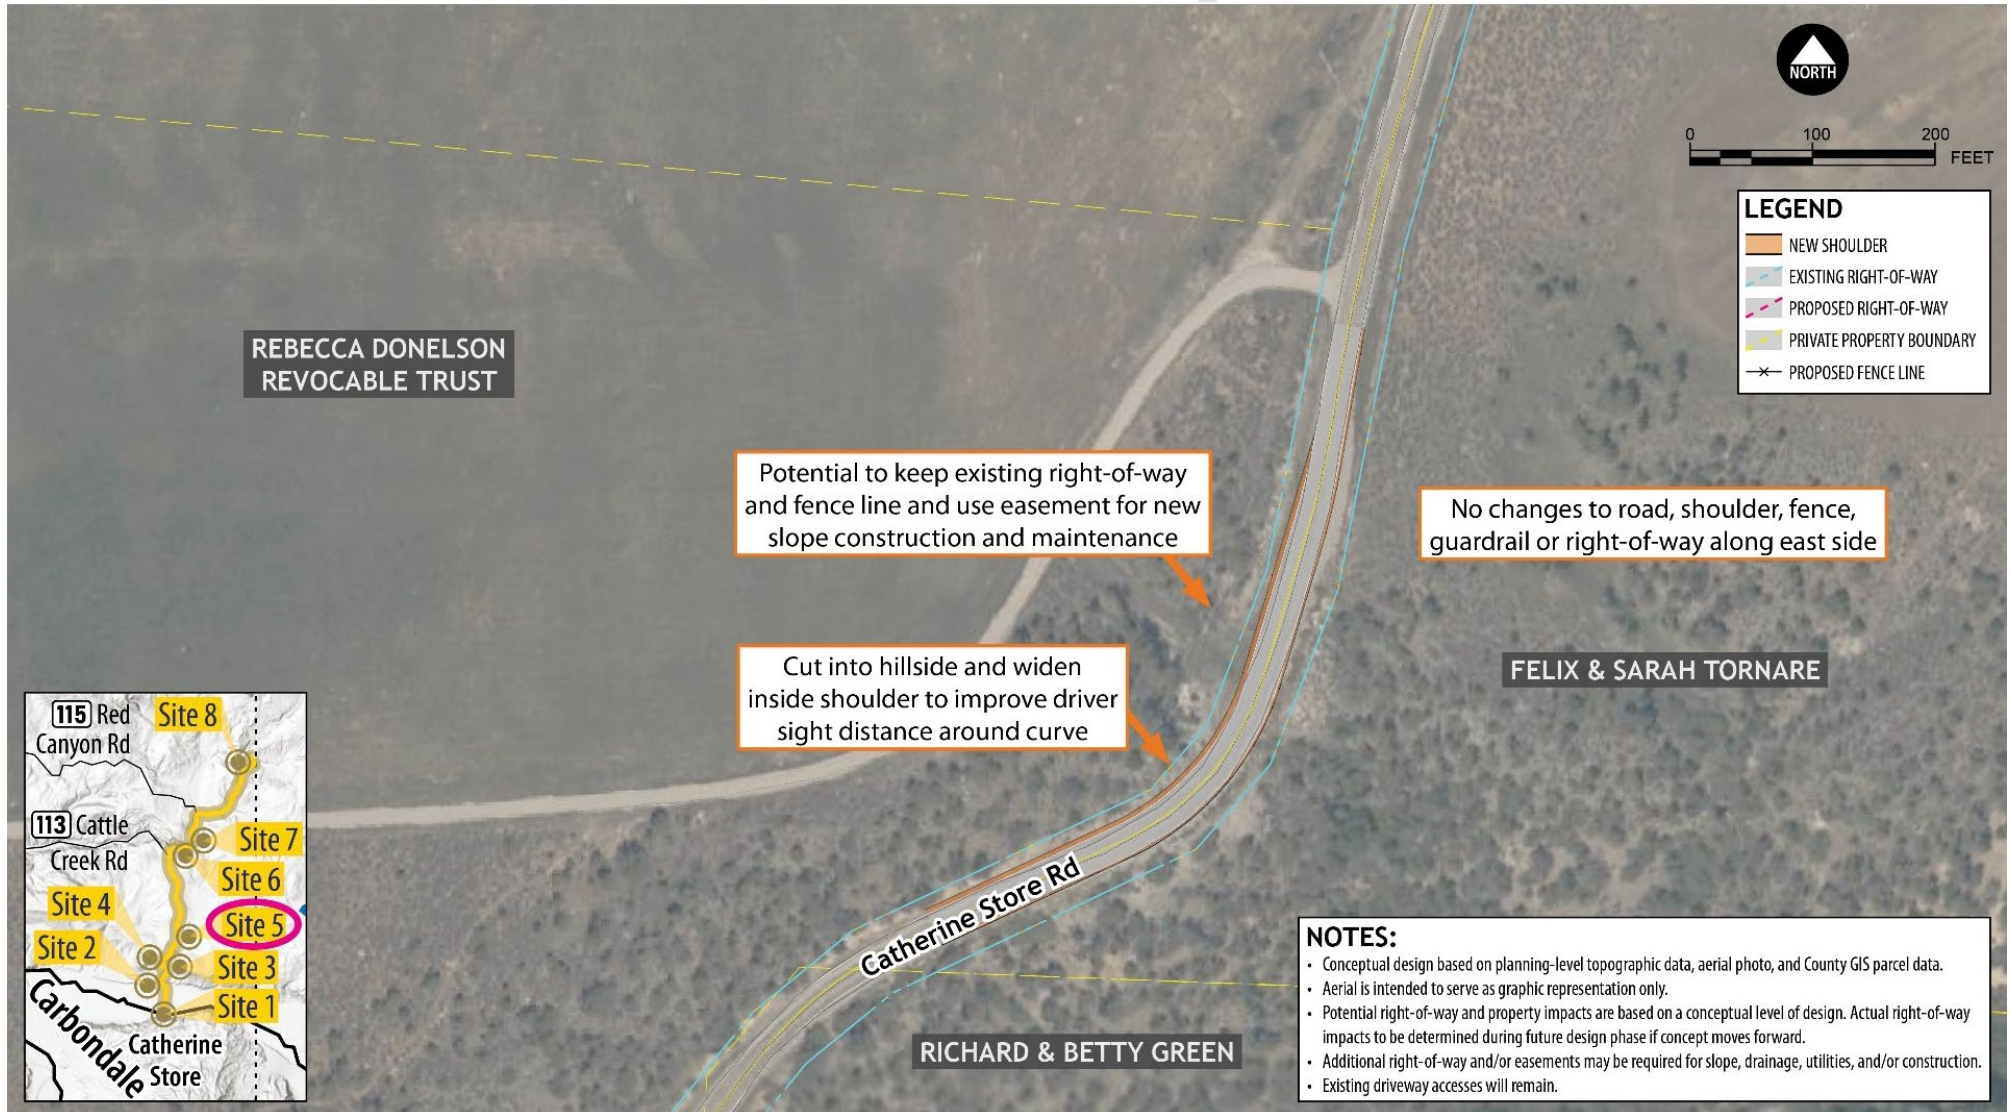
Figure 7. Garfield County Site 5 - Hillside Grading

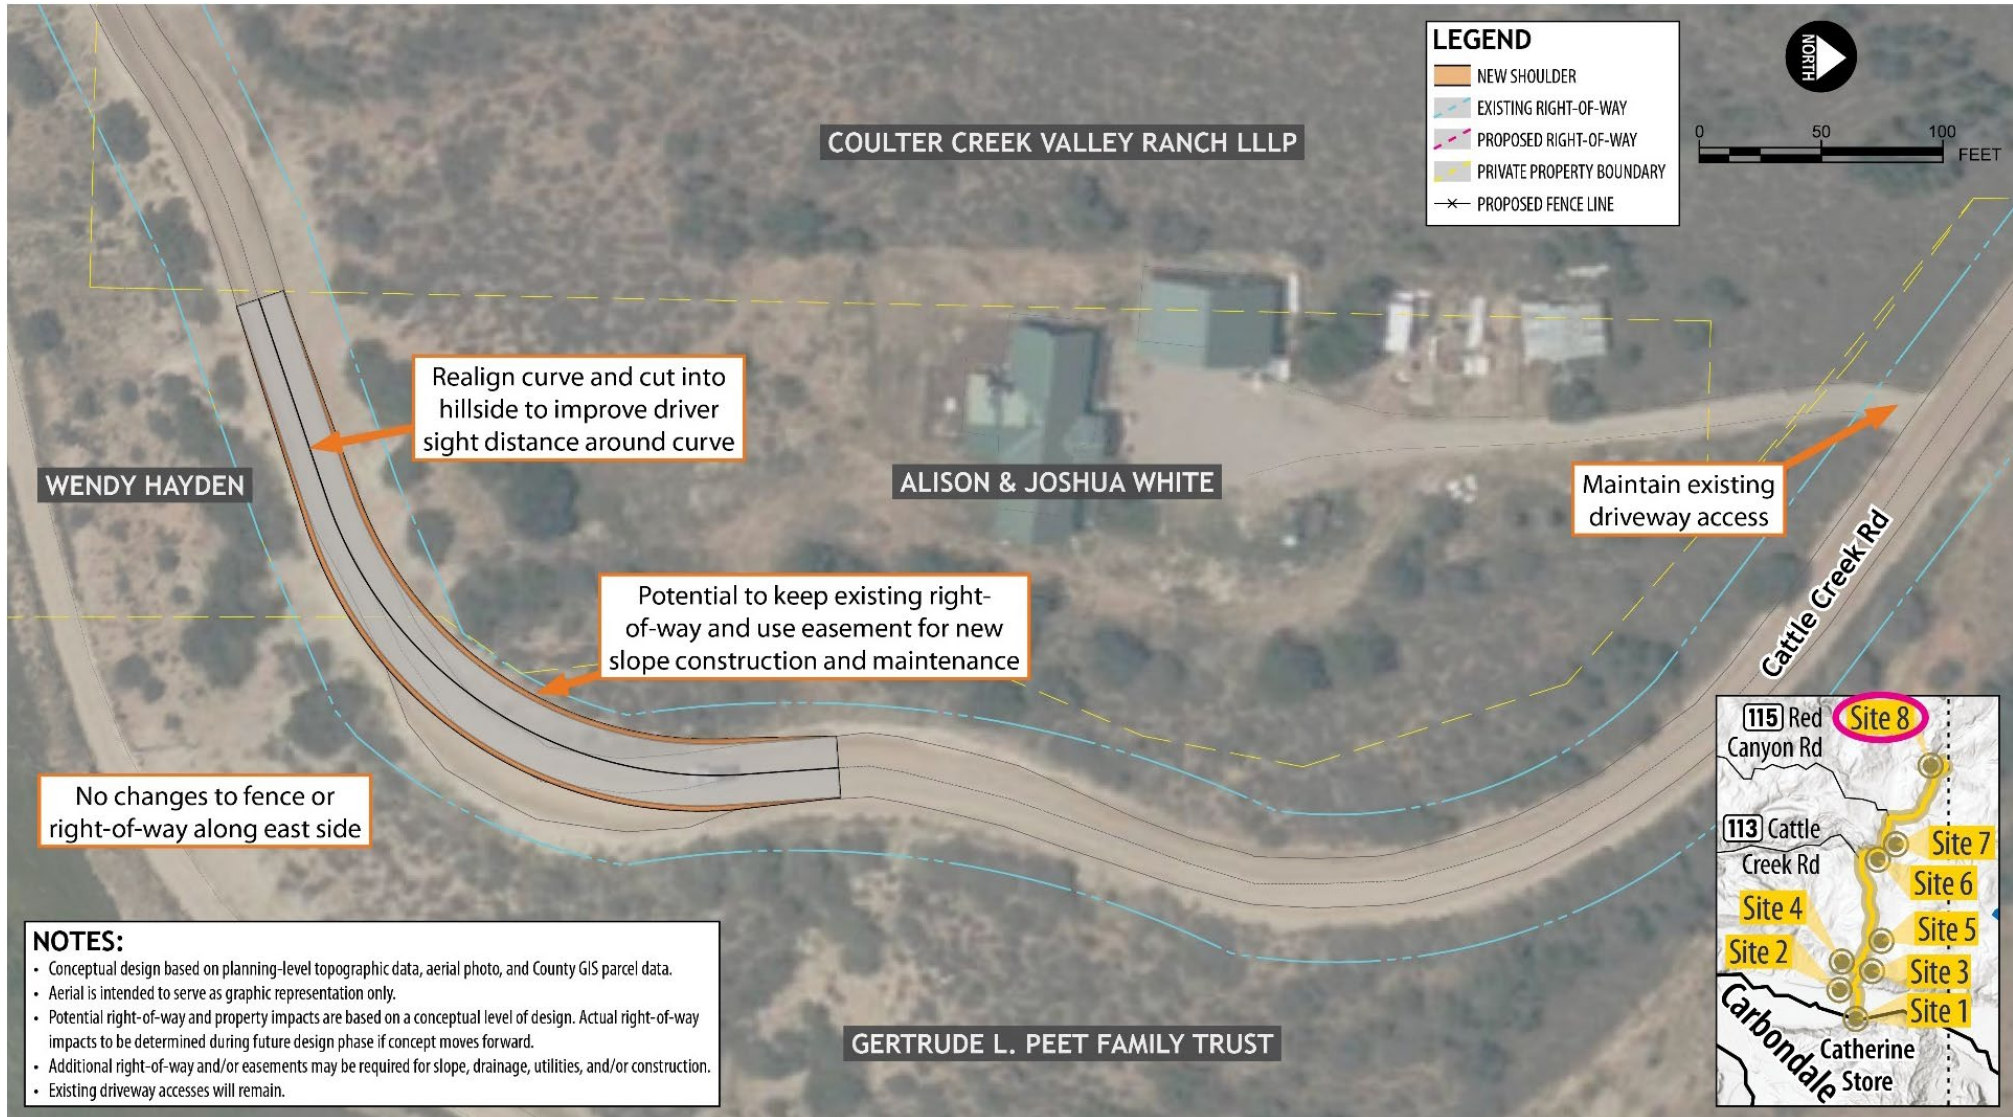
Figure 11. Garfield County Site 8 - Hillside Grading

Safety issues at this site include limited driver sight distance and the associated two-way traffic conflicts through the curve.

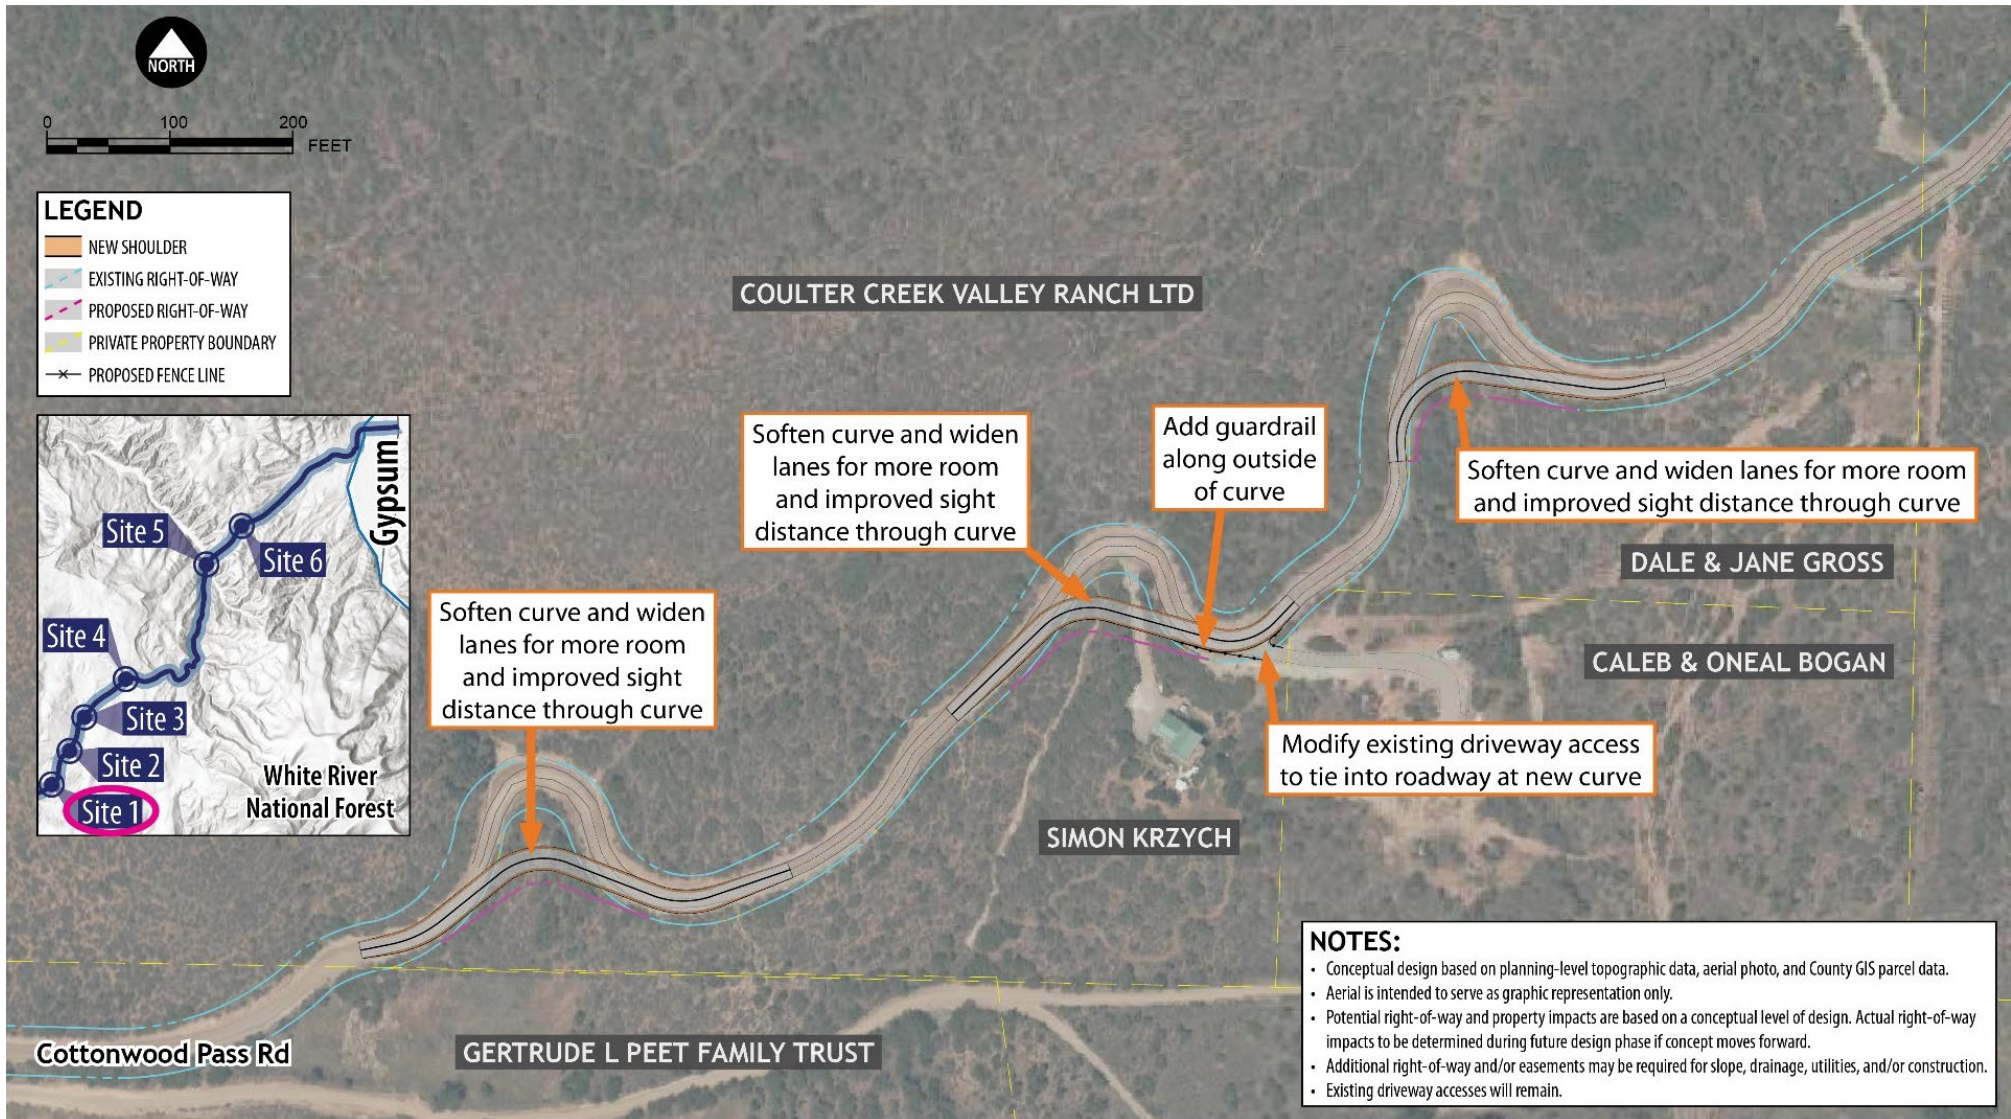
Figure 13. Eagle County Site 1 Option 2 - Realign Curves

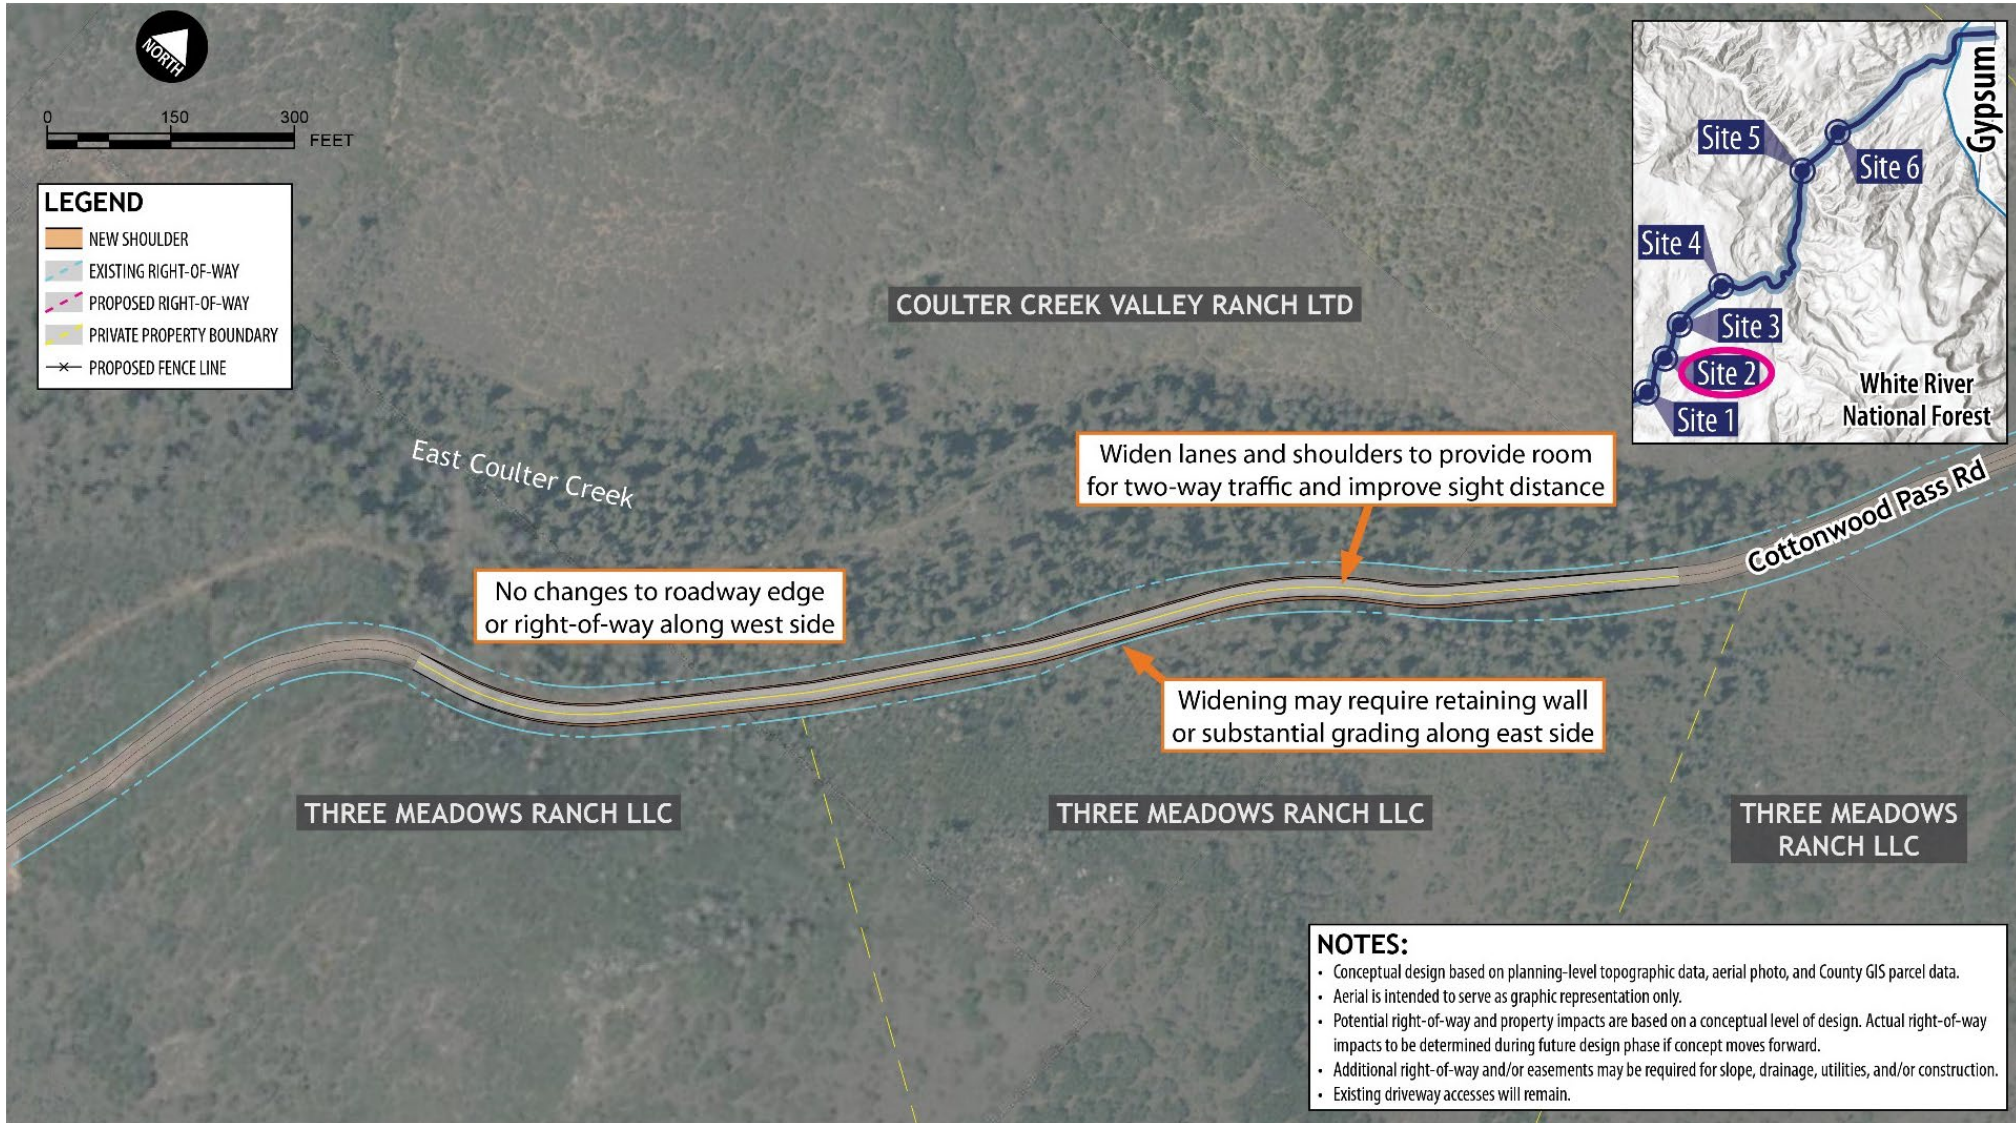
Figure 15. Eagle County Site 2 Option 1 - Widened Lanes and Shoulders

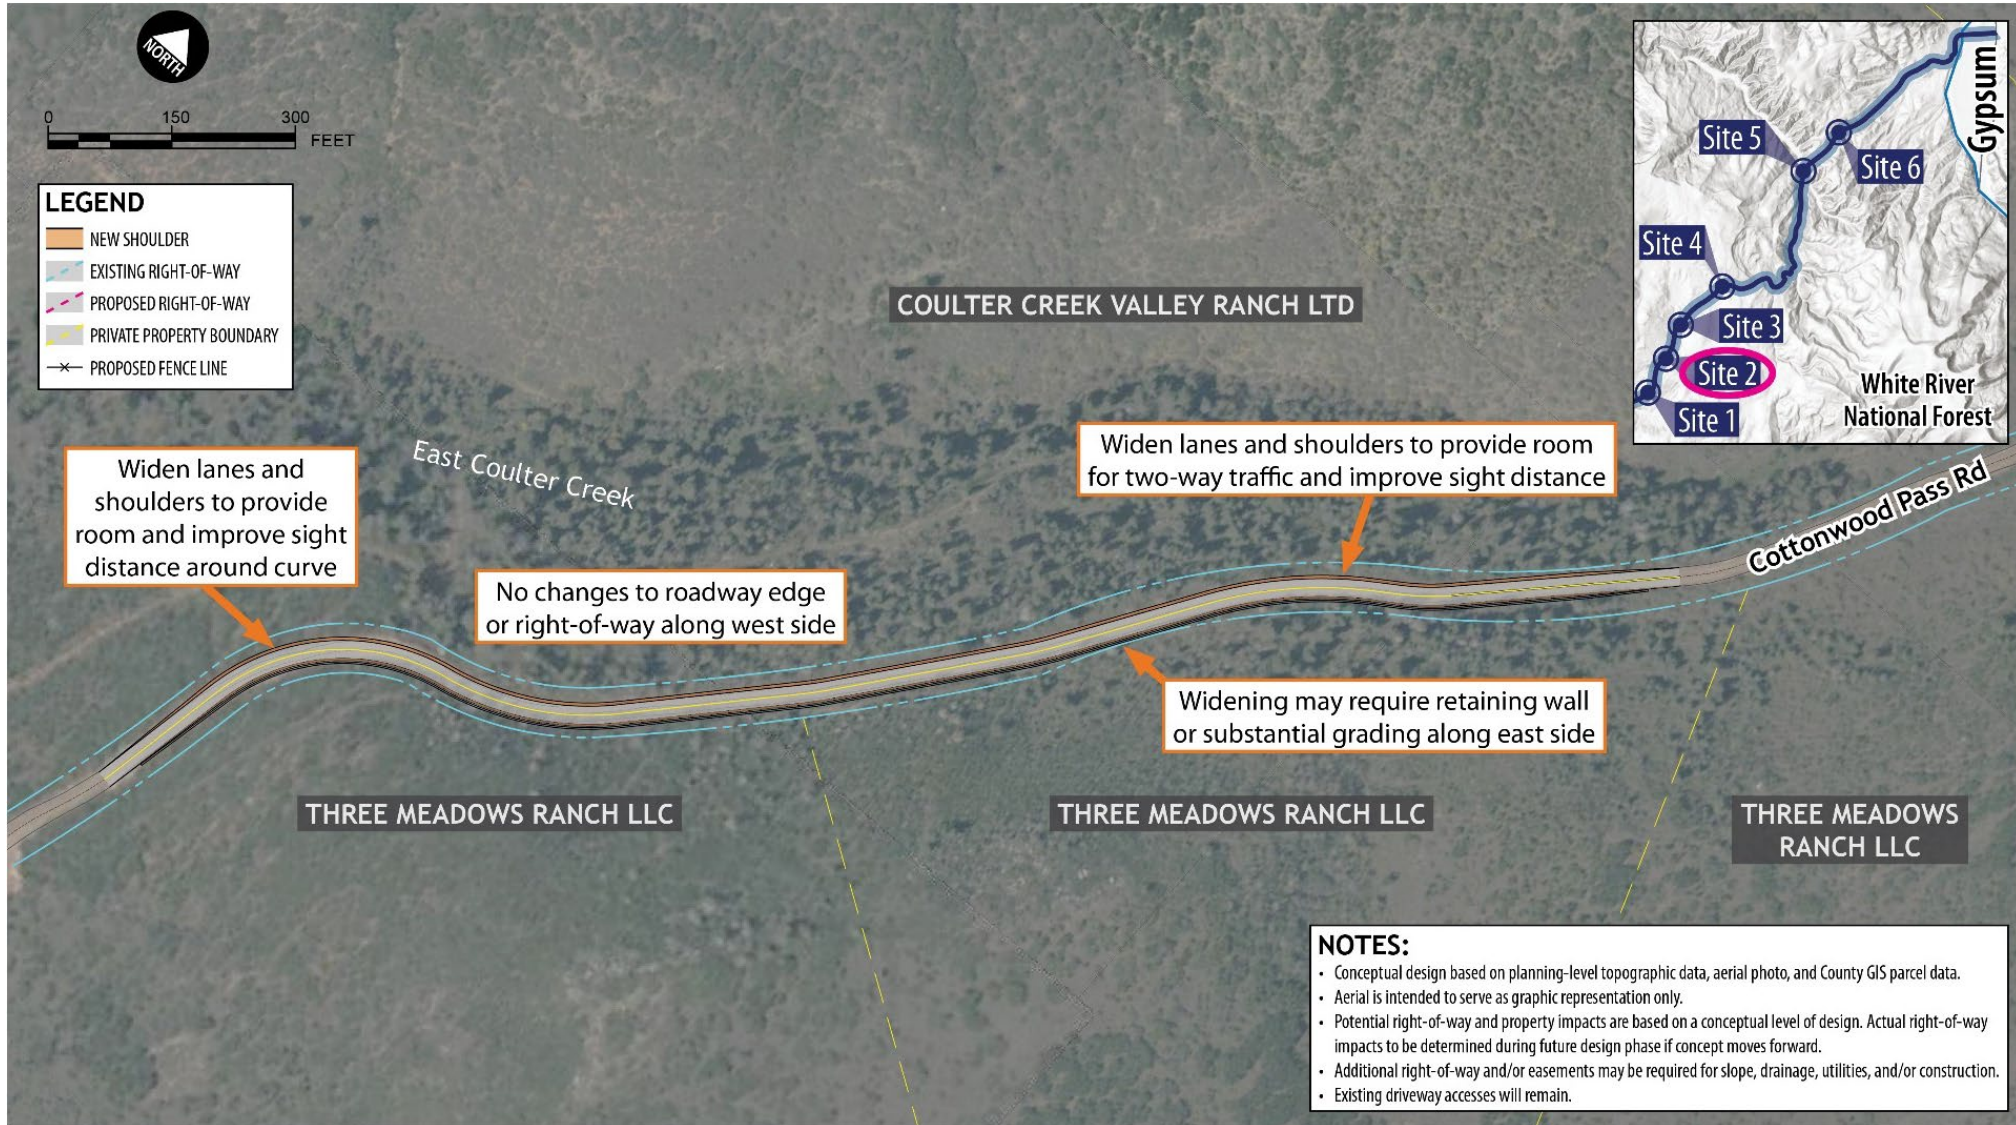
Figure 16. Eagle County Site 2 Option 2 - Further Widened Lanes and Shoulders

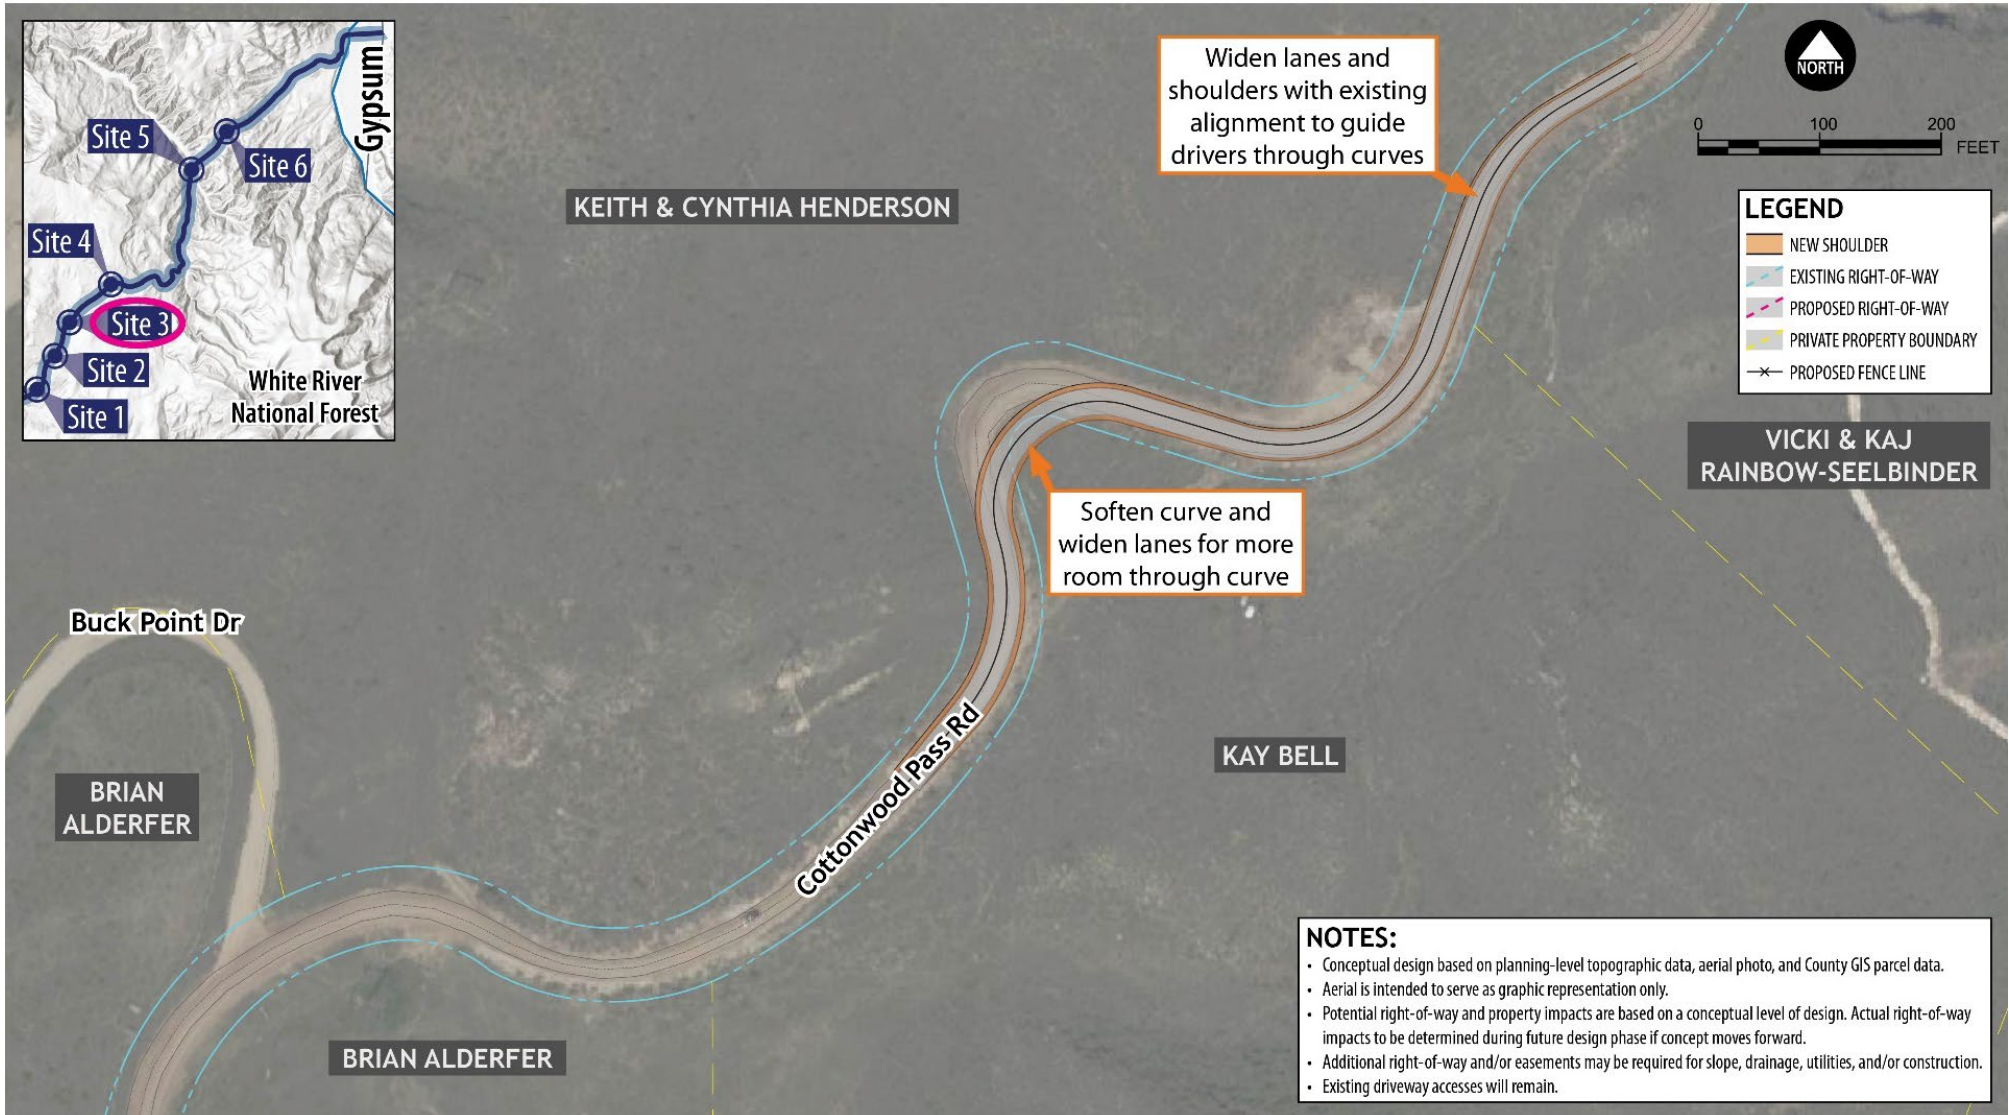
Figure 18. Eagle County Site 3 Option 2 - Soften Curves

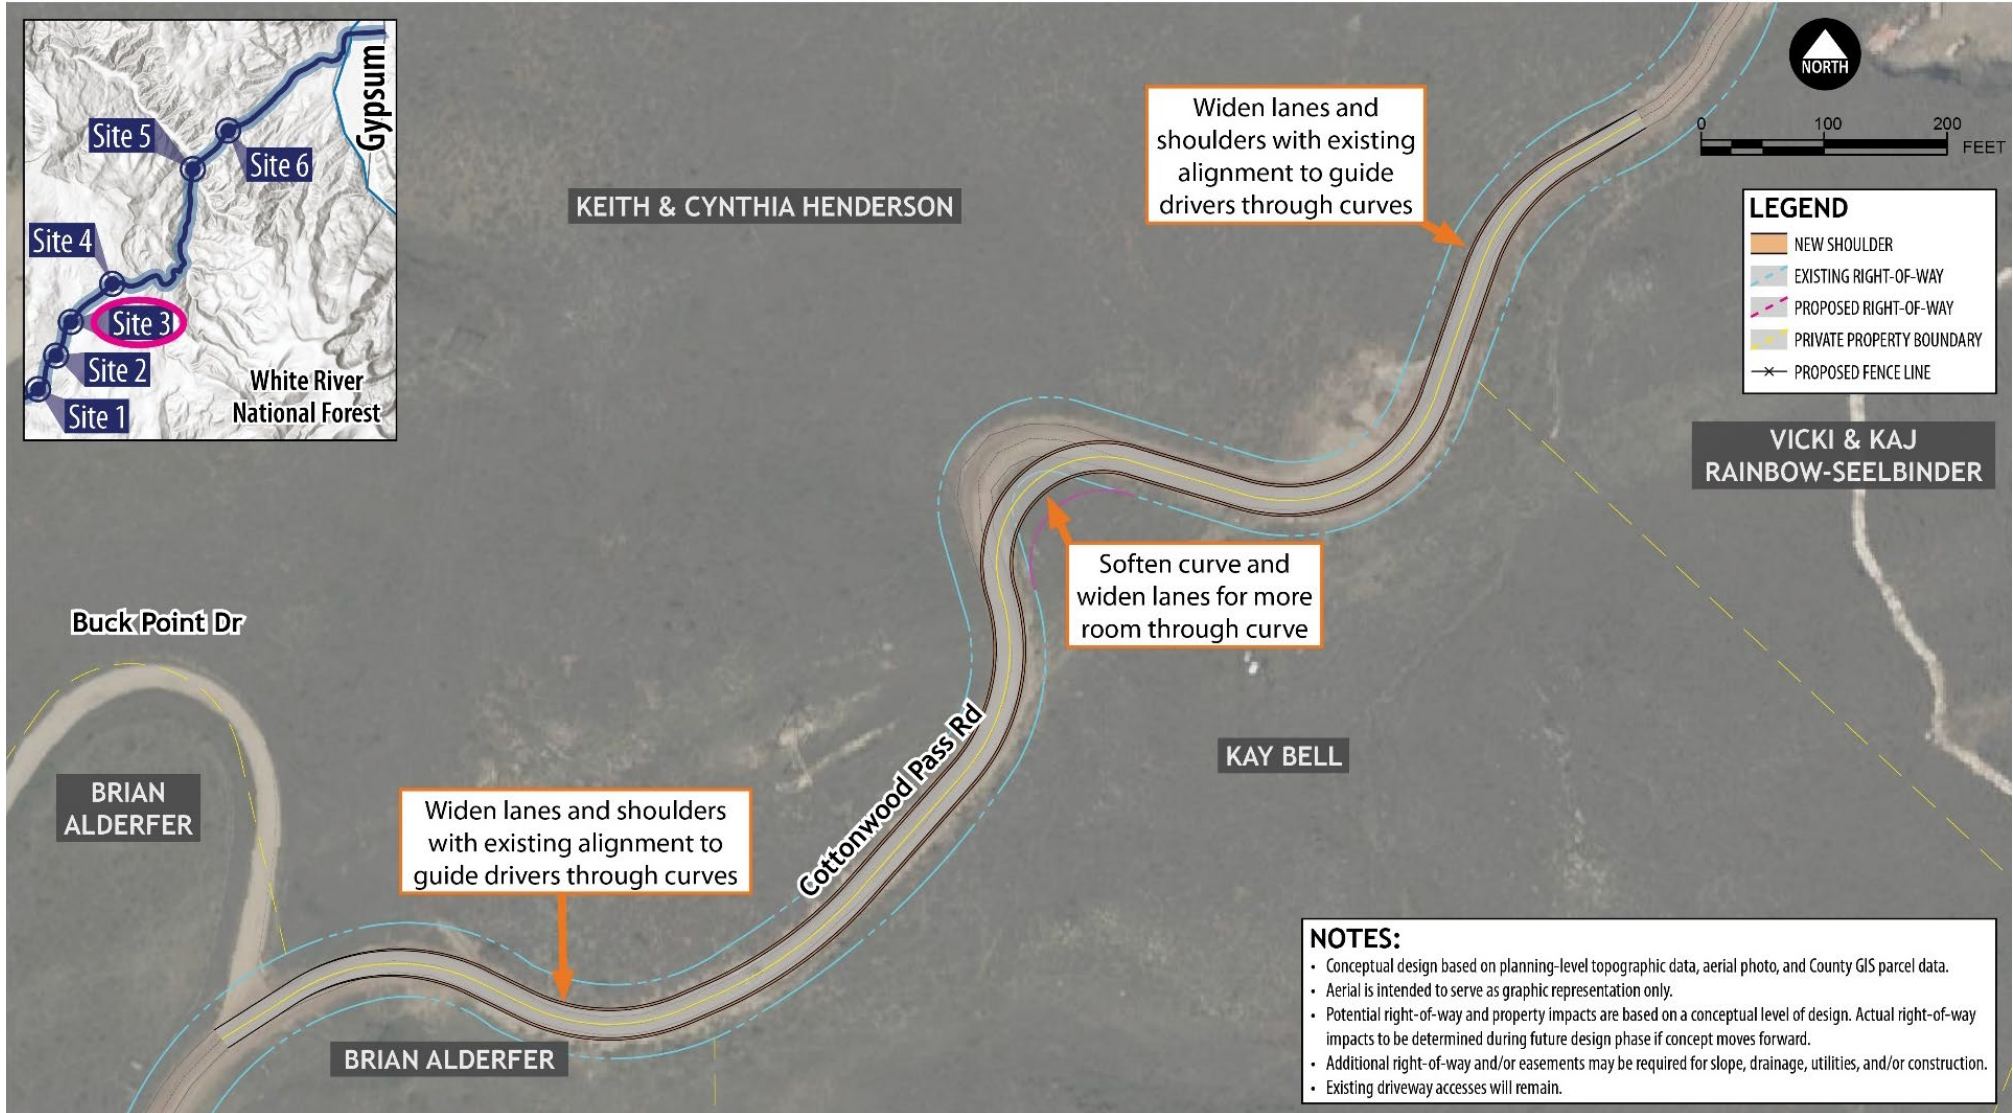
Figure 19. Eagle County Site 3 Option 3 - Further Soften Curves

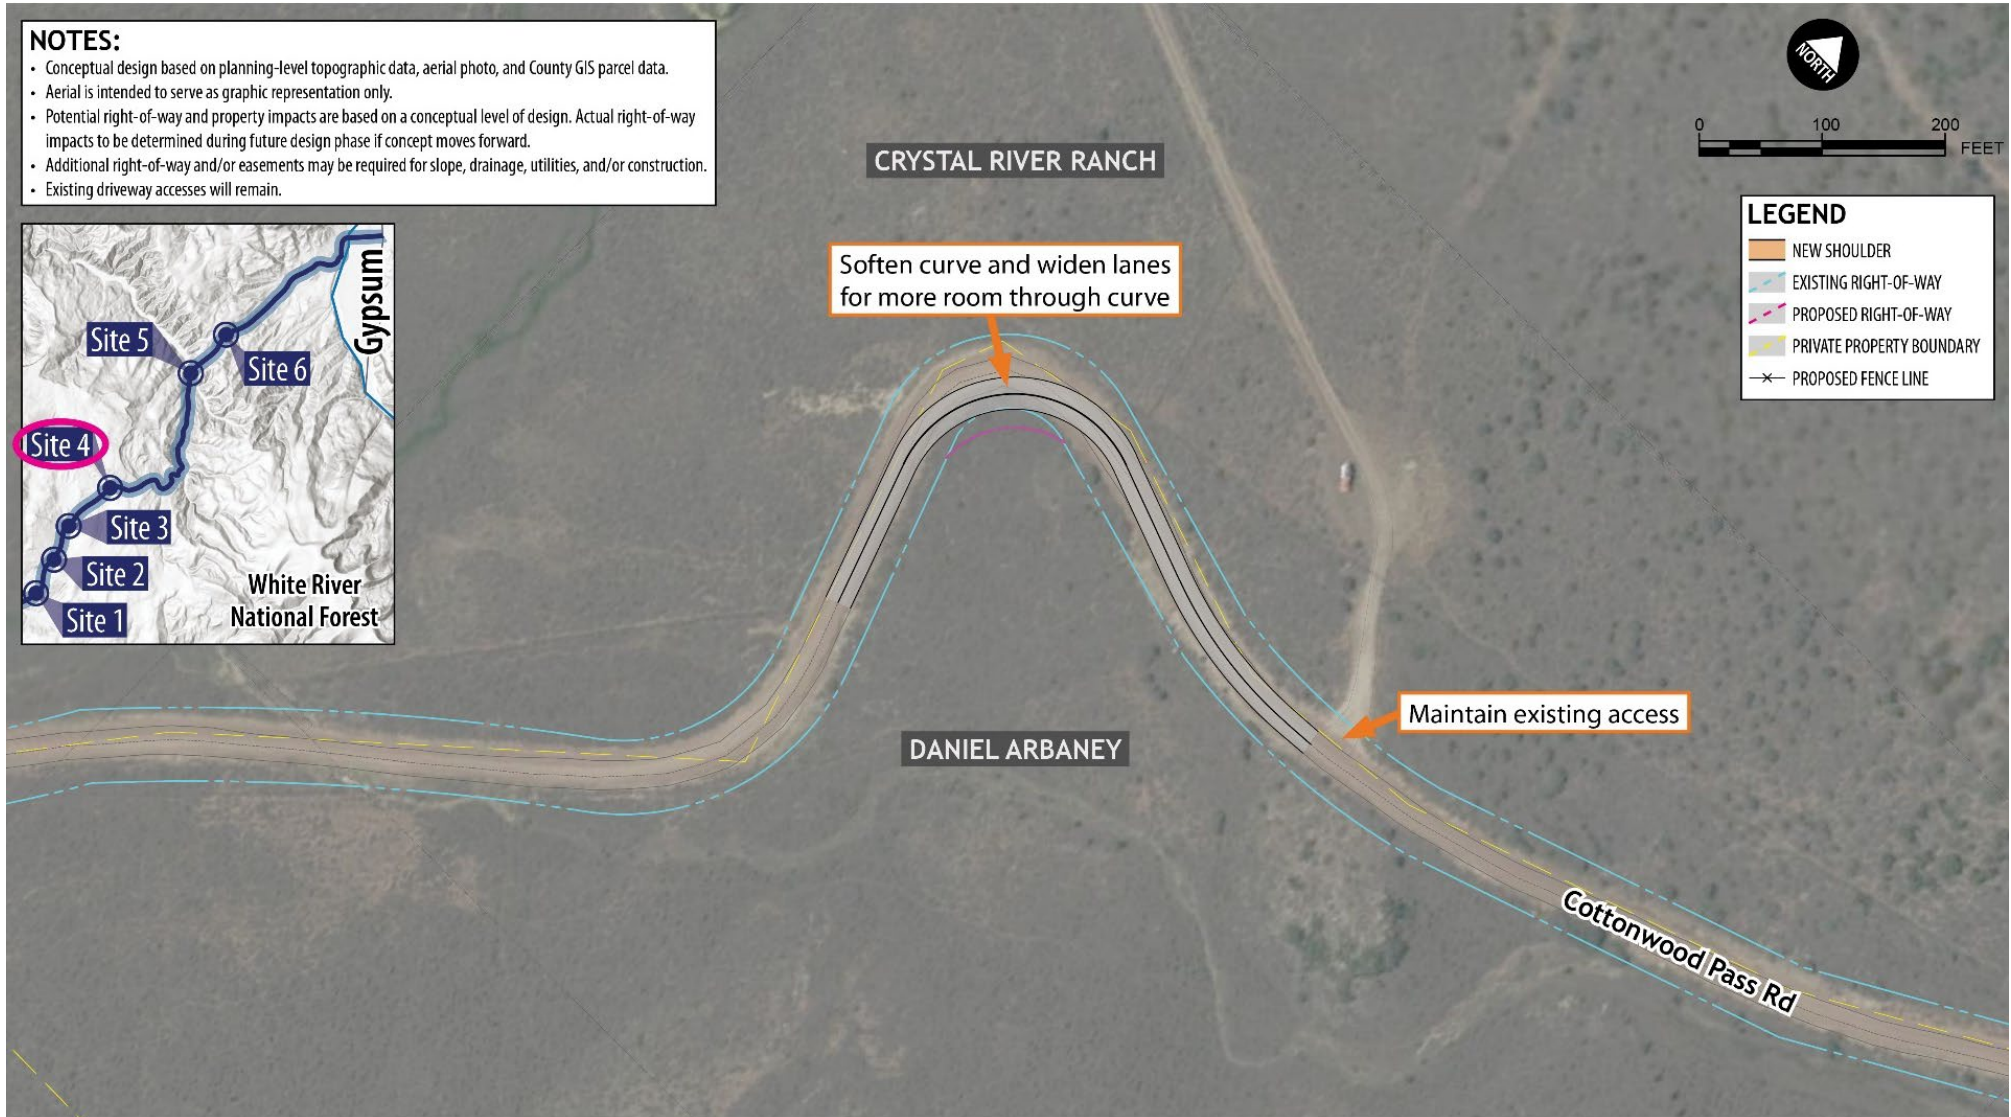
Figure 20. Eagle County Site 4 - Modified Curve with Widened Lanes

Safety issues at this site include driver speeds and two-way traffic conflicts through the curve.
