STRUCTURE SURVEY ASSESSMENT REPORT – I-70 VIADUCT E-17-FX

KIEWIT MERIDIAM PARTNERS

This Structural Survey Assessment Report (SSAR) was prepared on behalf of Kiewit Meridiam Partners (KMP) to address the presence of asbestos containing building materials (ACBMs), heavy metals containing paint, including lead based paint (LBP), and hazardous materials that may be associated with the Interstate 70 (I-70) viaduct, E-17-FX, located between mile posts 275 and 276 in Denver County, Colorado, as part of the Central 70 project.

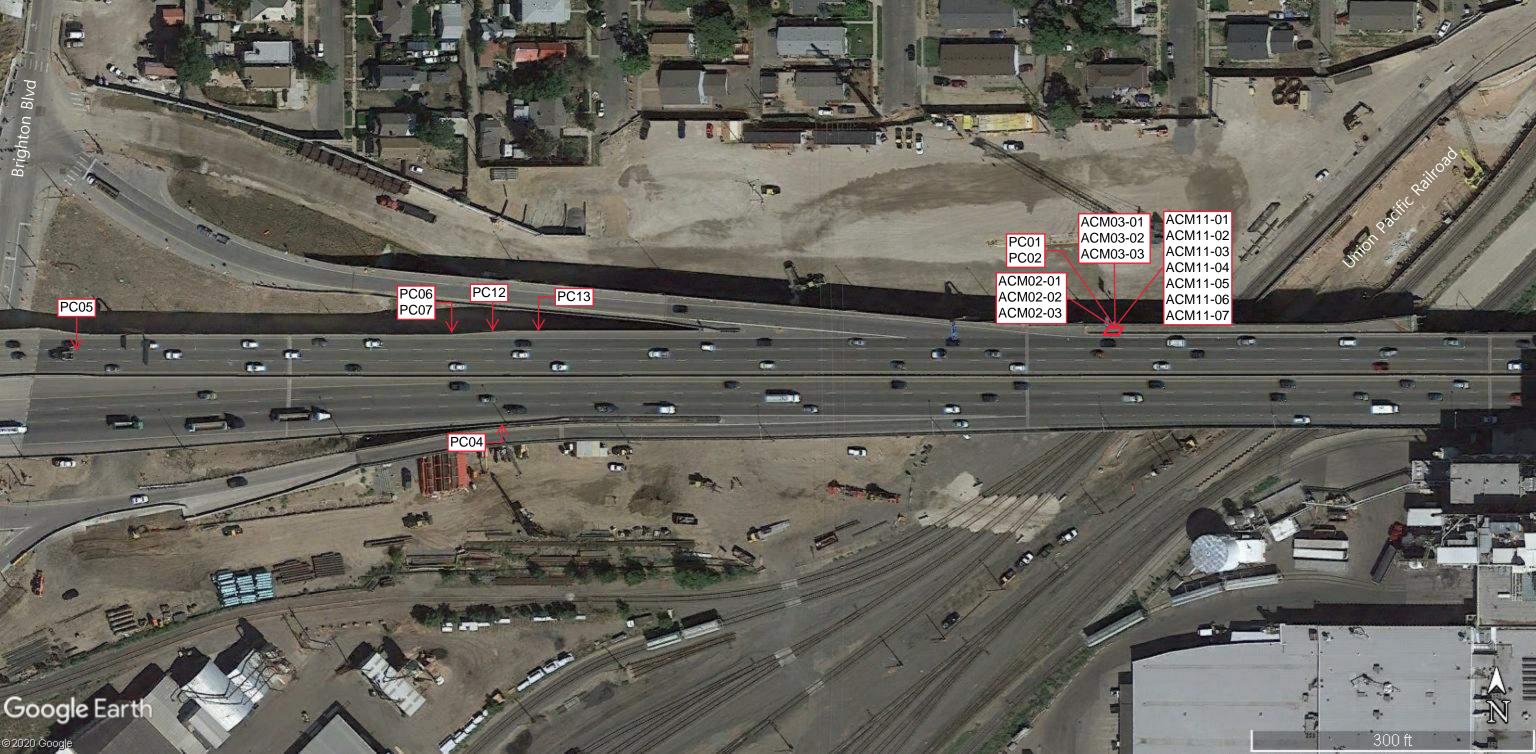
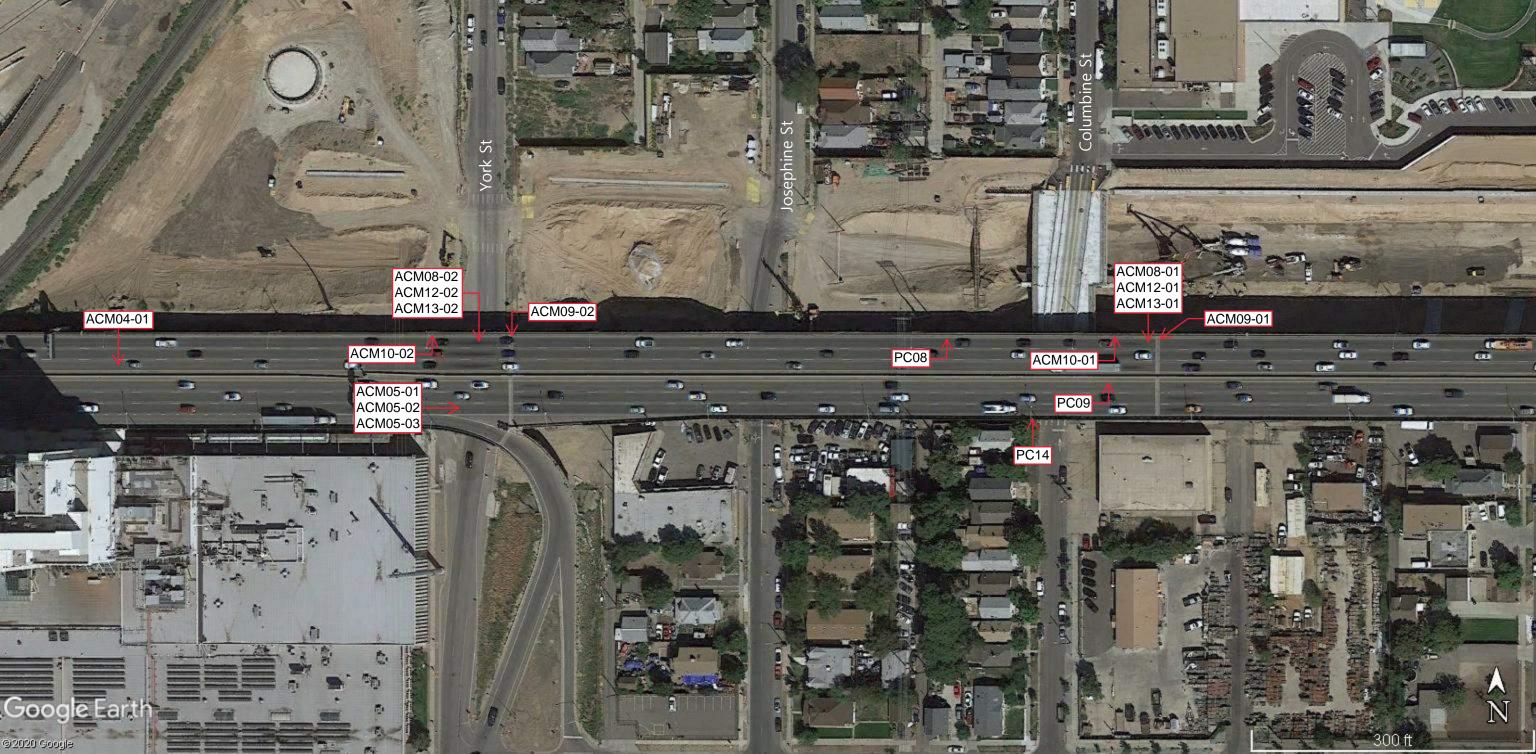
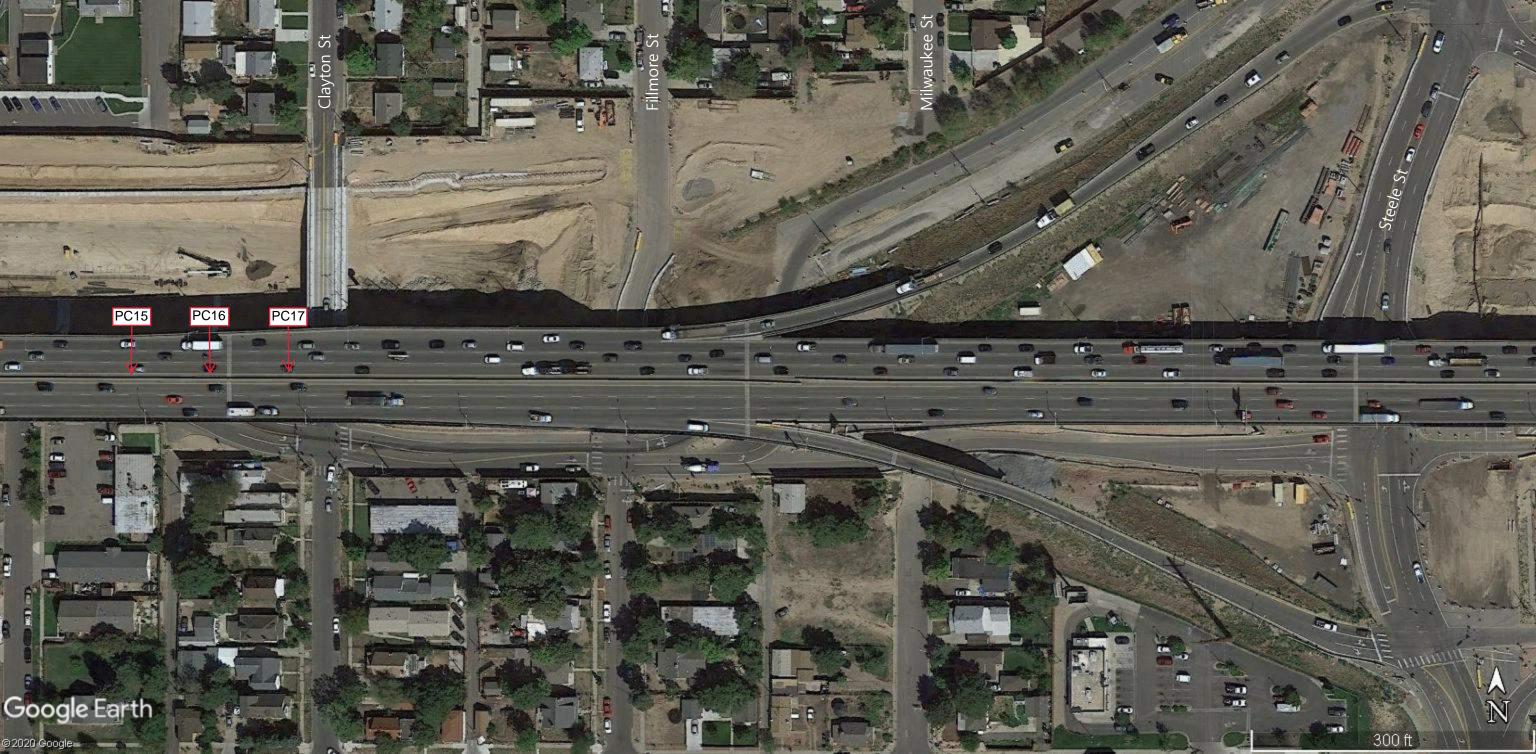
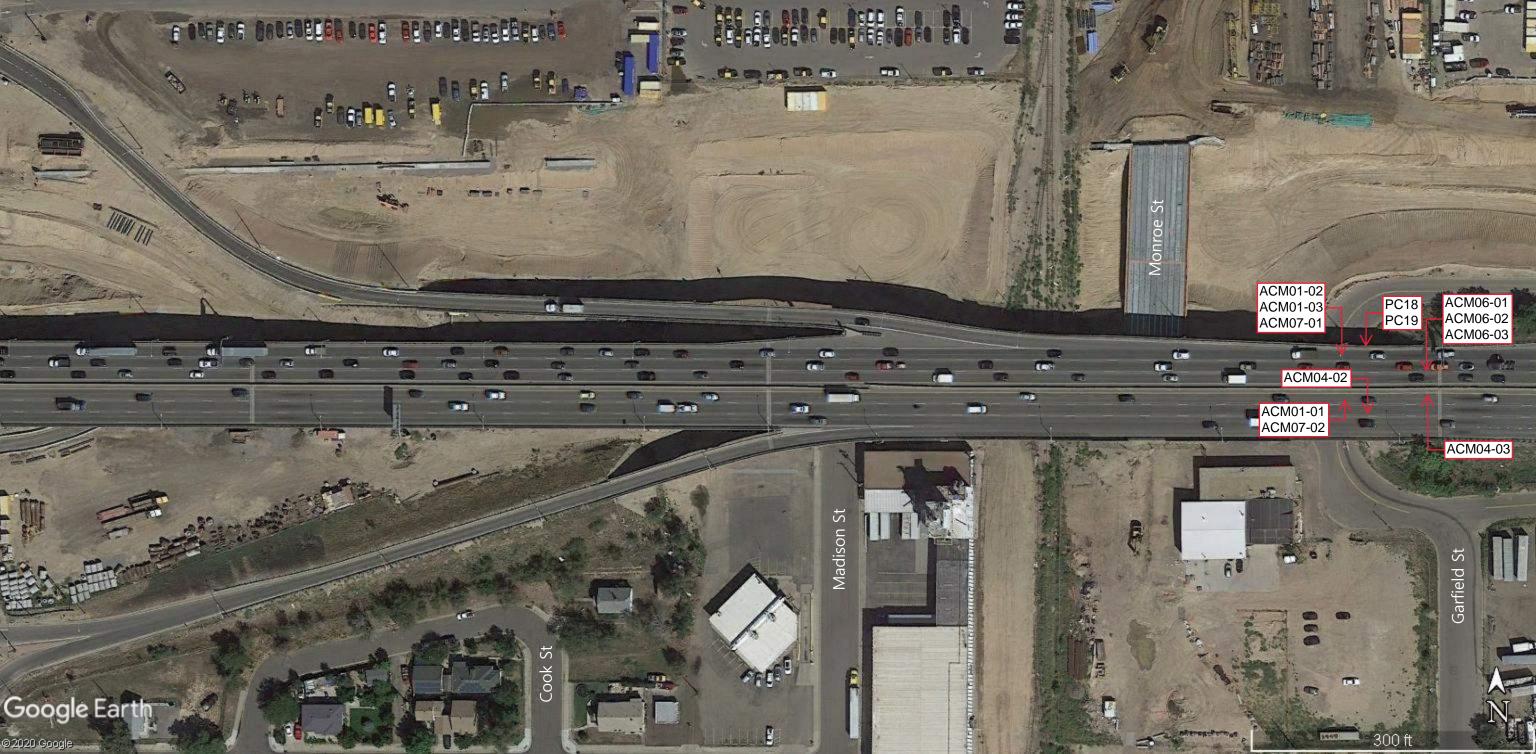
SAMPLING LOCATIONS ON AERIAL PHOTOGRAPHS

The paint chip samples were submitted to Origins Laboratory in Denver and analyzed by GEL Laboratories, LLC for RCRA 8 metals by EPA Method 6010C/7471. Aerial photographs of the viaduct structure that indicated sample collection locations are included in Appendix B. Photographs of the sampling locations are included in Appendix D.
