Existing Through Travel Lanes and Right-of-Way

Existing Typical Cross Sections (facing east)

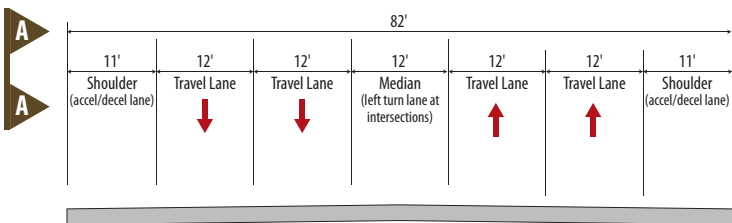
US 287 / SH 7: Baseline Road to Arapahoe Road
CORRIDOR CONSTRAINTS and DEFICIENCIES

- Narrow shoulders near intersections

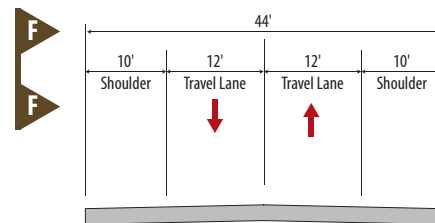
SH7: Sheridan Parkway to I-25
CORRIDOR CONSTRAINTS and DEFICIENCIES

- No median
- Offset intersection at CR 7 / Huron Street

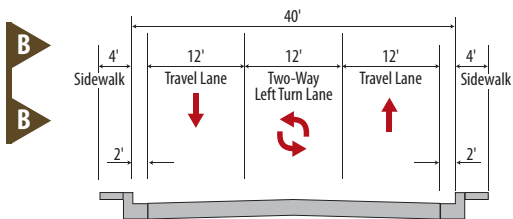
SH7: US 287 to Public Road
CORRIDOR CONSTRAINTS and DEFICIENCIES

- Constrained ROW
- Narrow sidewalks

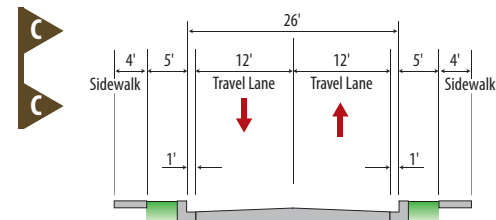
SH7: Public Road to Burlington Avenue
CORRIDOR CONSTRAINTS and DEFICIENCIES

- No median / left turn lanes
- Constrained ROW
- Narrow sidewalks

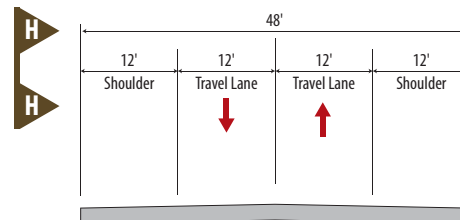
SH7: 166th Avenue to Yosemite Street and Tucson to US 85
CORRIDOR CONSTRAINTS and DEFICIENCIES

- No median
- Inadequate EB merge at SH 7 / 160th Ave.
- Inadequate sight distance at Colorado Blvd.
- No turn lanes at Colorado Blvd. due to Railroad bridge
- Vertical sight distance on eastbound approach to Quebec St.

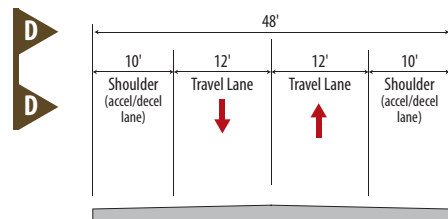
SH7: Burlington Avenue to Lowell Boulevard
CORRIDOR CONSTRAINTS and DEFICIENCIES

- Narrow shoulders near intersections

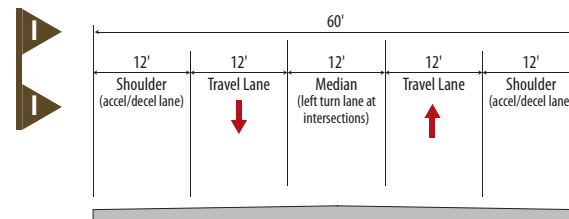
SH7: Yosemite Street to Havana Street and Riverdale Road to Tucson
CORRIDOR CONSTRAINTS and DEFICIENCIES

- Narrow shoulders at intersections

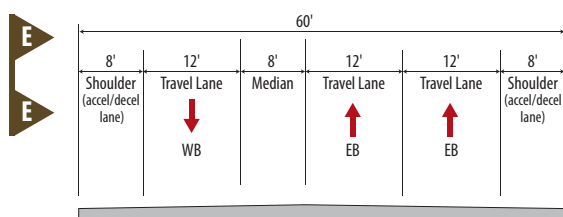
SH7: Lowell Boulevard to Sheridan Parkway
CORRIDOR CONSTRAINTS and DEFICIENCIES

- Narrow shoulders near intersections

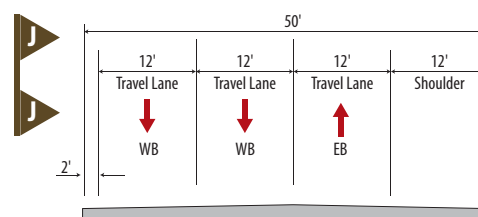
SH7: Havana Street to Riverdale Road
CORRIDOR CONSTRAINTS and DEFICIENCIES

- Narrow shoulder on north side
- No median
