In-depth Fracture Critical and Routine Inspection Report

Structure: K-18-R
Crossing: Arkansas River
Route: US 50 Business East-Bound
County: Pueblo
State: Colorado

Inspected by:
Stantec Consulting Services
2000 S. Colorado Blvd. Ste. 2-300
Denver, Colorado 80222
Frank J. Block, PE, NBI Team Leader

Inspection Date:
March 11, 2014

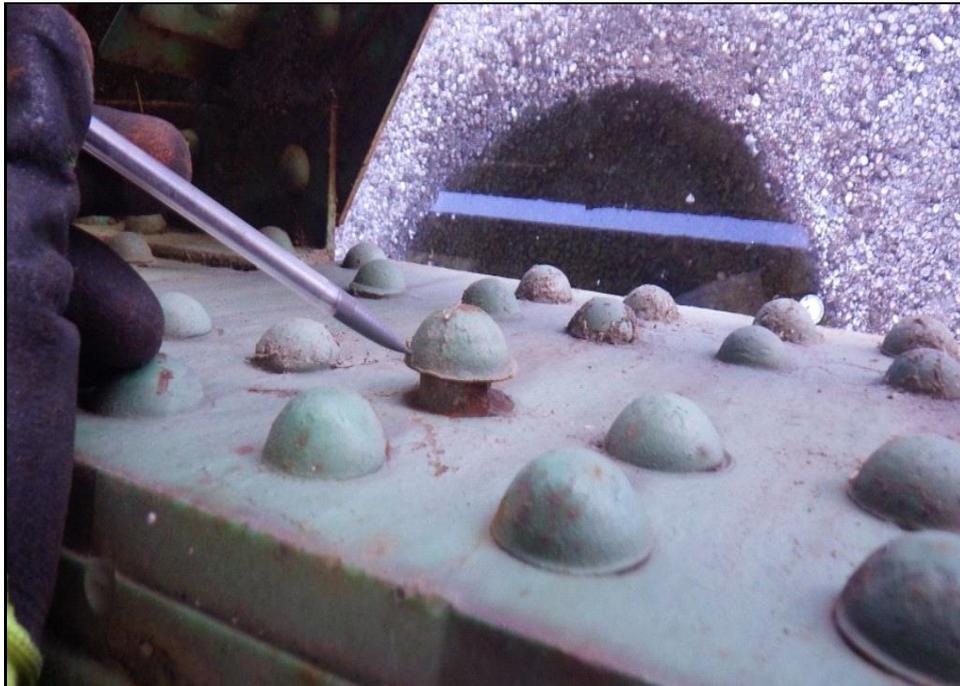
Inboard lower chord splice plate at Panel Point 8 of the Left Truss with top angle bottom row rivet, 3rd from south, with loss of head and popping out

Lower chord rivets with section loss to the rivet head to the degree that the rivet is no longer adequately restrained within its connecting member should be replaced with high strength bolts. Refer to the list of rivets for replacement and respective locations within Appendix D. Several gusset plates to the lower lateral bracings and lower chord splice plates with significant section loss should be considered for replacement during rivet replacement.

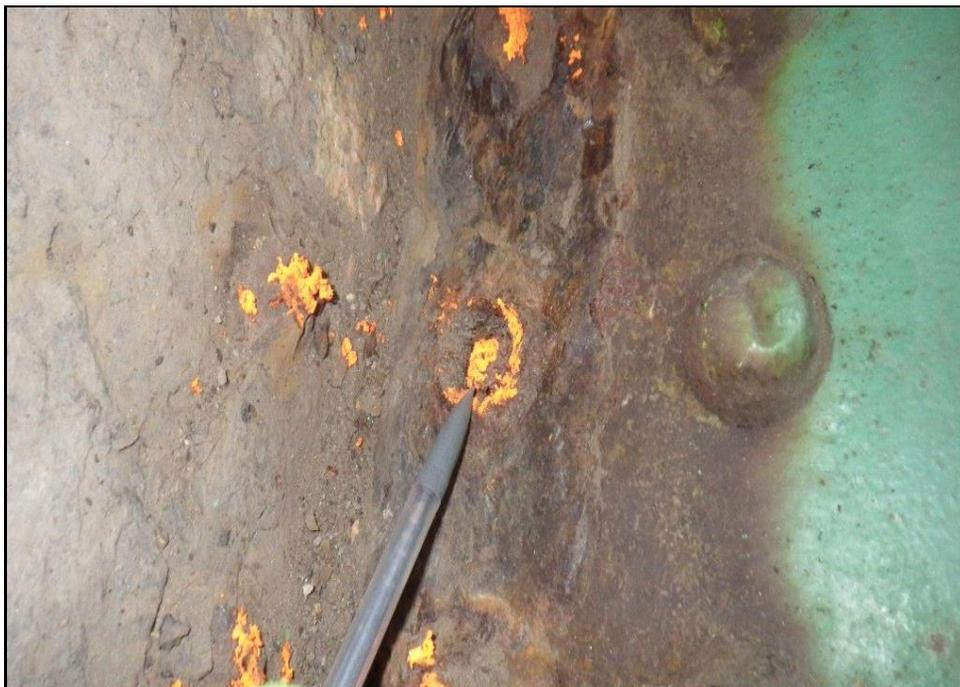
Lower chord splice at Panel Point 8 showing 100% loss of head to rivet which is popping out

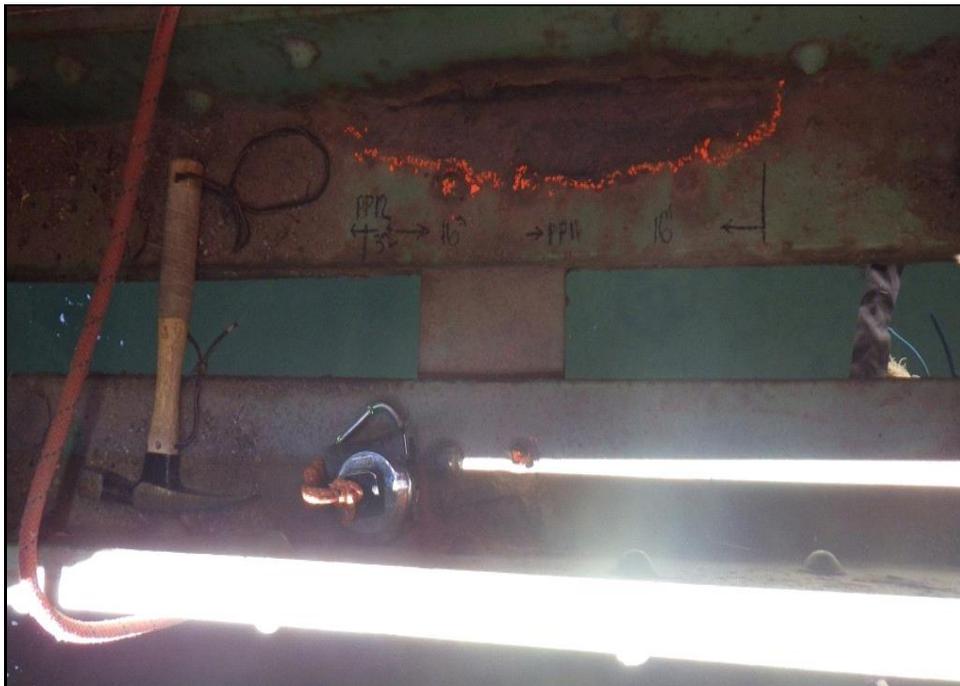
Lower chord near Panel Point 12 showing worst case section loss to top angles of the Left Truss (detailed on sketches in Appendix D)

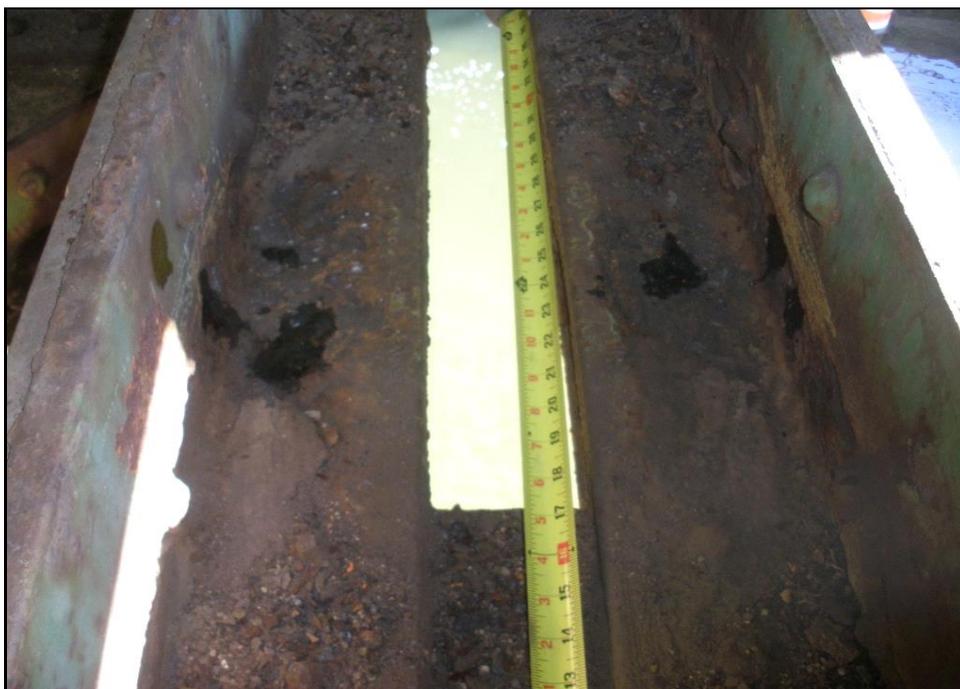
Isolated areas of R2 to R4 laminating corrosion of the lower chord top angles exist where debris has accumulated causing up to 5/8 inch section loss. The worst case lower chord top angle section loss was observed within Panel 10 of the right truss and Panel 12 of the left truss. Detailed measurements of section loss were recorded at these locations and are included in the cross-sectional sketches within Appendix D.

Lower chord near Panel Point 10 showing worst case section loss to top angles of the Right Truss (detailed on sketches in Appendix D)

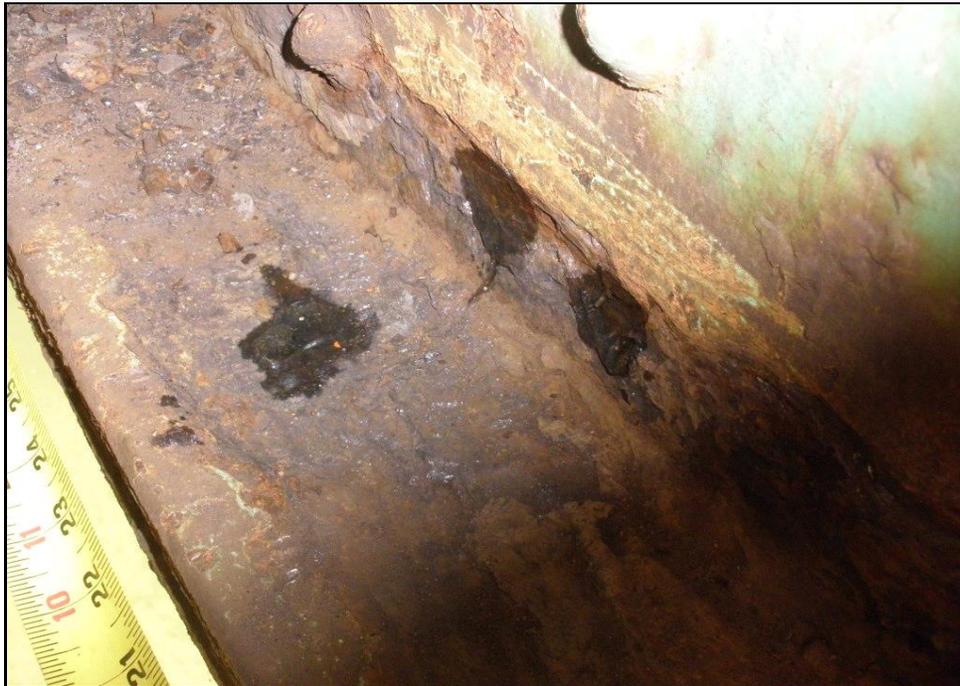
Close-up of section loss through detailed section of Right Truss lower chord top outboard angle where UT thickness measurements were taken

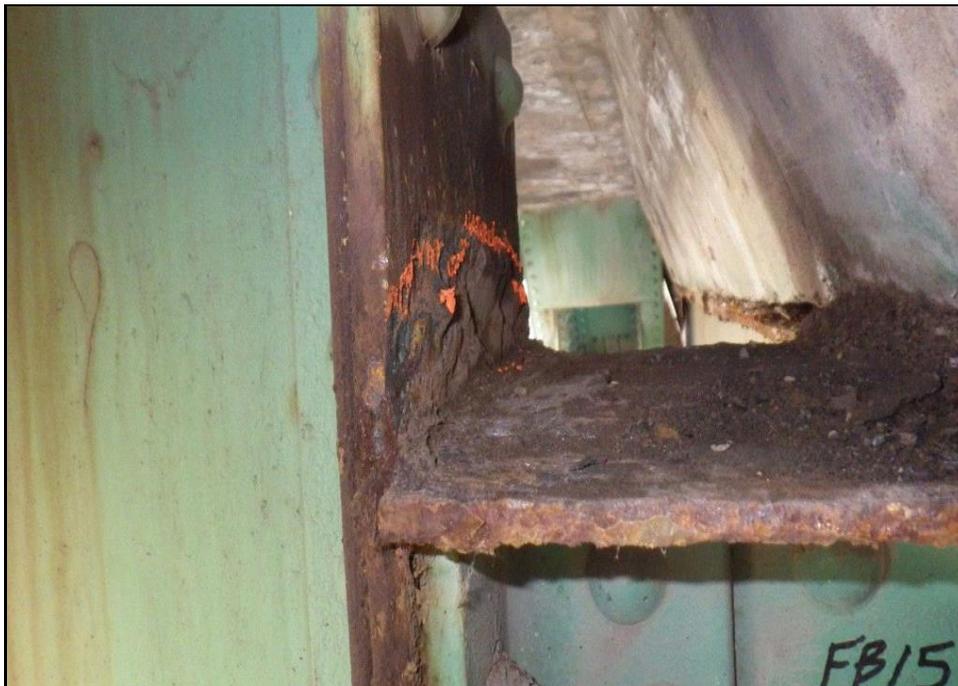
Corrosion and section loss to gusset plates typical at floorbeam to vertical and diagonal members

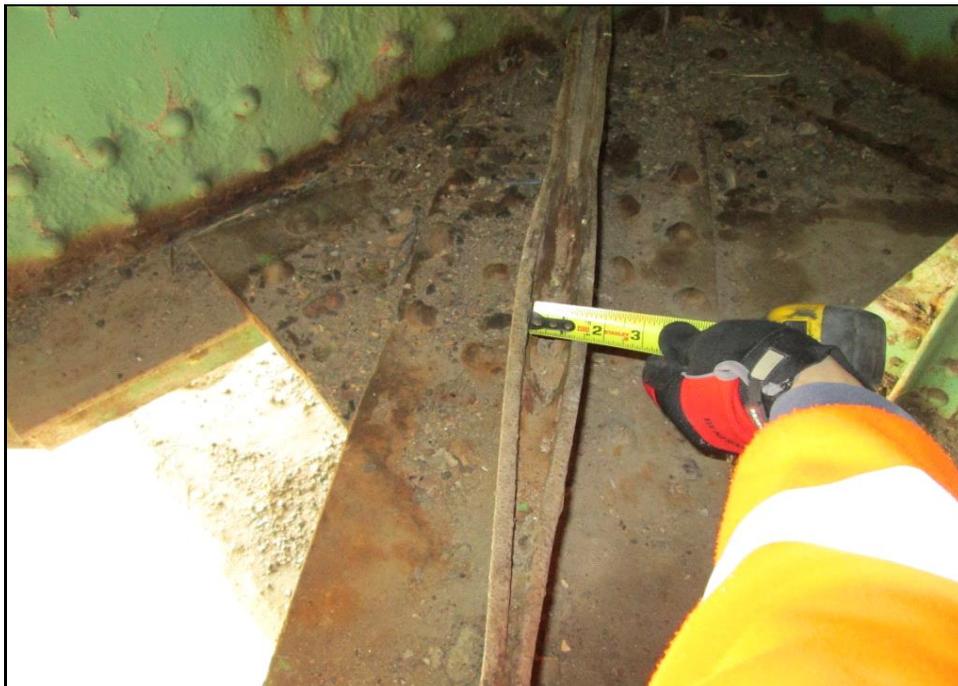
Typical pack rust separating vertical legs of lower lateral bracing angles, Panel Point 0, Right Truss

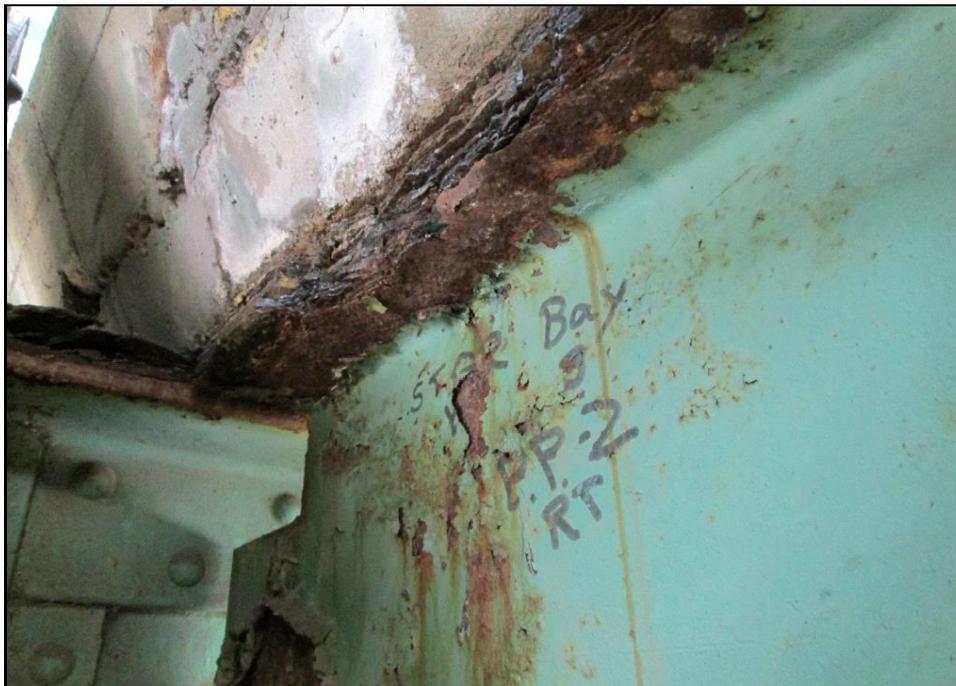
R4 corrosion of Stringer 3H top flange

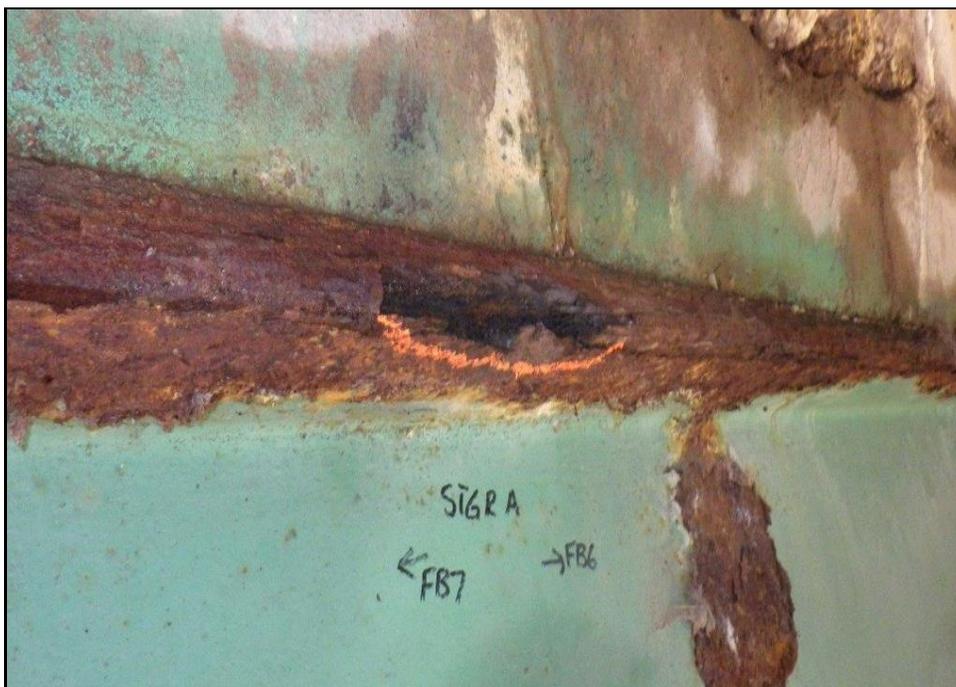
R4 with near 100% section loss to top flange of Stringer 7A

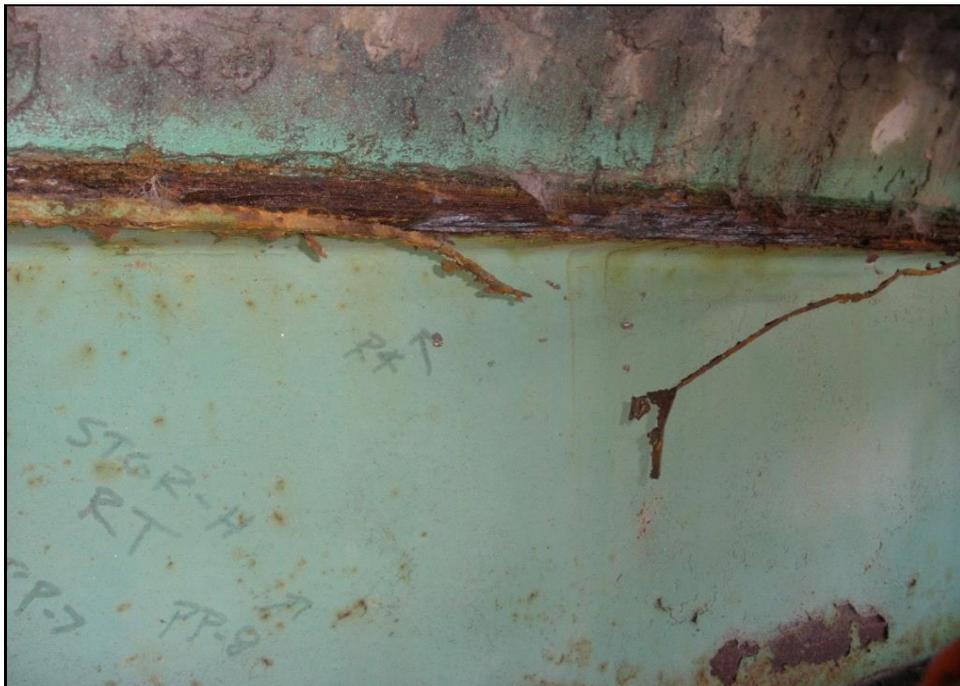
R4 with near 100% section loss to top flange of Stringer 8H

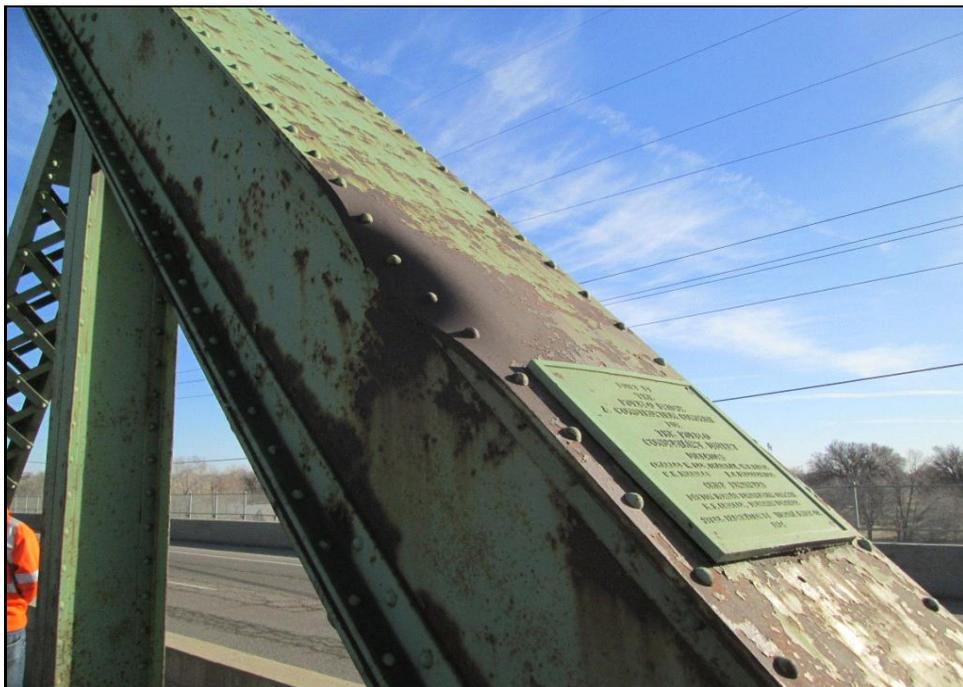
Impact to top flange of Left Truss upper chord L16M15 at south portal

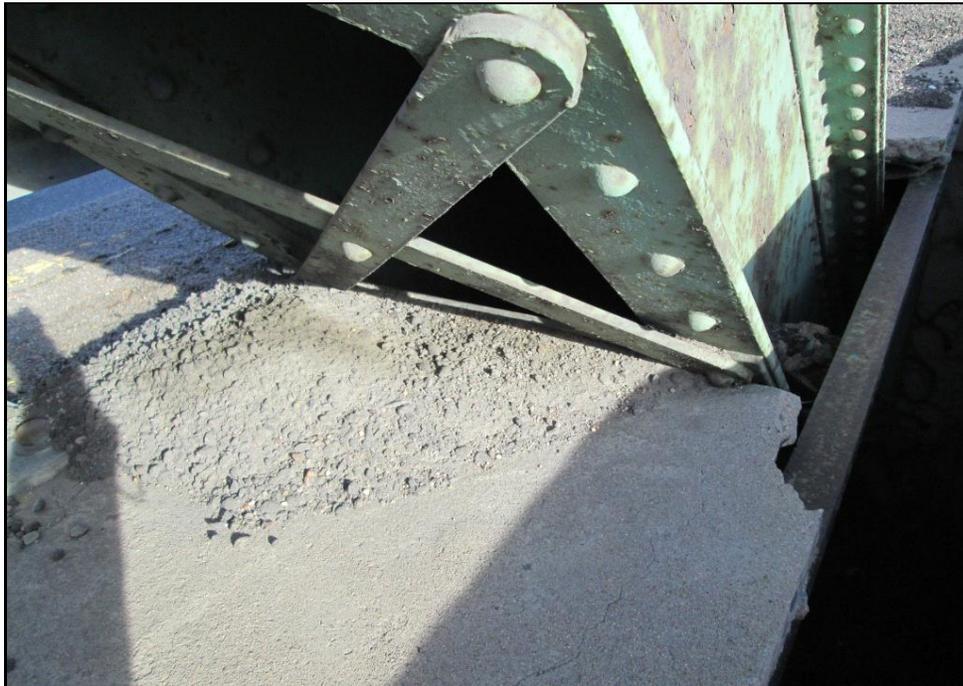
Deck impacting Left Truss upper chord at A1, typical at all four corners

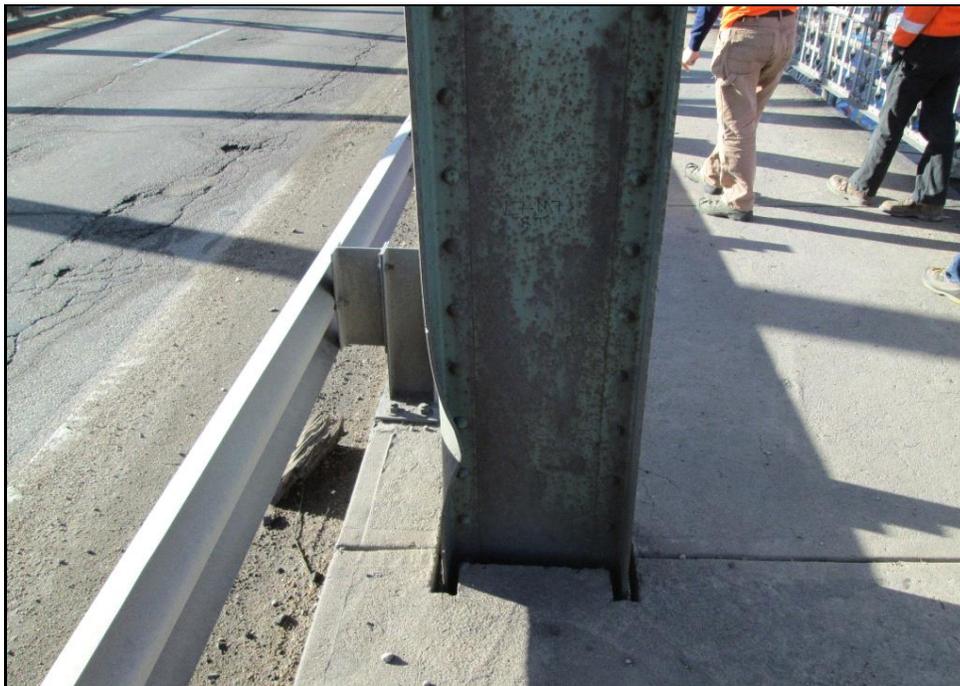
Impact damage to Vertical L7M7 of the Right Truss

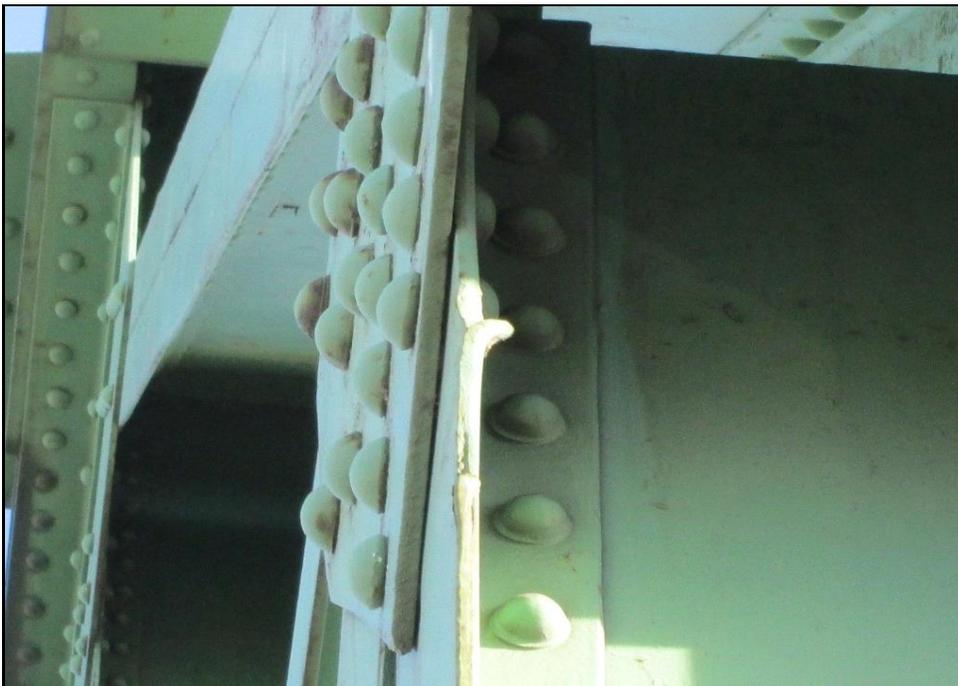
1 inch tear in southwest flange of Left Truss Vertical L5M5 near M5 connection

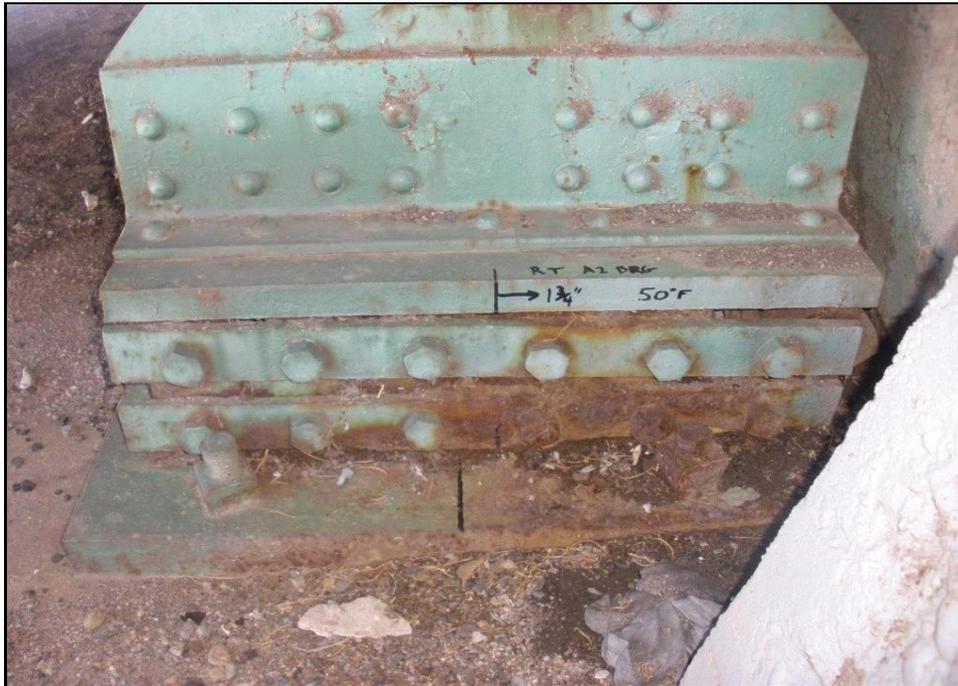
Rocker nest sole plate is approximately 1.75 inches off-center from the masonry plate suggesting the truss is locked in a state of expansion

The nested rocker bearing assemblies at Abutment 2 will also need to be repaired or replaced in order to return the ability of expansion and contraction to the structure.

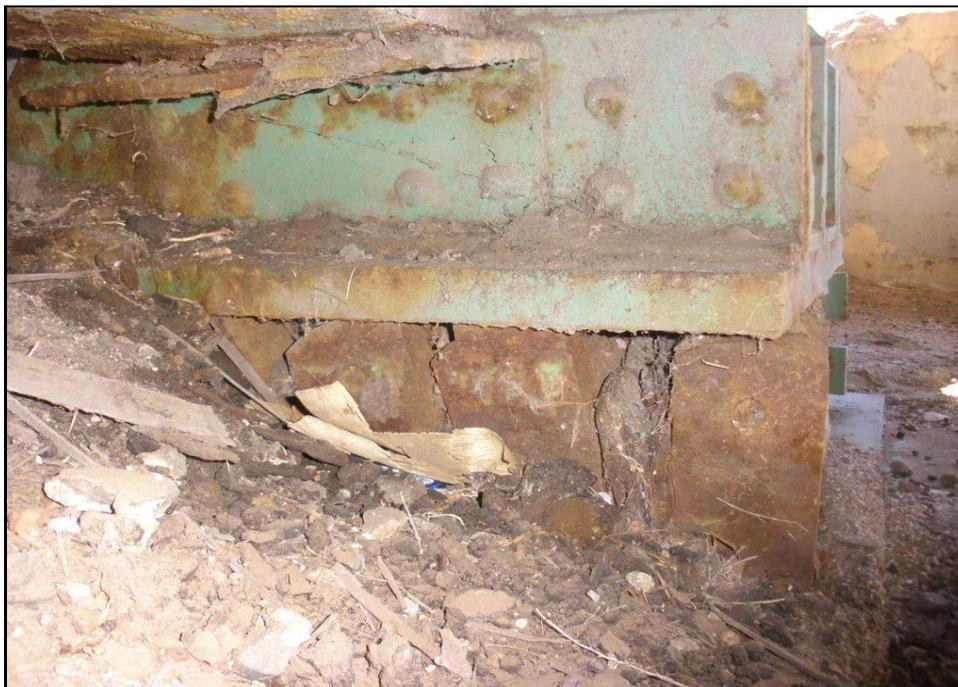
Debris from once failed joint at Abutment 2 causing loss of rocker retainer bars, misalignment and corrosion of rockers

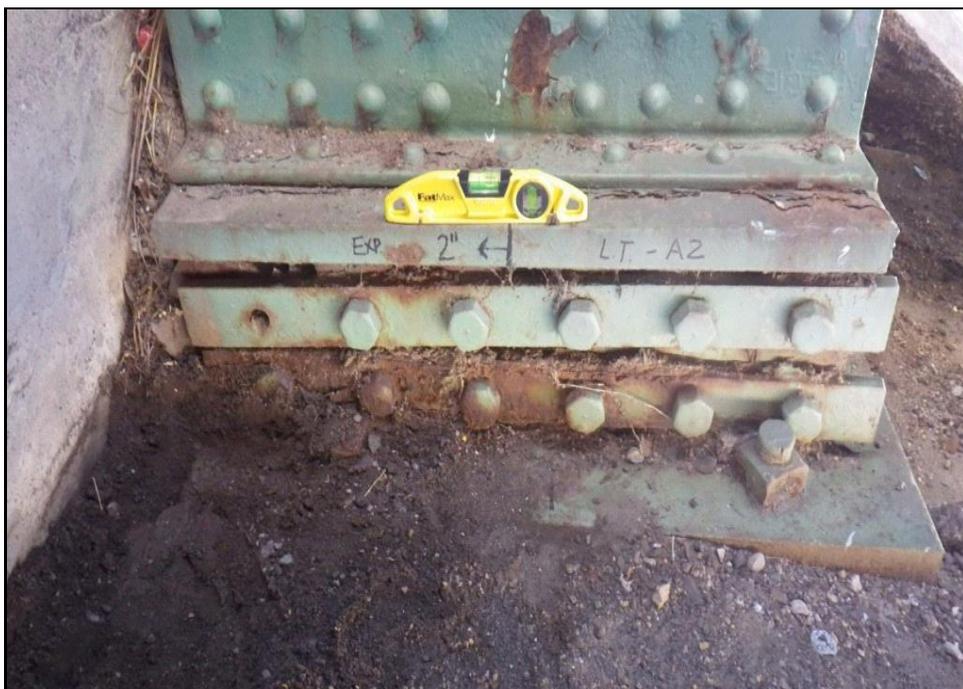
Rocker nest sole plate is approximately 2 inches off-center from the masonry plate suggesting the truss is locked in a state of expansion

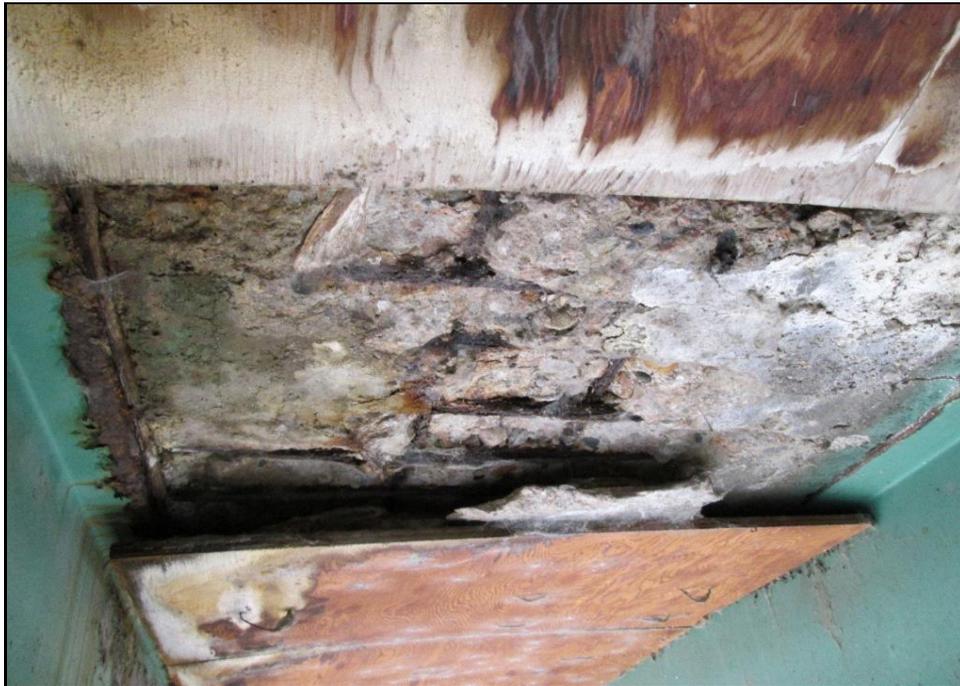
Deck soffit of Bay 2 between Stringers G and H showing previous full-depth deck patches with plywood forming in-place and perimeter spalling

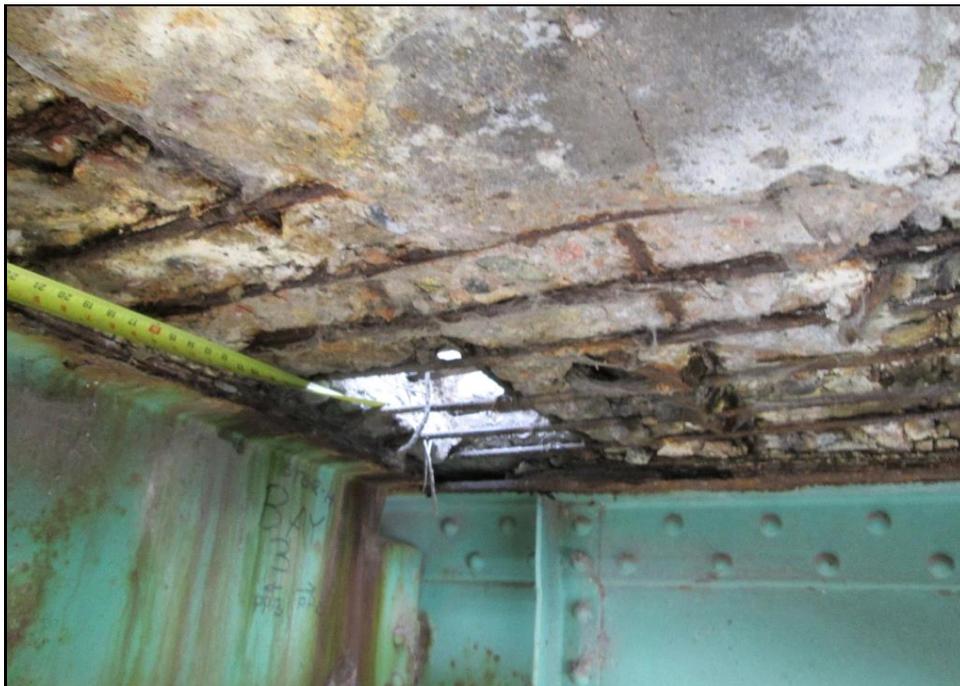
Typical deck soffit condition around drain openings

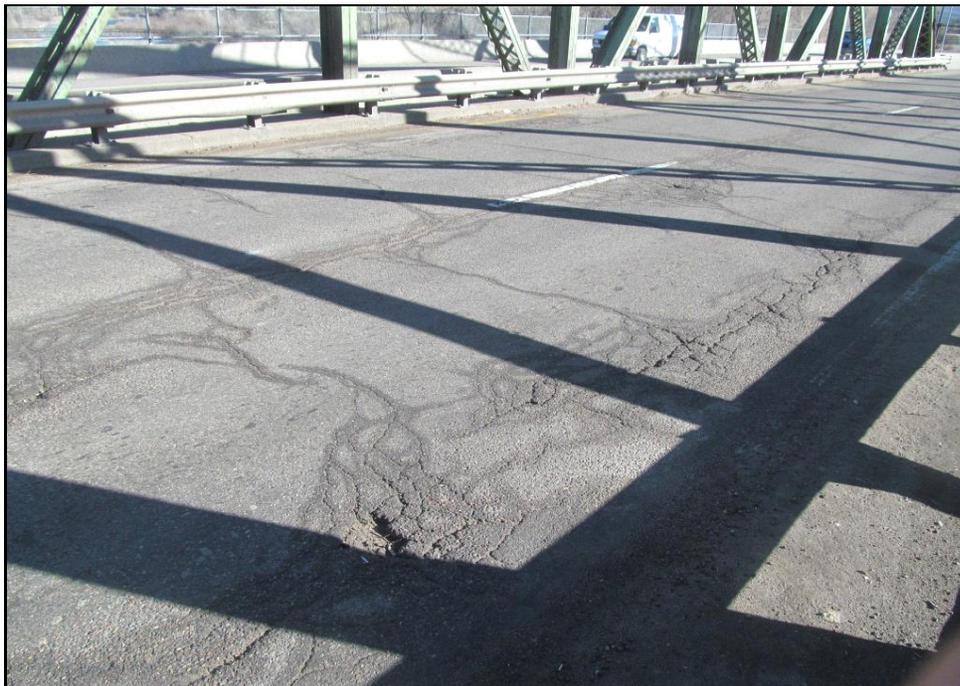
Cracking and potholing in asphalt deck overlay, typical throughout

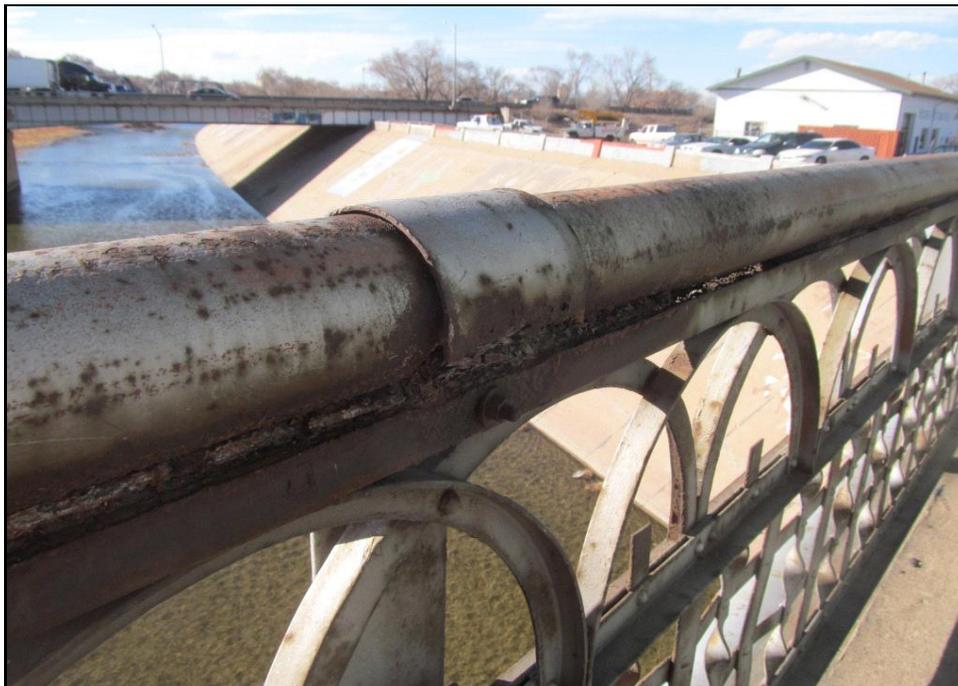
Metal pedestrian rail at west with corrosion of top rail splice plates leaving sharp edges

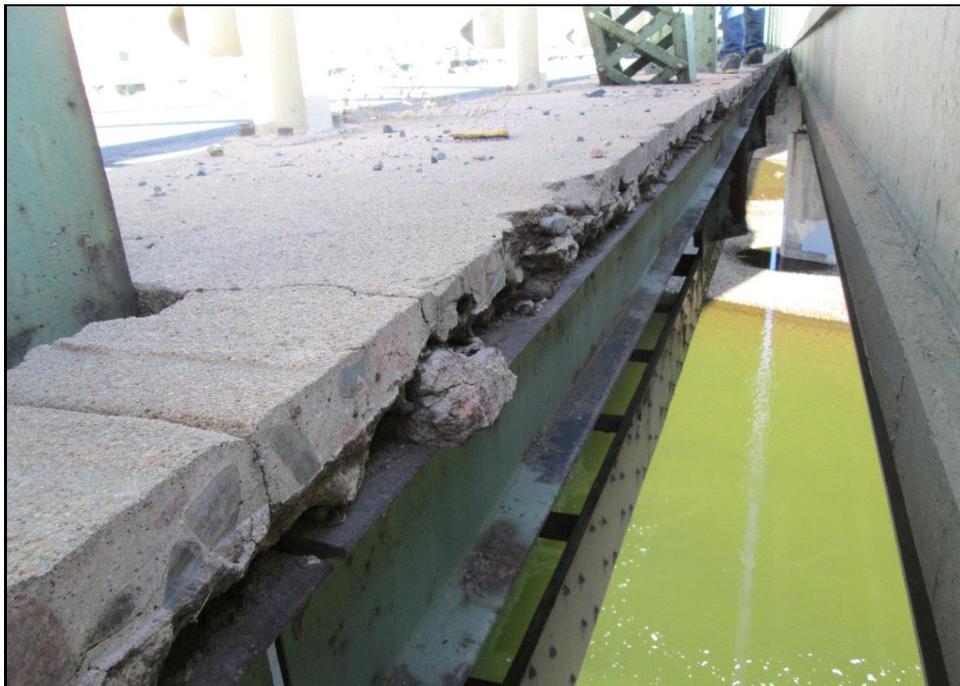
Saw-cut concrete sidewalk along the east deck edge with spalling and exposed reinforcing
