Report No. CDOH-DTD-R-90-4

PAVEMENT MARKING MATERIALS

Final Report
July 1990

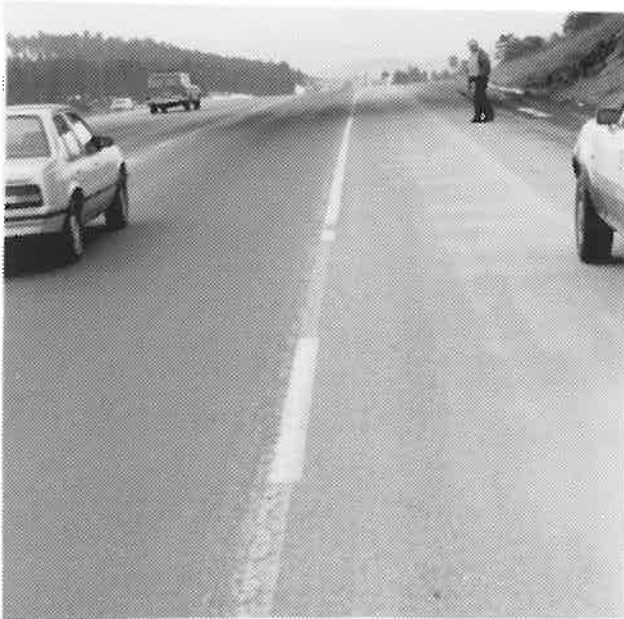
Photo 20. 3/6/89
I70 westbound, Buffalo
Heard Overlook, 1988 epoxy
and alkyd paints.

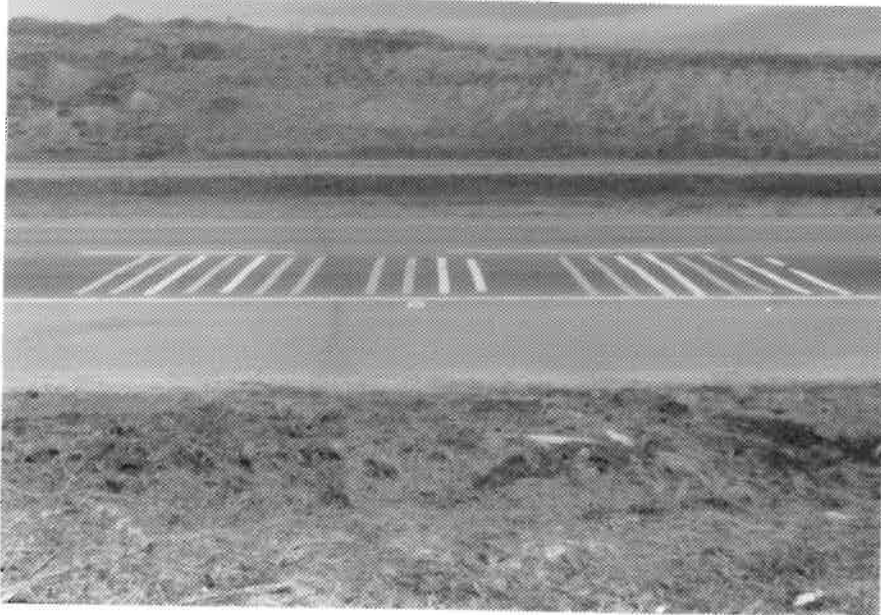
Photo 29. 3/29/88
Prismo removable grade
preformed plastic on
asphalt.

All the removable plastic materials tested remained over 94% intact for at least 120 days and are recommended.

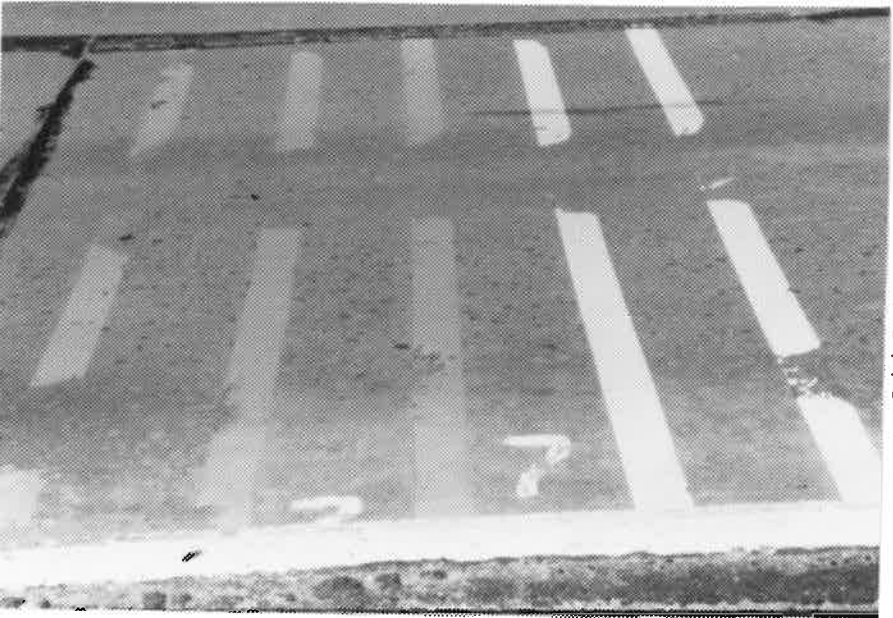
Photo 33. 3/8/89
Seibulite permanent grade
preformed plastic on
concrete.

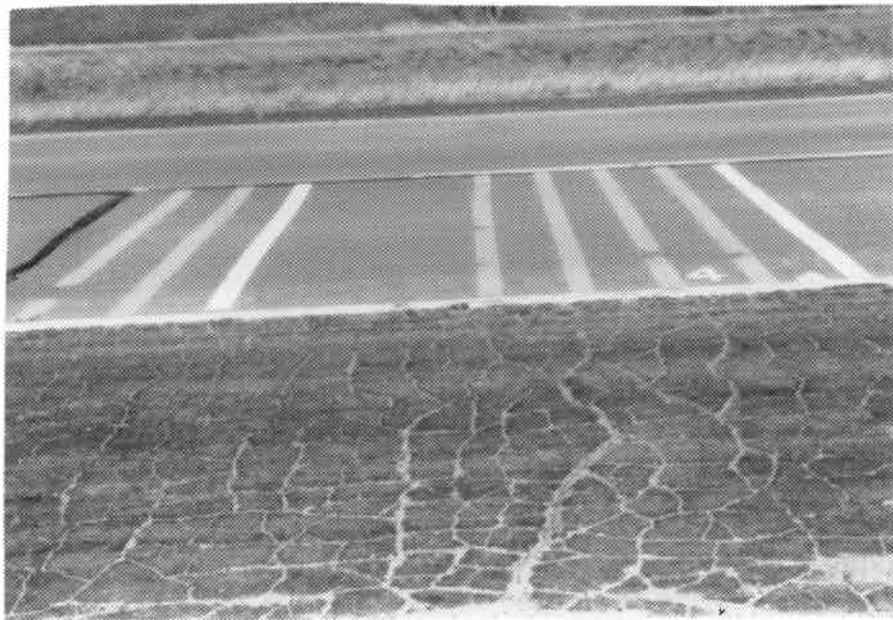
Photo 35. 3/8/89
Cataphote permanent grade
preformed plastic on
concrete.

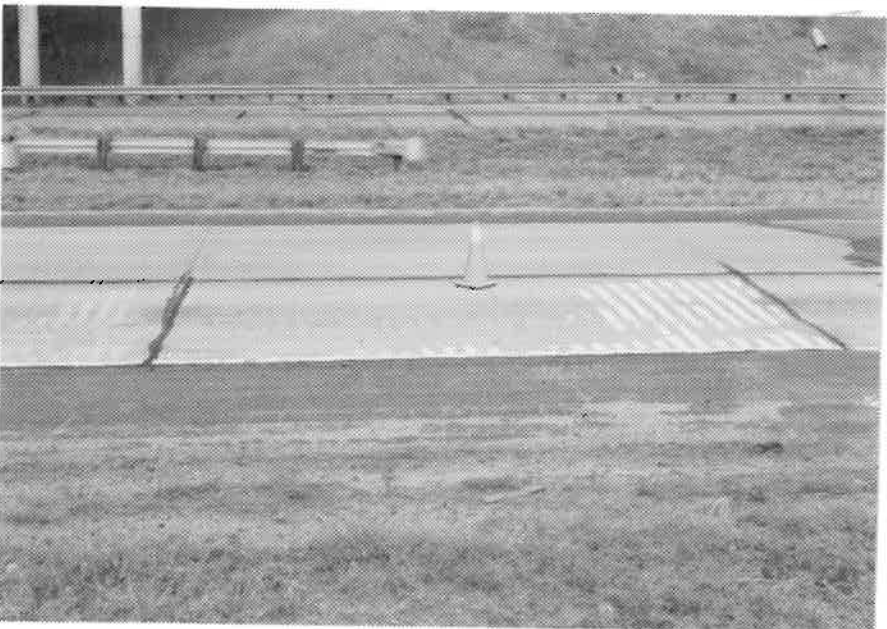
Extruded thermoplastic provides good nighttime visibility throughout its life. Extruded thermoplastic installed on asphalt was found to remain in place for years, while extruded thermoplastic installed on concrete tends to chip off in a matter of months.

Photo 39. 3/8/89
Extruded thermoplastic on
concrete.

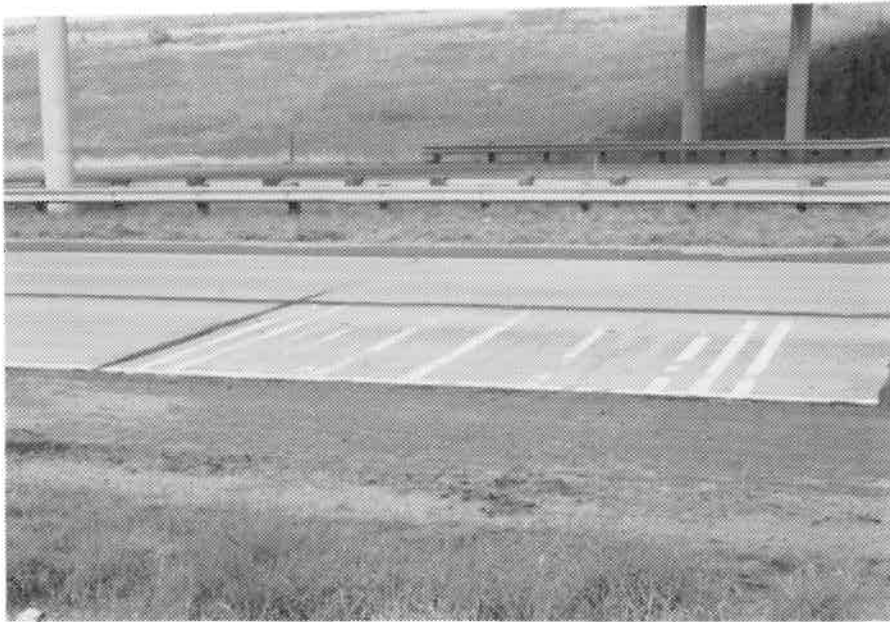
Photo 40. 3/8/89
Paints on concrete.

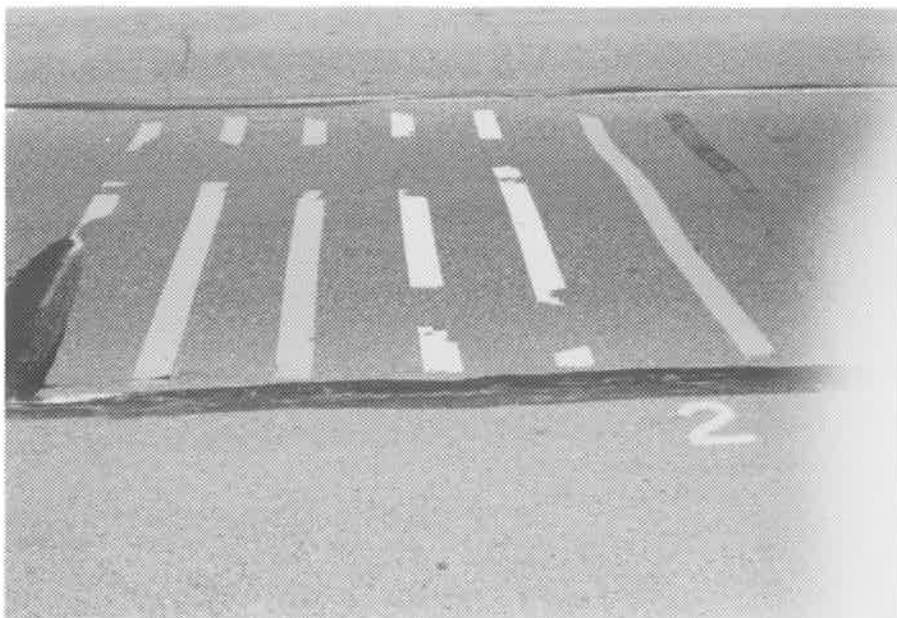
Photos 41 through 51 are photos that indicate the condition of the pavement marking at the end of the test on 3/8/89. The percentage intact of each of the materials was estimated and is shown below.

Photo 42. 3/8/89
Swarolite permanent grade
preformed plastic on
asphalt.

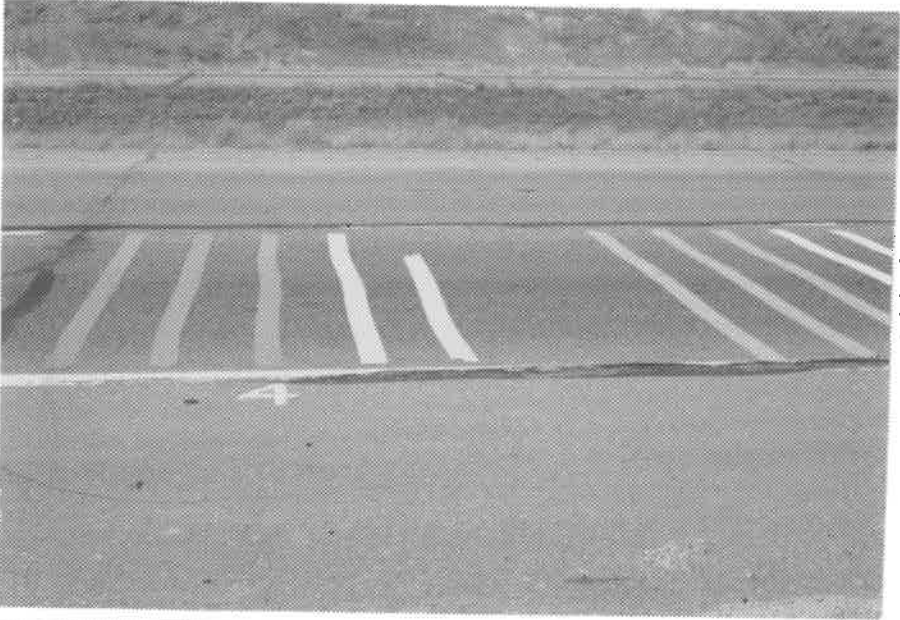
Photo 44. 3/8/89
Volare permanent grade
preformed plastic on
asphalt.
