Report No. CDOT-DTD-R-91-4

RUT-RESISTANT COMPOSITE PAVEMENT DESIGN

Donna S. Harmelink
Colorado Department of Transportation
4201 East Arkansas Avenue
Denver, Colorado 80222

Final Report
July 1991

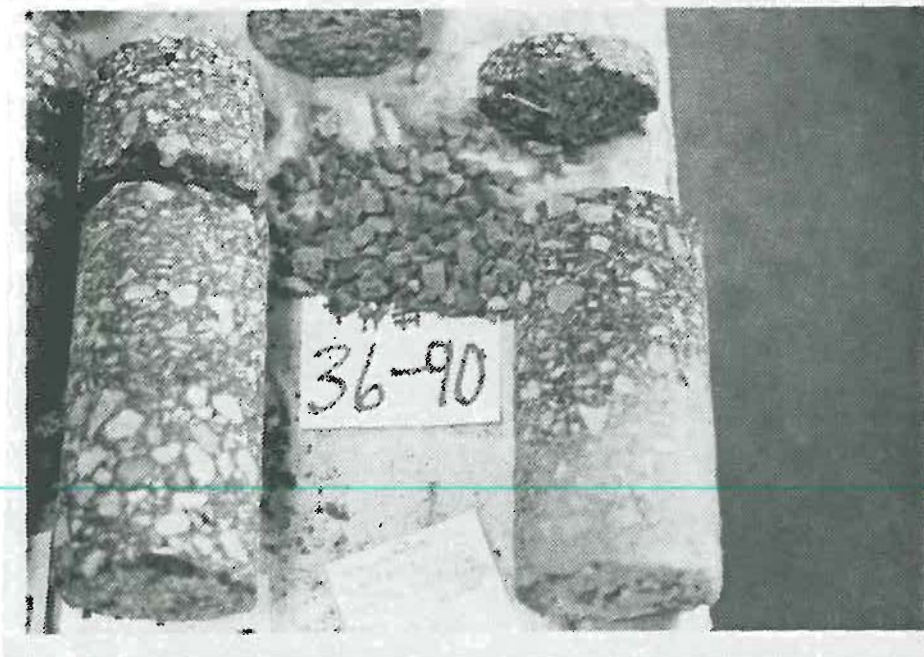
PHOTO 4

At most of the evaluation sites the cores showed signs of stripping progressing from year to year in the layer immediately below the PMSC, some sites more severe than others. A comparison of a core taken in 1990 at the Debeque location to a core taken in 1991 at the same location is shown in Photo 4. The core in Photo 5 was taken from C470 in 1990.

The final evaluation at the Debeque site showed no signs of failure on the surface, rutting was low and cracking was minimal. However, the cores showed signs of stripping in the layer immediately below the PMSC as shown in Photo 4.

This photo shows how stripping progresses. The core on the left taken in 1990. The core on the right taken in 1991 at the Debeque evaluation site. Note that the top lift of PMSC is undisturbed.

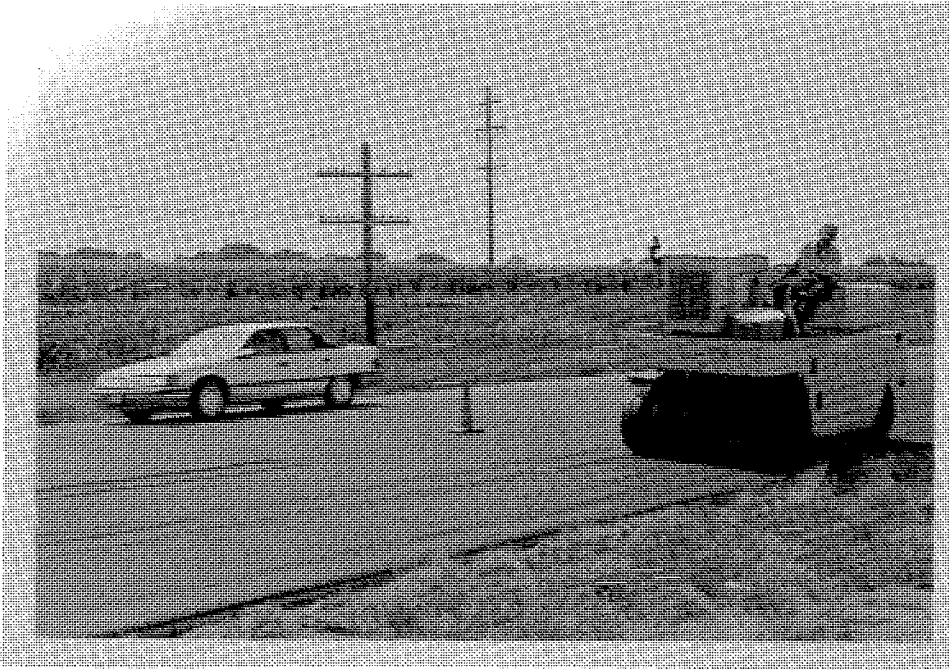
PHOTO 3

Pneumatic roller
was used prior to
finish roller.

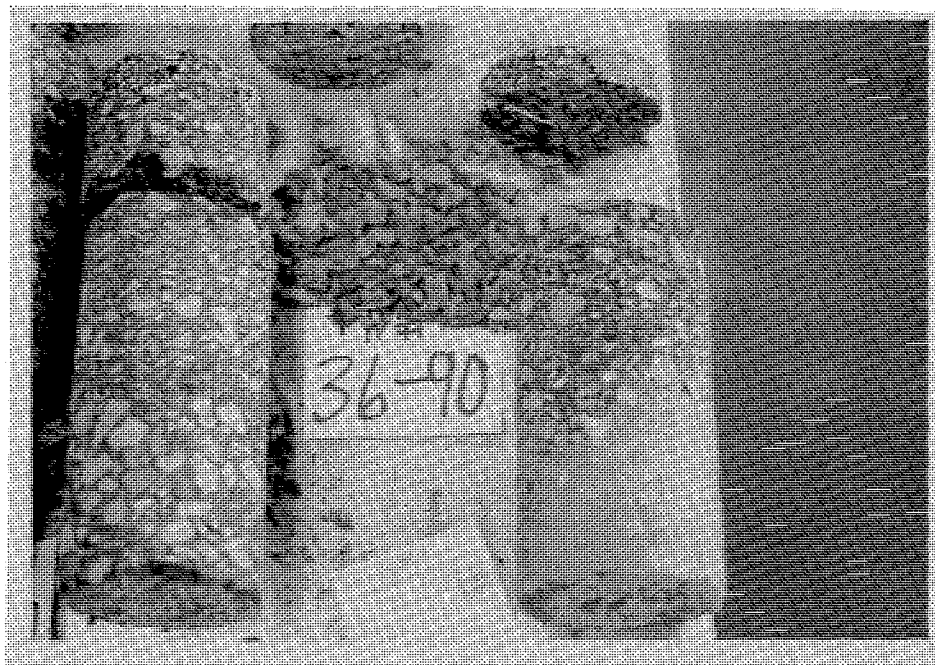
PHOTO 5

This photo shows an extreme case of stripping below the PMSC. Both cores were taken out of C470 in 1990.

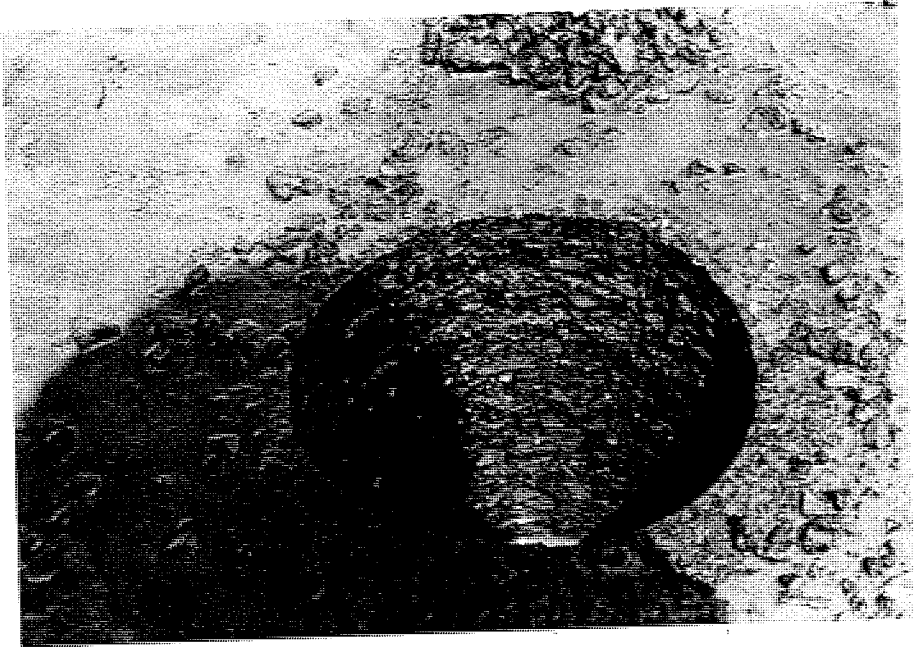
PHOTO 10

Photos 6 through 10 show examples of the failures on the C470, between US 285 and I-70 and on the I-70, east of Agate locations. Photo 9 taken on I-70, east of Agate was taken before this site was added to this study. Photo 10 was taken after the rehabilitation of the RRCP. This pavement was not a high-stability (RRCP) design.

This is not the high-stability (RRCP) design. This photo shows stripping occurring below the PMSC however. The portion stripping is a Grading C. This photo was taken at the test site on I70, east of Agate. The pavement had been down one year.
