COLORADO
Department of Transportation

EVALUATION AND PERFORMANCE OF HDPE PIPES UNDER CDOT HIGHWAYS, T-REX, AND OTHER LOCATIONS

Report No. CDOT-2018-09
March 2018

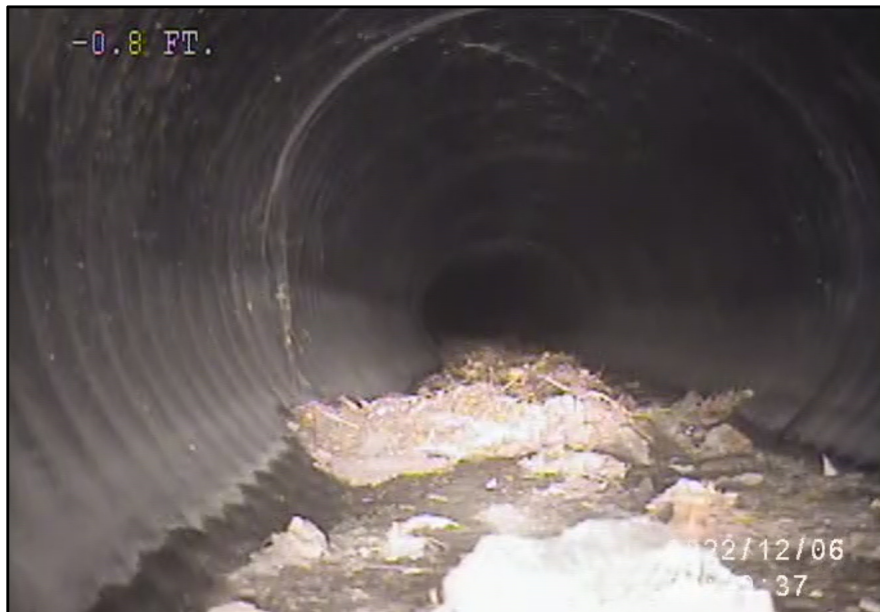
Figure 7. Recorded video imagery with location information under CDOT's T-Rex project

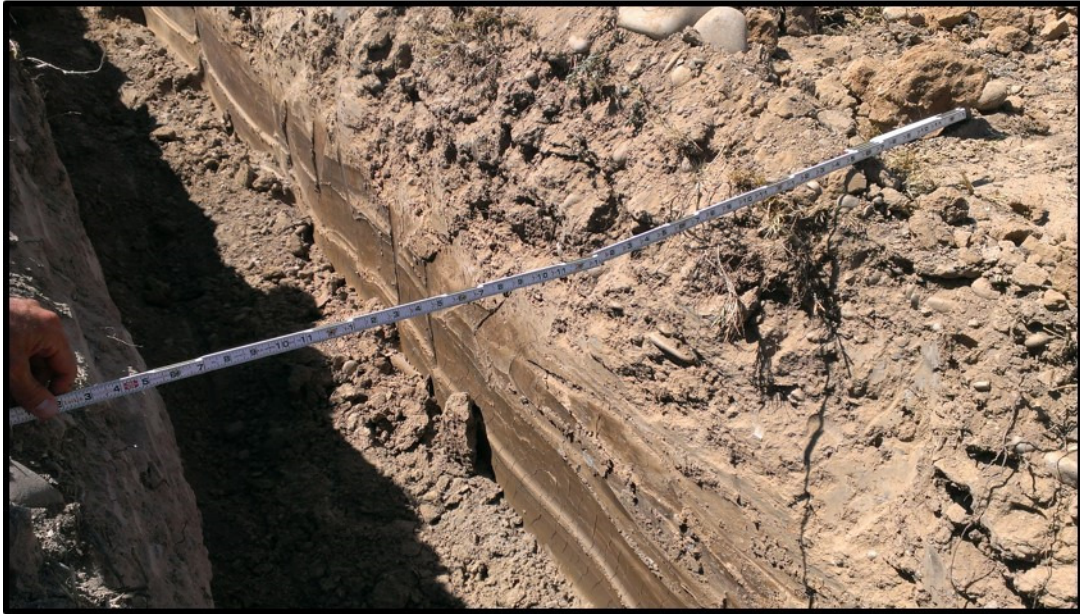
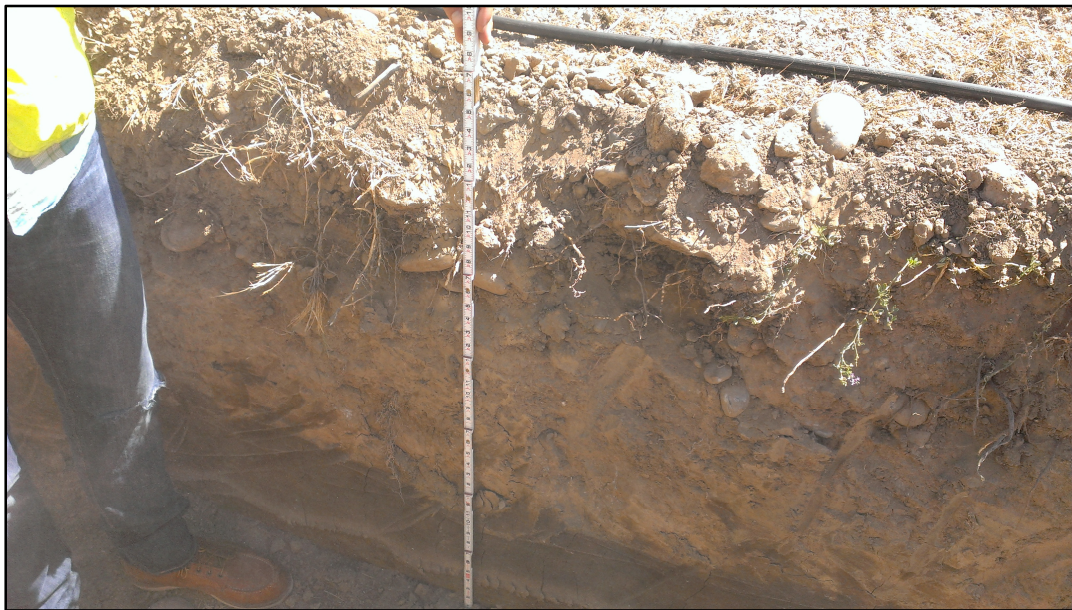
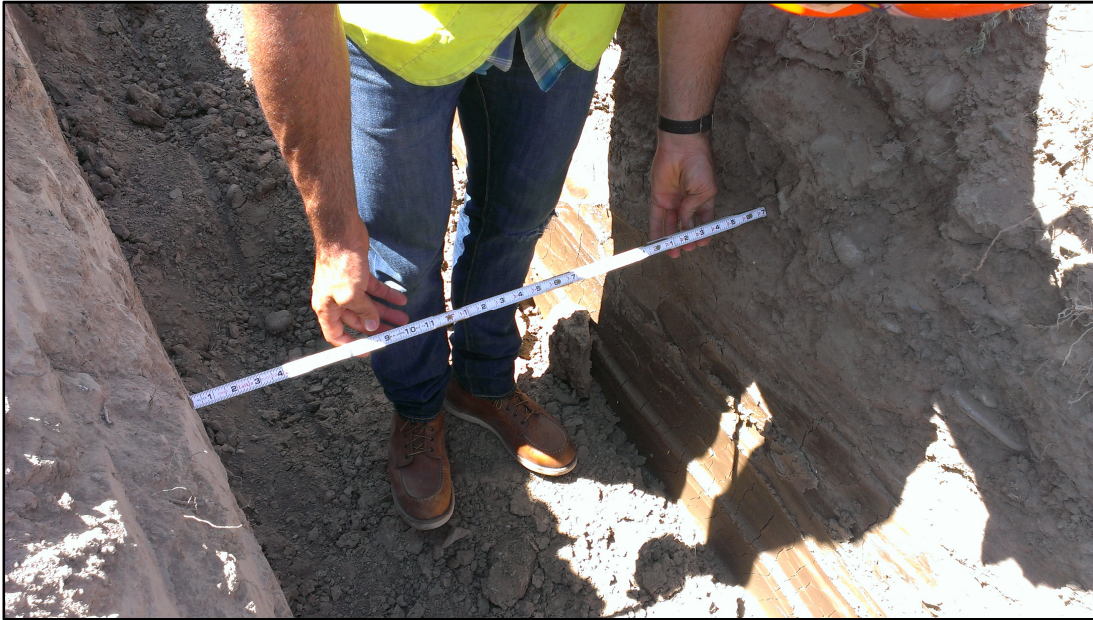
As a part of the HDPE pipe-performance study, a field trip to CDOT Region 3, Grand Junction, Colorado, was conducted to observe one of the stages of a 3,000-ft HDPE pipe installation. Figures 26 through 32 show the observed stages of a typical CDOT HDPE pipe installation for trench width, depth, and material placement.

Figure 28. Trench dimensions for HDPE pipe installation

Experiences by other DOTs revealed that not adhering to strictly-enforced installation procedures was the cause of some performance issues. A typical installation of an HDPE pipeline observed as part of this study showed that trench width, depth, and cover standards were not being followed. It is recommended that these standards be strictly enforced.

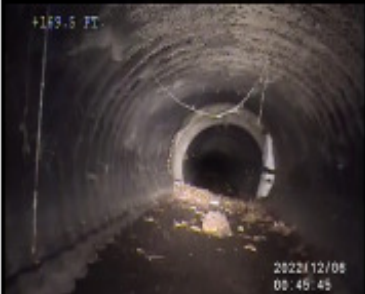
169.5	Debris coming into drop inlet

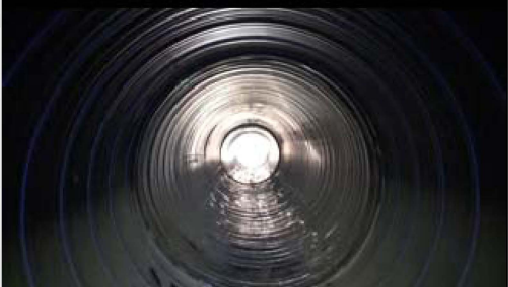
30.0	General Observation Remarks: Slight dent left springline	07:04 00:00:40

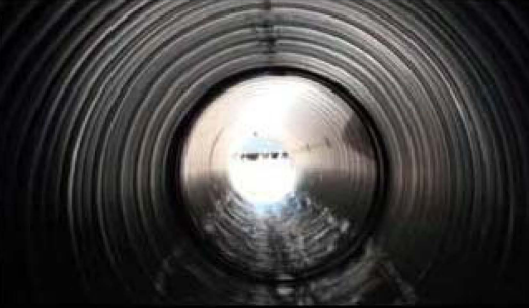
80.0	<p>General Observation Remarks: Stake driven through crown of pipe at 84 ft.</p>	<p>12:37 00:01:45</p>

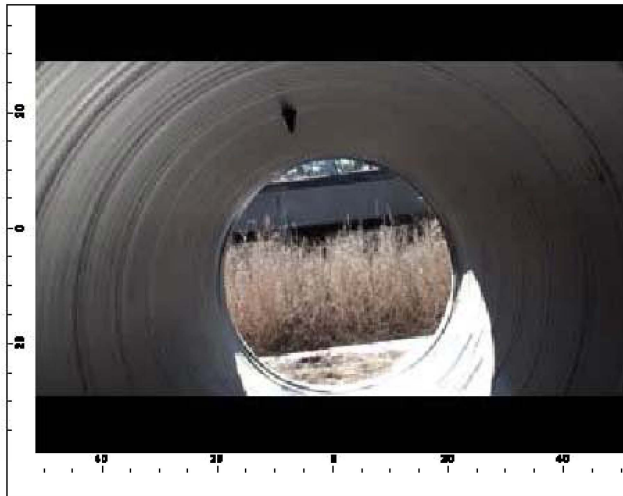
Stake for erosion control driven through crown of pipe.

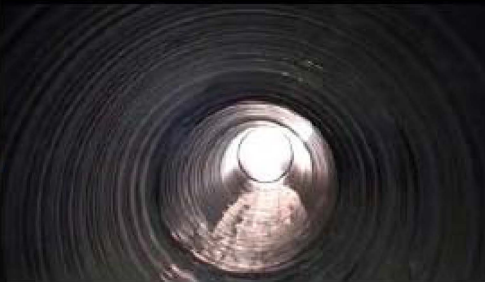
40.0	<p style="text-align: center;"> General Observation Remarks: View of joint at 43 ft. </p>	<p style="text-align: center;"> 05:44 00:01:39 </p>

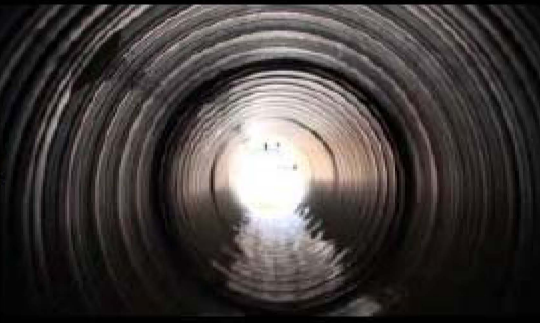
Distance	Fault Observation	Time	Picture
63.0	<p style="text-align: center;">General Observation Remarks: View of joint at 65 ft.</p>	<p style="text-align: center;">07:52 00:02:14</p>

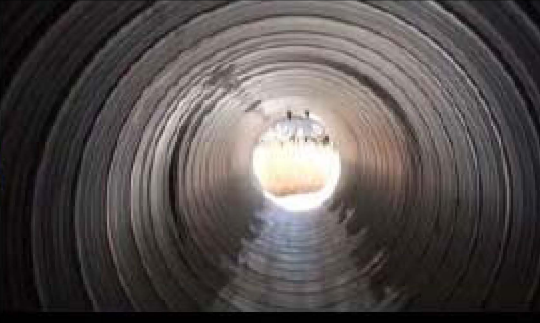
73.0	<p style="text-align: center;">General Observation Remarks: Small dent at left springline</p>	<p style="text-align: center;">09:22 00:02:30</p>

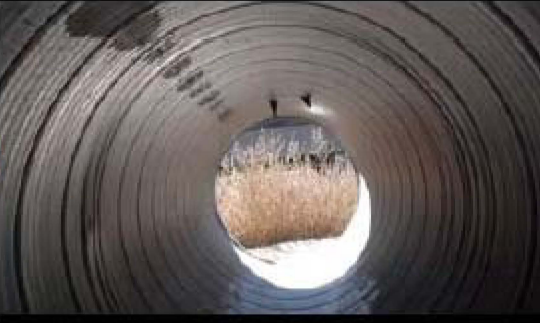
78.0	<p style="text-align: center;">General Observation Remarks: Small dent at left springline</p>	<p style="text-align: center;">10:33 00:02:53</p>

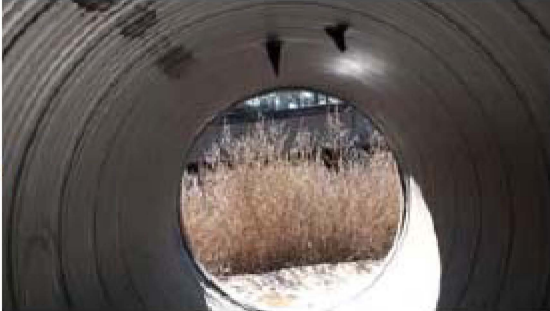
Distance	Fault Observation	Time	Picture
82.0	General Observation Remarks: Wood stakes driven through crown of pipe	11:40 00:03:10

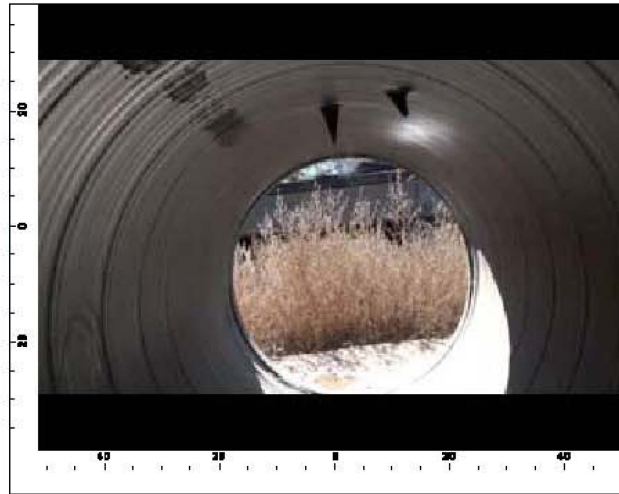
Stakes from erosion control devices.

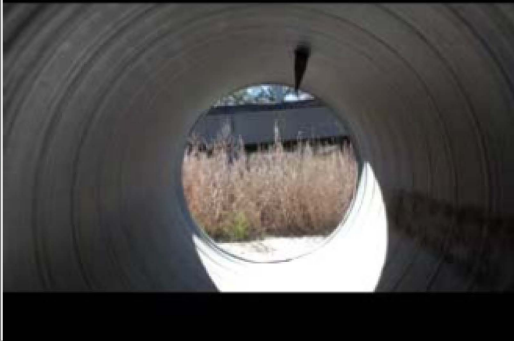
84.0	General Observation Remarks: Stake through crown of pipe	2:33:18 00:01:54

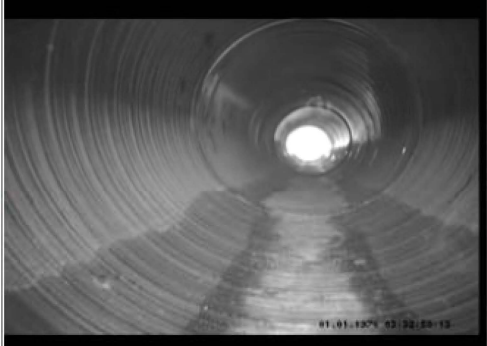
22.0	General Observation Remarks: View of first joint at approx 22 ft.	06:09 00:00:48

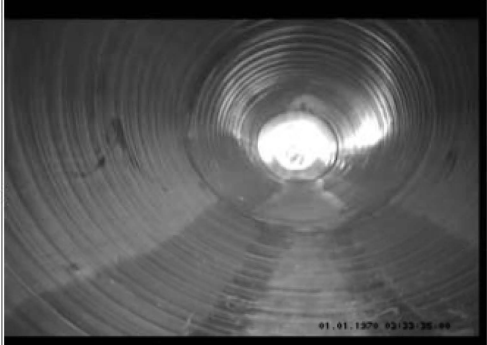
44.0	General Observation Remarks: View of second joint at approx. 44 ft.	07:51 00:01:24

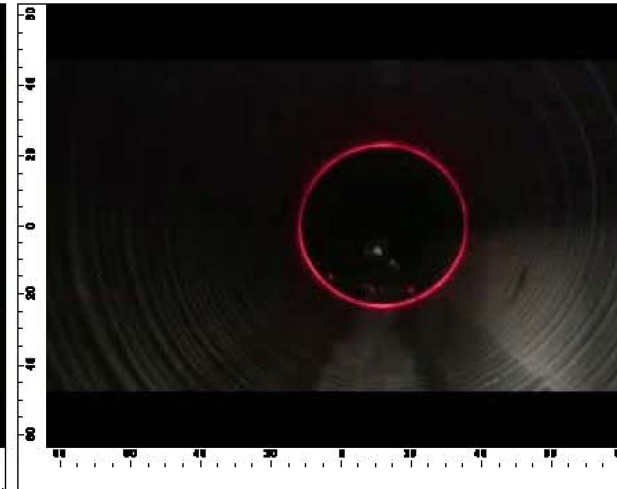
Spike due to outside light noise.

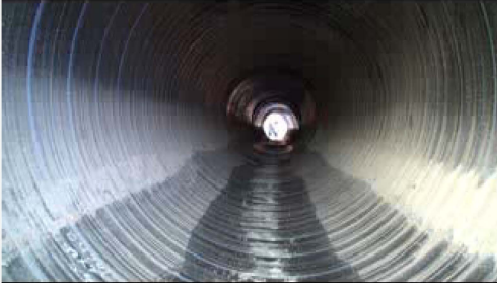
8.0	General Observation Remarks: Pipe slightly racked, small puncture at crown from stake at 10 ft.	02:30 00:00:43

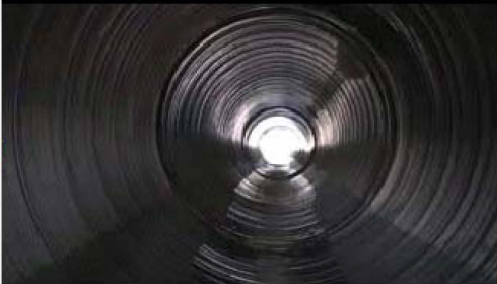
26.0	General Observation Remarks: View of joint at 26 ft.	12:08 00:01:27

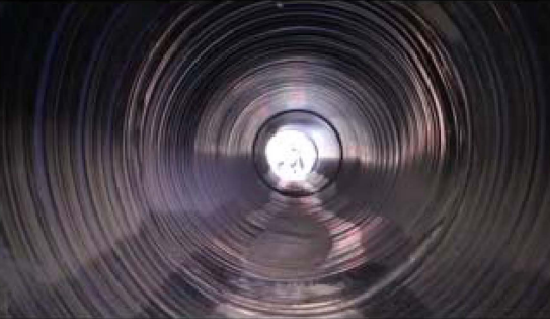
Distance	Fault Observation	Time	Picture
46.0	<p>General Observation Remarks: View of joint at 46 ft. Slight hump at right haunch.</p>	<p>14:40 00:02:17</p>

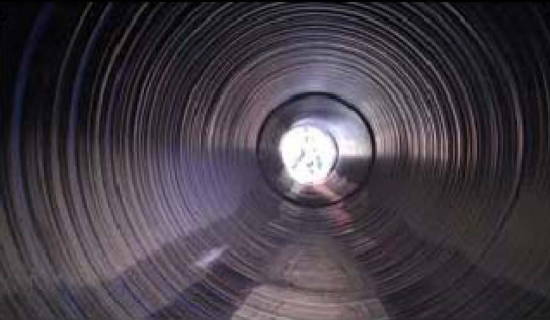
56.0	<p>General Observation Remarks: Slight dent in invert at 56 ft.</p>	<p>16:11 00:02:33</p>

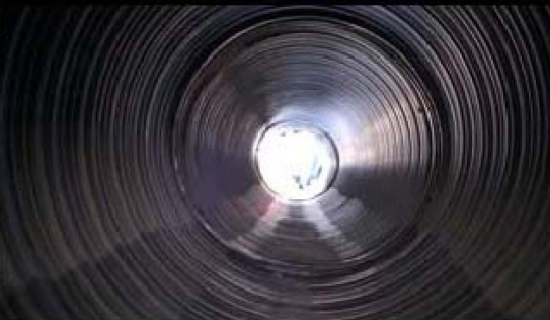
70.0	<p>General Observation Remarks: View of joint at 70 ft.</p>	<p>17:18 00:03:03</p>

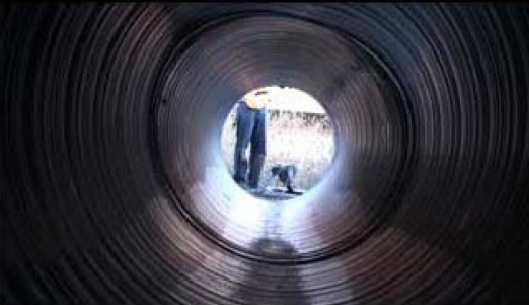
Distance	Fault Observation	Time	Picture
90.0	<p align="center">General Observation Remarks: Pipe slight racked in right crown.</p>	<p align="center">18:41 00:03:48</p>

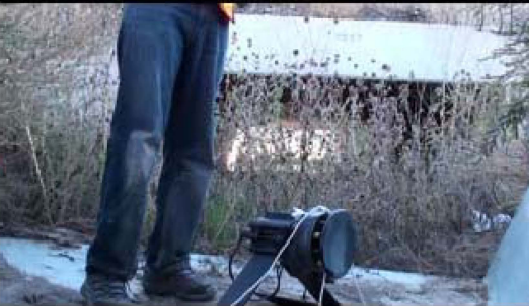
103.0	<p align="center">End Inspection Remarks: End inspection, view of laser skid at inlet.</p>	<p align="center">21:21 00:04:14</p>

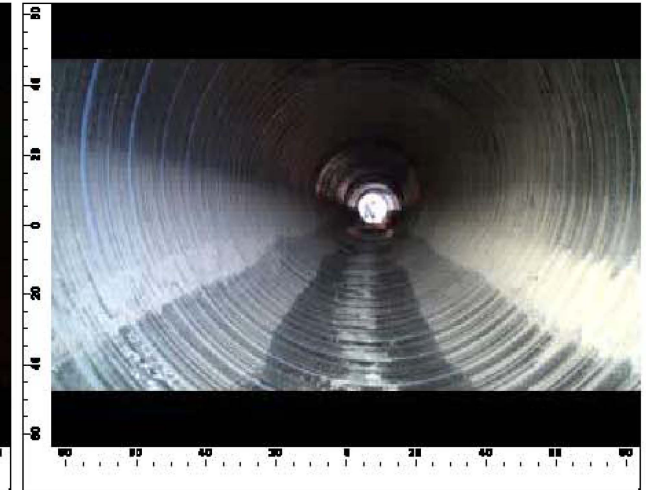
View from outlet end, pipe slight racked near outlet end not caught by laser.

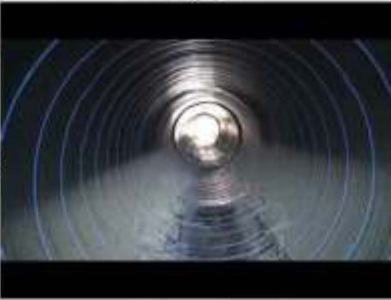
20.0	General Observation Remarks: Joint No. 1	03:13 00:00:26

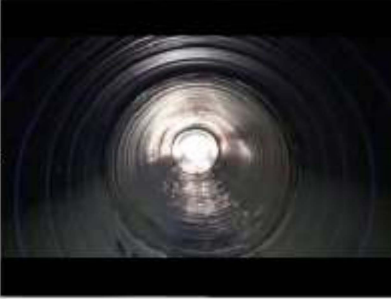
30.0	General Observation Remarks: Slight dent left springline	07:04 00:00:40

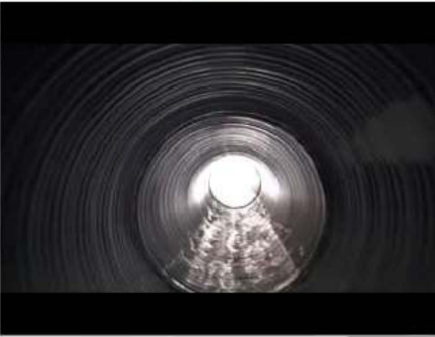
Distance	Fault Observation	Time	Picture
40.0	General Observation Remarks: View of joint at 40 ft.	8:10 00:00:45

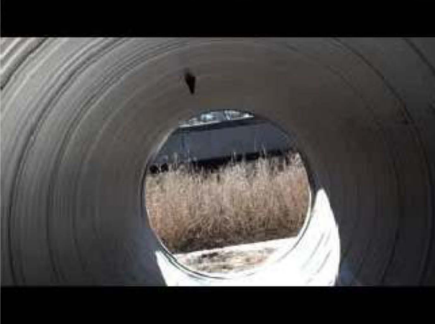
80.0	General Observation Remarks: Stake driven through crown of pipe at 84 ft.	12:37 00:01:45

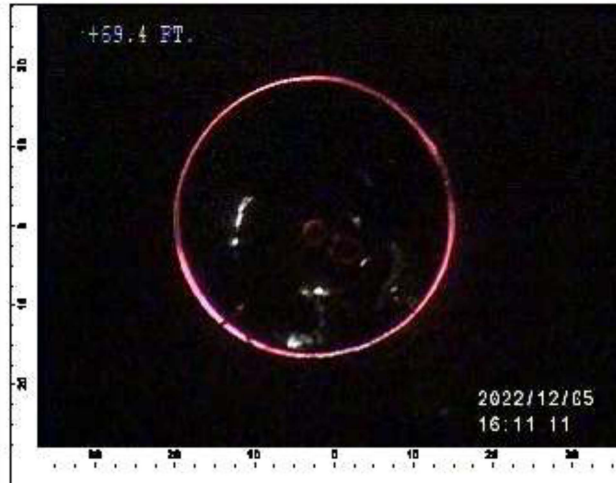
Noise causing spike in data

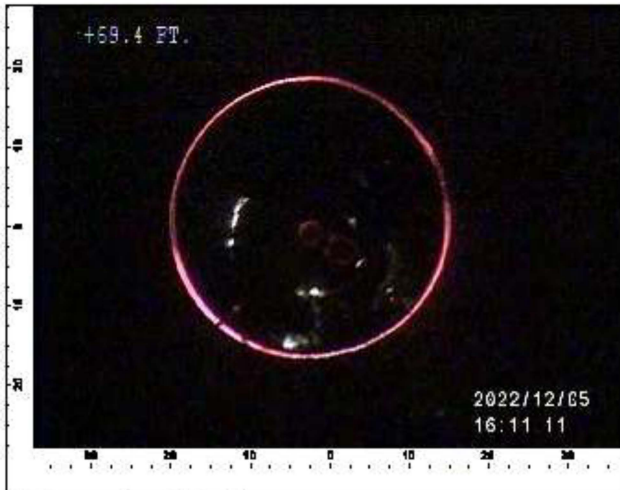
Noise causing spike in data

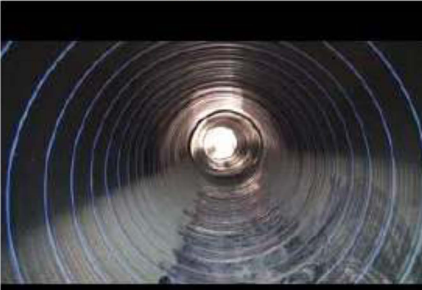
Distance	Fault Observation	Time	Picture
2.0	Start Inspection Remarks: Start inspection, center pipe	01:09 00:00:00

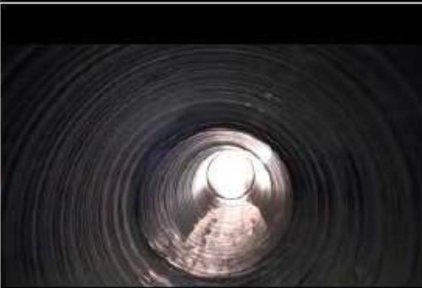
40.0	General Observation Remarks: View of joint at 43 ft.	05:44 00:01:39

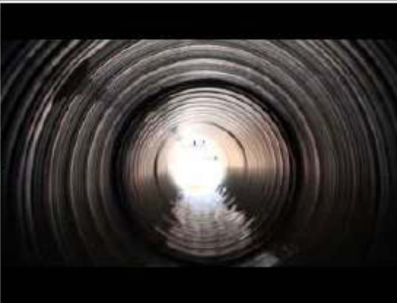
Distance	Fault Observation	Time	Picture
63.0	General Observation Remarks: View of joint at 65 ft.	07:52 00:02:14

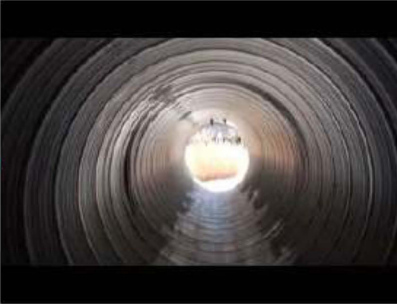
73.0	General Observation Remarks: Small dent at left springline	09:22 00:02:30

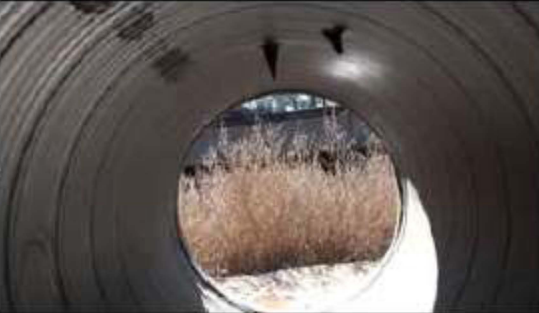
Distance	Fault Observation	Time	Picture
82.0	General Observation Remarks: Wood stakes driven through crown of pipe	11:40 00:03:10

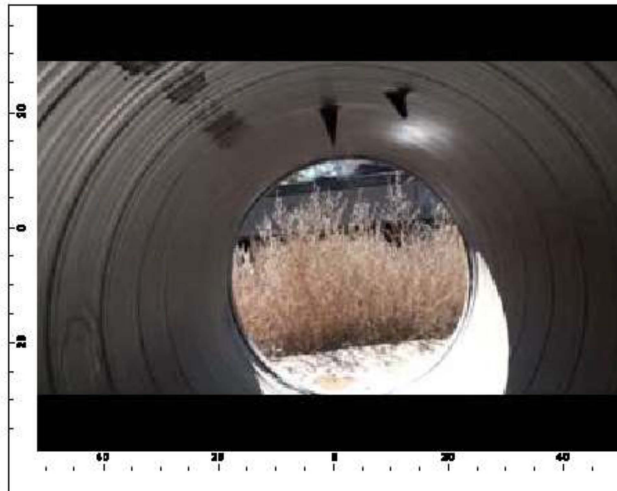
Stakes from erosion control devices.

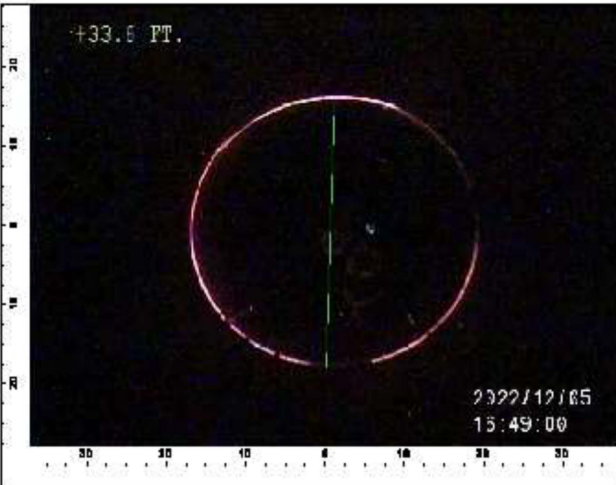
Pipe deflected near 5%.

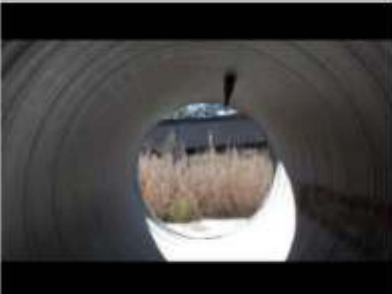
84.0	General Observation Remarks: Stake through crown of pipe	2:33:18 00:01:54

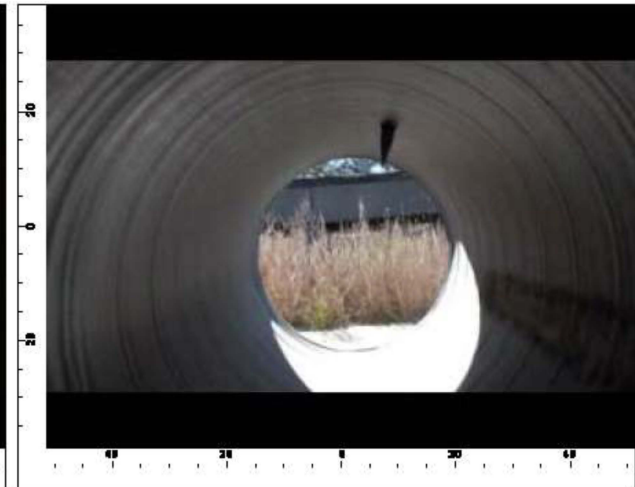
View of erosion control stake through crown of structure.

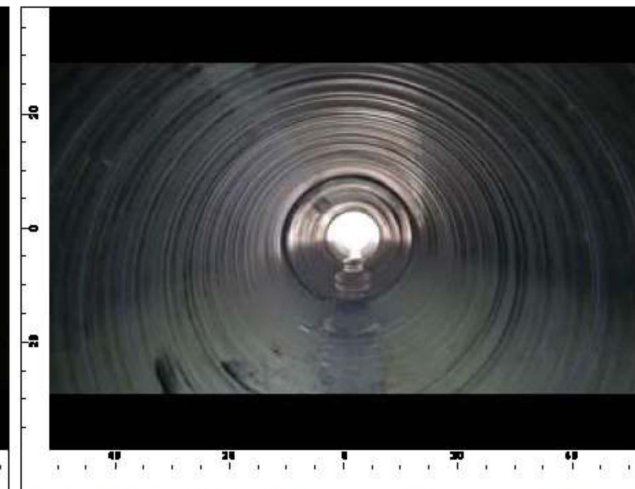
View of pipe towards outlet end of the structure. Pipe appears to be round and uniform.

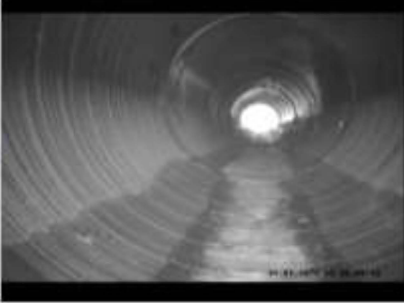
44.0	General Observation Remarks: View of second joint at approx. 44 ft.	07:51 00:01:24

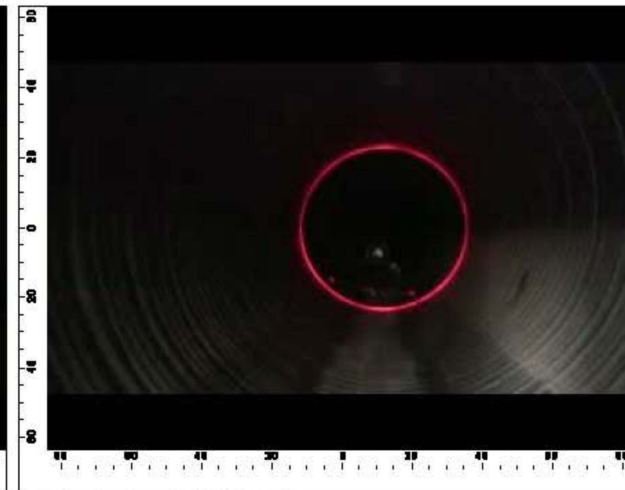
Spike due to outside light noise.

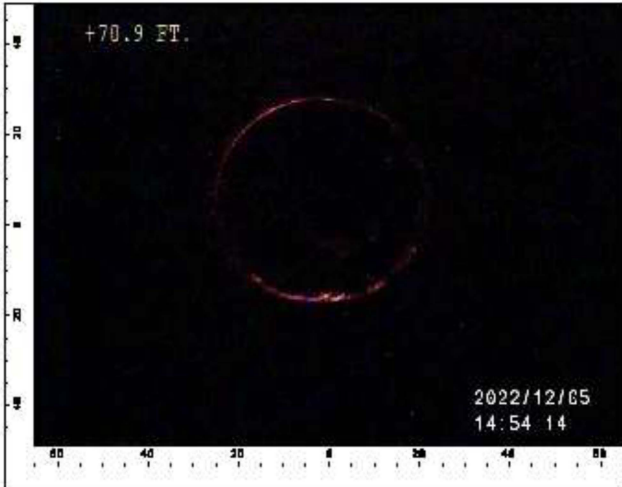
Tractor Bouncing causing scatter in data.

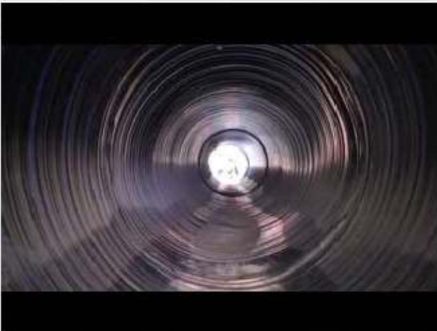
Distance	Fault Observation	Time	Picture
46.0	General Observation Remarks: View of joint at 46 ft. Slight hump at right haunch.	14:40 00:02:17

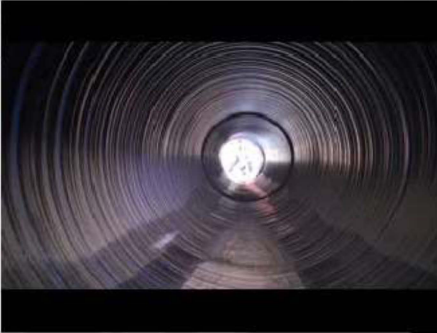
56.0	General Observation Remarks: Slight dent in invert at 56 ft.	16:11 00:02:33

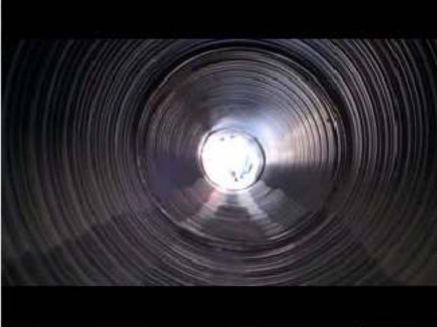
70.0	General Observation Remarks: View of joint at 70 ft.	17:18 00:03:03

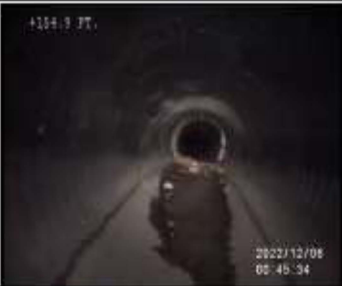
Distance	Fault Observation	Picture
154.9	View down barrel

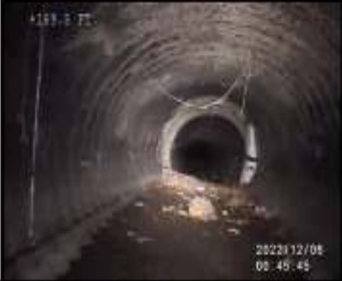
169.5	Debris coming into drop inlet
