# Rock Cut Blasting Aesthetics Best Management Practices Phase II

## Technical Report Documentation Page

1. Report No. CDOT-2021-02	2. Government Accession No.	3. Recipient's Catalog No.	
4. Title and Subtitle ROCK CUT BLASTING AESTHETICS BEST MANAGEMENT PRACTICES PHASE II		5. Report Date June 2021

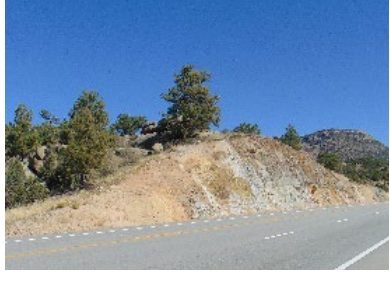
US Highway 24/285, westbound, north side, MP 217.9 to 218.1, 7.4 miles east of Buena Vista  REGION 5 <a href="#">us242852179</a>

Granodiorite with foliated biotite gneiss xenoliths/inclusion, spheroidally weathered outcrops	Height: 10 to 25 ft Length: 640 ft 65-70 degree southeast facing slope	Westbound 20 seconds; Eastbound 33 seconds; static view from driveway that intersects road northeast of cut	Controlled blasting using pre-split blasting and cushion blasting techniques. Excavation of weathered zones in decomposed granite by machine. Scaling, rock dowels and draped wire mesh rockfall mitigation.	Post-excavation rockfall evaluation may have shown that draped mesh was not needed on this low cut.
US Highway 24/285, westbound, north side, MP 218.1 to 218.3, 7.5 miles east of Buena Vista  REGION 5 <a href="#">us242852181</a>

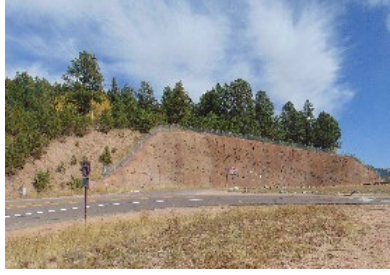
Location	Example (ctrl click link or photo for more)	Geology	Slope Dimensions	Visibility	Construction Methods	Comments
<b>US Highway 24</b>						
US Highway 24, westbound, north side, MP 283.8, 1.2 miles southwest of Woodland Park; cut faces frontage CR 231/CR 25  REGION 2 <a href="#">us242838</a>

Granite with shotcrete facing, fault in area of cut	Height: 25 to 40 ft Length: 306 ft 85 degree southeast to southwest facing slope, wall curves	Westbound 10 to 14 seconds; Eastbound 32 to 58 seconds; static view from house to south and bicycle lanes	Controlled blasting using pre-split blasting and cushion blasting techniques. Use of sculpted shotcrete to improve appearance, stabilize the excavated face, and hide visible signs of blasting. Reestablished vegetation on the flatter slopes at the ends of the cut.	This site is a good example of the use of sculpted and stained or pigmented shotcrete to create a visual effect of a natural rock slope. The sculpting consists of a semi-random pattern of deeply incised "joints". Advance planning and cooperation between the designer, geologist, landscape architect, and contractor were required for success.

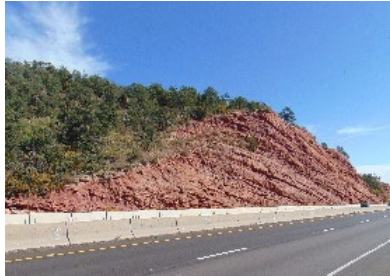
US Highway 24, westbound, north side, MP 298.4, Manitou Springs  REGION 2 <a href="#">us242984</a>

Sedimentary rock-layered shale, sandstone, conglomerate, with boulder size clasts; dipping approximately 9 to 12 degrees toward southeast.	Height: 30 to 40 ft Length: 793 ft 65 degree south facing slope	Westbound 38 seconds; Eastbound 23 seconds; static view from private residences south of cut	Controlled blasting using conventional presplitting techniques. Some of the half-casts (drilling traces) are still visible but many have eroded due to the soft nature of the bedrock materials.	The cut slope is a source of rockfall caused by the different rates of erosion between the harder sandstone and conglomerate layers versus the softer claystone and siltstone units. Presplitting methods have helped control the rockfall following the original construction.
<b>US Highway 34</b>						
US Highway 34, westbound, north side, MP 77.4 to 77.6, 15 miles west of Loveland  REGION 4 <a href="#">us34775</a>

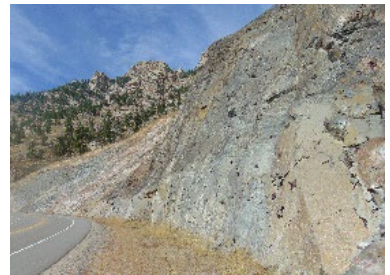
Granite, tonalite (granitoid) and mica schist and gneiss	Height: 75 to 150+ ft Length: 1120 ft 45 to 75 degree southwest facing slope, wall curves	Westbound 30 seconds; Eastbound 35 seconds; static view from houses and a pullout to south	Presplit blasting for excavation to the cut line and cushion blasting to follow existing joints and fractures, where possible. Following a rockslide during construction, the western portion of the cut was laid back to follow foliation planes. The east portion of the cut is benched to give more natural appearance. Rockfall mitigation includes draped mesh on upper and lower benches and rock bolts. Both mesh and exposed portions of the bolts were colored dark brown.	The slope grade breaks within the cut provide a more natural appearance. This example shows how rock bolts are used to stabilize large blocks. Maintenance of upper draped mesh may be required as debris accumulates on the bench. ROW acquisitions allowed for an adequate rockfall catchment ditch and allowed the draped mesh to terminate 20+ feet above the roadway, lessening the visual impact of the mesh.

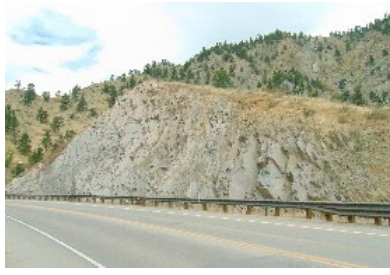
US Highway 34, westbound, north side, MP 78.3 to 78.4, 14.2 miles west of Loveland  REGION 4 <a href="#">us34783</a>

Gneiss, schist, some garnetiferous, possible metaconglomerate	Height: 40 to 60 ft Length: 240 ft 50 degree southwest facing slope	Westbound 16 seconds; Eastbound 14 seconds; static view from houses on south and west end above road, and fishing activity	The north face of a slot cut for roadway realignment. Presplit blasting along the final face with production blasting. Due to the dominant joint and foliation in the rock structure, half-casts from the presplitting are not prevalent. Due to favorable jointing and adequate rockfall catchment, the planned rockfall mesh was eliminated during construction. Rock bolts used to stabilize large blocks and colored dark brown to blend in with the rock face.	Prominent jointing within the rock mass provided preferred planes for the rock slope to break back to, even with presplitting techniques. These natural joints provide an irregular pattern to the face.

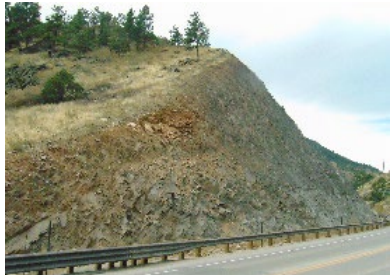
US Highway 34, eastbound, south side, MP 78.3 to 78.4, 14.2 miles west of Loveland  REGION 4 <a href="#">us34783s</a>

Gneiss, schist, some garnetiferous, possible metaconglomerate	Height: 70 to 80 ft Length: 300 ft 50 degree north facing slope	Eastbound 8 seconds; Westbound 11 seconds; static view from house on west end, north side above road, and fishing activity	The south face of a slot cut for roadway realignment. Presplit blasting along the final face with production blasting. Due to the dominant joint and foliation in the rock structure, half-casts from the presplitting are not prevalent. Rockfall mitigation includes draped mesh and rock bolts. Both mesh and exposed portions of the bolts were colored dark brown.	ROW acquisitions allowed for an adequate rockfall catchment ditch and allowed the draped mesh to terminate 20+ feet above the roadway, lessening the visual impact of the mesh

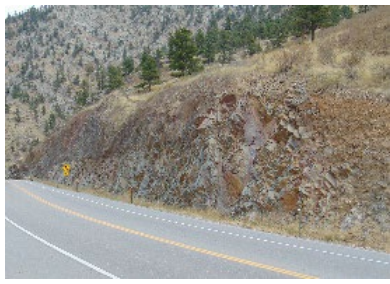
Location	Example (ctrl click link or photo for more)	Geology	Slope Dimensions	Visibility	Construction Methods	Comments
<b>US Highway 34</b>						
US Highway 34, eastbound, south side, MP 78.4 to 78.6, 14 miles west of Loveland  REGION 4 <a href="#">us34785</a>

Gneiss, schist, some garnetiferous, possible metaconglomerate	Height: 35 to 40 ft Length: 650 ft 70 degree southwest facing slope	Westbound 14 seconds; Eastbound 17 seconds; static view from fishing access west of and below cut	Presplit blasting along the final face with production blasting. Half-casts from the presplitting were mitigated with rock staining. Rockfall mitigation includes dark brown draped mesh and rock bolts. Rock bolts used to stabilize large blocks are colored dark brown to blend with the rock face.	ROW acquisitions allowed for an adequate rockfall catchment ditch and allowed the draped mesh to terminate 20+ feet above the roadway, lessening the visual impact of the mesh. Rock staining following excavation provided a weathered look to the rock and masked the presence of the half-casts.

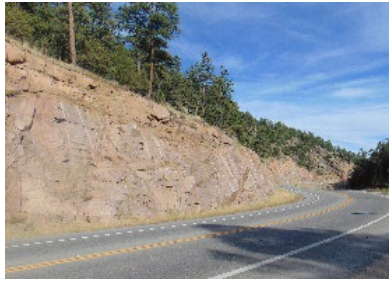
Granite with schist foliations	Height: 15 to 40 ft Length: 3150 ft 80 to 85 degree south to west facing slope, cut has curves	Westbound 72 seconds; Eastbound 61 seconds; static view from house and pullout on west end	Presplit blasting left half-casts in the massive granite. Production blasting removed half-casts where natural fractures guided post-blast excavation.	Natural rock features were left undisturbed between areas where excavation was required.

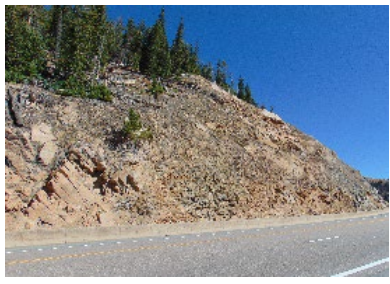
<b>US Highway 40</b>						
US Highway 40, eastbound, north side, MP 244.5, 12.7 miles south of Winter Park  REGION 1 <a href="#">us402445</a>

Granite and gneiss	Height: 140 ft Length: 476 ft 50 to 75 degree southwest facing slope	Eastbound 12+8 seconds-2 views; Westbound 18 seconds; static view from bicyclists	Most of the rock cut at this location was removed using cushion blasting and production blasting techniques. An excavator was used to remove loose material at the slope face and pull some of the rock back to the natural seams within the bedrock mass.	The slope was heavily rounded to provide an older eroded appearance similar to the surrounding topography. Meetings were held with the CDOT Landscape Architects, Geotechnical Staff, Construction Staff and USFS to help develop the approach during construction.
US Highway 40, westbound, north side, MP 248.8, 17.1 miles south of Winter Park  REGION 1 <a href="#">us402488</a>

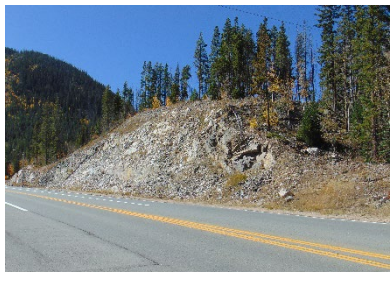
Granite with gneiss and migmatite	Height: 50 ft Length: 315 ft 45 degree south-southeast facing slope	Westbound 23 seconds; Eastbound 11 seconds; static view from intersection of US Hwy 40 and CR 202 NNE to cut	Most of the rock cut at this location was removed using cushion blasting and production blasting techniques. An excavator was used to remove loose material at the slope face and pull some of the rock back to the natural seams within the bedrock mass.	The slope was heavily rounded to provide an older eroded appearance similar to the surrounding topography. Meetings were held with the CDOT Landscape Architects, Geotechnical Staff, Construction Staff and USFS to help develop the approach during construction.

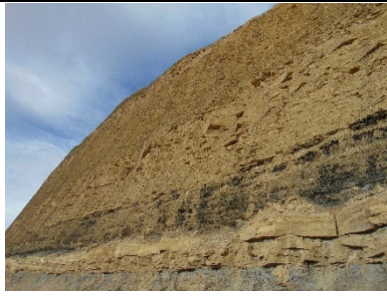
Location	Example (ctrl click link or photo for more)	Geology	Slope Dimensions	Visibility	Construction Methods	Comments
<b>US Highway 50</b>						
US Highway 50, westbound, east side, MP 56, 15 miles northwest of Delta  REGION 3 <a href="#">us5056</a>

Sedimentary rock-layered shale, sandstone, and carboniferous deposits (coal), with gypsum; dipping approximately 8 degrees toward southwest.	Height: 60 ft Length: 700 ft 75 degree south-southwest to southwest facing slope on curve	Westbound 14 seconds; Eastbound 12 seconds; static view from nearby trails, hikers, cyclists	Ripping was used to excavate soft bedrock layers. Limited cushion blasting followed by machine scaling was used in harder layers.	Difficult blasting conditions due to variable bedrock consistency. Alternating hard and soft rock layers continue to generate small size rockfall events. Draped mesh at this site is effective at reducing rockfall hazard.

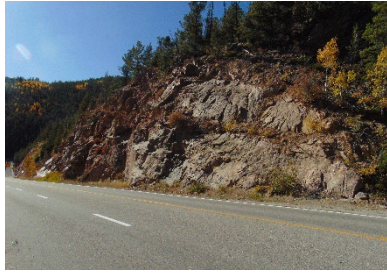
US Highway 50, westbound, north side, MP 194.2, east of runaway truck ramp, 5.1 miles west of Monarch Pass, 23 miles west of Poncha Springs, and 37 miles east of Gunnison  REGION 5 <a href="#">us50192e</a>

Granite with metamorphic rock; porphyritic gneissic granite intruded by finer grained granite, some with biotite (mica); colluvial cover (gravels, loose material) above cut	Height: 30 to 40 ft Length: 315 ft 65 to 70 degree southeast facing slope	Westbound 7 seconds; Eastbound 18 seconds; No static view areas noted	The rock excavation was completed using cushion and production blasting methods. The final face was sculpted using an excavator by pulling portions of the rock face back to the natural rock fractures and joint structure.	Benches were introduced in the rock slope to provide a more naturally appearing cut. Where possible, portions of the top of cut were rounded to reduce rockfall at the brow and provide an eroded appearance.

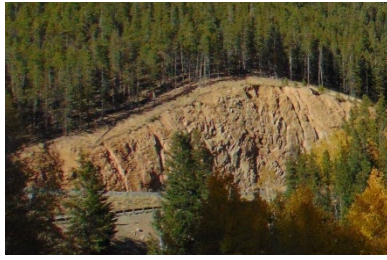
US Highway 50, westbound, north side, MP 194.2, above runaway truck ramp, 5.1 miles west of Monarch Pass, 23 miles west of Poncha Springs, and 37 miles east of Gunnison  REGION 5 <a href="#">us50192</a>

Granite with metamorphic rock; porphyritic gneissic granite intruded by finer grained granite, some with biotite (mica); colluvial cover (gravels, loose material) above cut	Height: 60 ft Length: 540 ft 50 to 75 degree southeast facing slope	Westbound 13 seconds; Eastbound 32 seconds; No static view areas noted	The rock excavation was completed using cushion and production blasting methods. The final face was sculpted using an excavator by pulling portions of the rock face back to the natural rock structure.	Benches were introduced in the rock slope to provide a more naturally appearing cut slope. Where possible, portions of the top of cut were rounded to reduce rockfall at the brow and provide an eroded appearance.

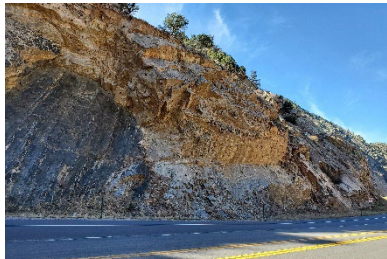
US Highway 50, westbound, north side, MP 258.0, 20 miles west of Canon City  REGION 2 <a href="#">us50258</a>

Migmatitic Gneiss, layered gneisses	Height: 60 ft Length: 820 ft 45 to 60 degree northwest facing slope	Eastbound 14 seconds; Westbound 13 seconds; Static views from Pinnacle Rock parking area opposite cut and recreational users of Arkansas River	Rock cuts in this area were excavated using cushion blasting techniques. Loose and blasted material was removed to the natural fractures to develop a more natural appearing rock slope. Rock bolts were installed in areas where continuous and unfavorable discontinuities created unstable slope conditions. Some of the rock bolts were installed to a depth of 35 feet and consisted of 150 grade, #10 threadbar.	The timber structure at the south end of the cut that has the appearance of a pyramid is a timber-faced soil nail wall built as part of the rock slope and widening project. It was constructed to protect an archaeological site which is the remnants of a small stone fort. The fort was one of several areas that men were stationed during the Railroad War between the Denver & Rio Grande Railroad and Atchison, Topeka, and Santa Fe Railway in the late 1800's.

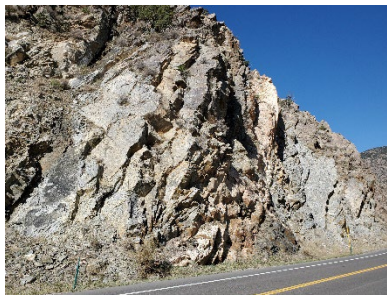
US Highway 50, westbound, north side, MP 259.7, 18.3 miles west of Canon City  REGION 2 <a href="#">us502597</a>

Migmatitic Gneiss, layered gneisses	Height: 60 ft Length: 1009, includes 470 ft of slope at east end, then estimated 200 ft of cut continues to east 85 to 100 (overhang) degree northeast facing slope	Eastbound 19 seconds; Westbound 19 seconds; Static view Salt Lick overlook at W end of cut; Five Points Campground at E end of cut; recreational users of Arkansas River	The rock excavations in this area were removed using cushion blasting in the harder rock and ripping in the softer material. Pockets of cobbles and soil material were removed and cleaned back to bedrock to eliminate the areas of oversteepened loose material.	Slope angles were steepened in the more resistant rock and then laid back at a shallower angle in the softer material. This technique was used to develop a more natural appearing slope and to address potential long-term stability and erosion.

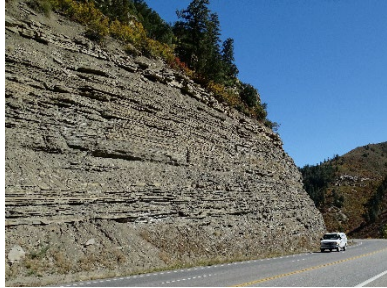
Location	Example (ctrl click link or photo for more)	Geology	Slope Dimensions	Visibility	Construction Methods	Comments
<b>US Highway 160</b>						
US Highway 160, westbound, north side, MP 79.2, 4.3 miles west of Durango  REGION 5 <a href="#">us160791</a>

Sedimentary rock-layered shale, sandstone, and siltstone; massive sandstone above cut; areas of shale undercutting sandstone ledges; erosional debris fans at base of cut; dipping approximately 5 to 10 degrees toward north and northwest.	Height: 60 to 90 ft Length: 1,200 ft 45 to 90 degree south-southeast to south-southwest facing slope on curve	Westbound 17 seconds; Eastbound 24 seconds; static view from nearby residential south of cut; driveway intersects US 160 across from cut	Ripping was used to re-cut the rock face during a roadway and ditch widening project that improved rockfall catchment.	Limited ROW access to the top of the cut prohibited laying back the face to create a more stable and visually appealing slope. Minor rockfall continues to be a maintenance concern.

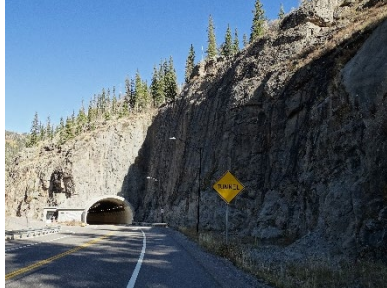
US 160 eastbound, east side, MP 174.0-174.5, 12 miles southwest of South Fork and 30 miles northeast of Pagosa Springs  REGION 5 <a href="#">us160174</a>

Tertiary age ash flow, quartz latite tuff	Height: 80 to 100 ft Length: 2,890, includes 1,055 feet of tunnel, 80 to 90 degrees west to southwest facing slopes	Eastbound 62 seconds; Westbound 57 seconds; Static view possibly from fishing along Pass Creek, west side of US 160 and rock cut.	The rock excavation primarily consisted of presplitting blasting techniques with limited cushion blasting that utilized the naturally occurring, near vertical fractures to control overbreak. The presplitting did result in visible half-casts. Shotcrete was applied in select areas where the cut slope intersected portions of oversteepened glacial till. The shotcrete was anchored using soil nails and rock bolts. The final slope face was covered with brown colored draped wire mesh.	Seepage from behind shotcrete in glacial till areas has eroded the slope at the toe of the shotcrete east of the tunnel. The shotcrete near the west portal is a good example of sculpting and staining to mimic surrounding natural formations.  Dark coloring of draped wire mesh helps to reduce the visibility of the rockfall mitigation.

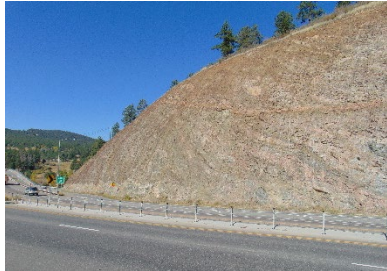
<b>US Highway 285</b>						
US Highway 285, westbound, north side, MP 231, 5 miles southwest of Conifer  REGION 1 <a href="#">us285231</a>

Migmatitic biotite gneiss, metamorphic layering (foliation) with granitic gneiss lenses	Height: 70 to 90 ft Length: 1,160 ft 68 to 73 degree southeast facing slope	Westbound 20 seconds; Eastbound 56 seconds; static view from house and industrial buildings south and west of cut and from intersection for Elk Creek Road with stop sign; exit ramps have slow moving traffic	The rock excavation utilized primarily pre-split rock blasting techniques. The slope was also rounded using an excavator to reduce the potential for the brow of the cut to erode in the less resistive bedrock and overlying soils. Draped wire mesh was applied to the final rock face to further reduce the potential rockfall hazards.	Pre-splitting coupled with draped wire mesh was used on this cut due to the zones of unfavorable rock structure present in the formation and the concern over long-term rockfall potential.

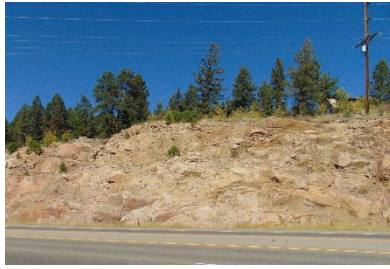
Location	Example (ctrl click link or photo for more)	Geology	Slope Dimensions	Visibility	Construction Methods	Comments
<b>US Highway 285</b>						
US Highway 285, westbound, north side, MP 233, 2.9 miles southwest of Conifer  REGION 1 <a href="#">us285233</a>

Granite, foliated with inclusions of biotite schist; some spheroidally weathered granite in outcrop adjacent to cut	Height: 35 ft Length: 700 ft 55 to 60 degree southeast facing slope	Westbound 20 seconds; Eastbound 28 seconds; Static view possible from houses southeast of cut; private driveway intersects US 285 at east end of cut	Cushion blasting techniques were used to excavate the rock cuts in this area. Spot rock bolts were installed to stabilize individual rock blocks.	Steps in the slope follow natural rock fractures. The steps promoted revegetation and reduced the rockfall hazard from this relatively low cut. ROW limits were sufficient to provide an adequate catchment ditch and flatter slope angle.

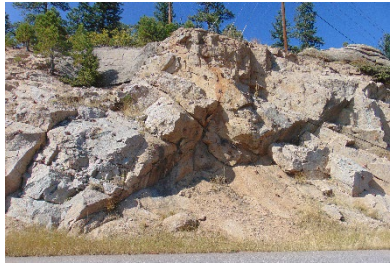
US Highway 285, westbound, northwest side adjacent to Old Highway 285, MP 240.5, 5.0 miles northeast of Conifer  REGION 1 <a href="#">us2852405</a>

Granite, foliated, may have gneiss inclusions; some spheroidally weathered granite in outcrop adjacent to cut; grus (eroded granite debris) at bottom of slope	Height: 40 ft Length: 420 ft 63 to 75 degree east-southeast facing slope	From US 285, Westbound 22 seconds; Eastbound 10 seconds; Static view from Old Highway 285; slow speed on deceleration/acceleration lanes on US 285; private driveway SSE southeast of US 285	Cushion blasting techniques were used to excavate the rock cuts in this area. Some blast damage did occur in this cut during construction. Heavy rock scaling using an excavator was used to develop the final slope configuration. Spot rock bolts were installed to stabilize individual rock blocks.	The variations and blocky nature of the cut face contribute to a more natural appearance. However, the numerous rock bolts, required for slope stability and rockfall hazard mitigation detract from the overall visual appeal.

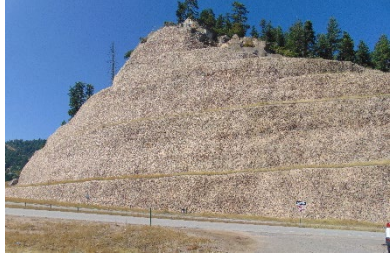
US Highway 285, westbound, north side, MP 240.9, 5.4 miles northeast of Conifer  REGION 1 <a href="#">us2852409</a>

Granite and migmatite with foliated schist and gneiss; some spheroidally weathered granite in outcrop adjacent to cut	Height: 100 ft Length: 875 ft 78 to 79 degree south to southeast facing slope	Westbound 12 seconds; Eastbound 26 seconds; Static view possible from houses on south side below US 285; private driveway on south side of US 285 faces cut slope	The rock excavation in the location locally referred as "Windy Point" utilized cushion blasting techniques for most of the cut. Spot rock bolting was applied to location to selected locations throughout the face of the cut as the excavation was removed. Shotcrete was then applied to the entire excavated slope and then cultured stone was installed as the final facing. The cultured stone was attached using convention masonry techniques.	It was determined during the planning phases of the US 285 corridor that the walls would use an ashlar pattern as the final facing. The cut at Windy Point is an approximately 200 feet high, six-tier wall configuration. To mimic an ashlar pattern, it was determined that to construct the facing, smaller masonry units placed individually would be the only practical method to construct the wall facing.

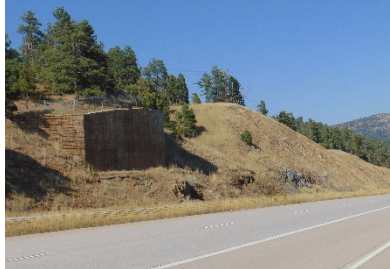
US Highway 285, westbound, northwest side, MP 242.8, 7.1 miles northeast of Conifer  REGION 1 <a href="#">sh2852428</a>

Biotite gneiss with schist, foliated, some pegmatite	Height: 70 ft Length: 1,250 ft 42 degree southeast facing slope	Westbound 50 seconds; Eastbound 36 seconds; static view from intersection of Surrey Drive with US 285 southeast of cut	Most of the cuts in this area were excavated using ripping techniques with a dozer and an excavator. Minimal blasting was required in the more resistive zones in the bedrock. The upslope cut wall was constructed using soil nails/rock bolts as the reinforcing elements and shotcrete as the primary wall facing. The final facing used a cast-in-place concrete with an ashlar patten which was subsequently colored with a brownish stain.	The upslope wall was constructed to protect a group of trees and provide variability to the slope configuration.

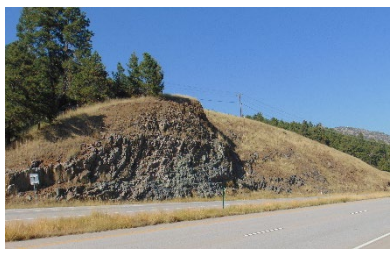
US Highway 285, westbound, northwest side, MP 243.2, 7.4 miles northeast of Conifer  REGION 1 <a href="#">us2852432</a>

Biotite gneiss with schist, foliated, some pegmatite	Height: 60 ft Length: 800 ft Weathered rock at 41 degree southeast facing slope; Intact rock at 70 to 80 degree southeast facing slope	Westbound 19 seconds; Eastbound 50 seconds; static view from intersection of Surrey Drive with US 285 south of cut	The cuts in this area were excavated using ripping techniques with a dozer and an excavator. Cushion blasting was required in the more resistive zones in the bedrock. A pattern of rock bolts was installed in the steeper portion of the rock slope.	The steepened portion of the rock cut was constructed to provide variability to the slope configuration and to protect a natural rock outcrop that was important to the local community.

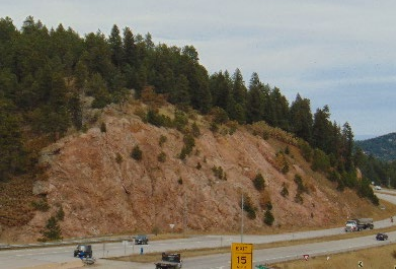
Location	Example (ctrl click link or photo for more)	Geology	Slope Dimensions	Visibility	Construction Methods	Comments
<b>US Highway 285</b>						
US Highway 285, westbound, west side, MP 244.2, 8.5 miles northeast of Conifer  REGION 1 <a href="#">us2852442</a>

Granodiorite with pegmatite and foliated granodiorite with biotite	Height: 70 ft Length: 1,300 ft South end of cut rock at 86 degree east-southeast facing slope; north end of cut at 70 degree northeast facing slope	Westbound 14 seconds; Eastbound 36 seconds; static view from residential and commercial on south side of US 285; westbound deceleration lane next to cut	Cushion blasting and machine scaling were used to allow the excavation to follow natural planes of weakness in the formation.	Flatter slopes and natural weathering promoted establishment of vegetation over the long term. Weathering around rock bolts has exposed the reinforcement. Use of fully grouted dowels can prevent this.

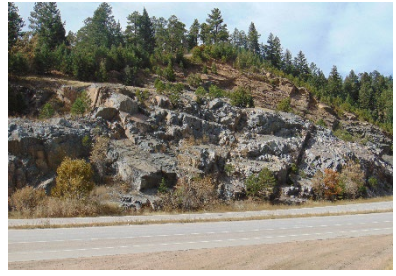
US Highway 285, westbound, northwest side, MP 245.6, 9.2 miles NE of Conifer, and 7.2 miles SW of intersection US Hwy 285 and Colorado State Highway 470 (west Denver)  REGION 1 <a href="#">us2852456</a>

Gneiss, generally foliated/layered, granitic appearance; may include migmatite	Height: 100 ft at center Length: 1,080 ft 59 to 67 degree east to northeast facing slope on curve	Westbound 12 seconds; Eastbound 22 seconds; static view from deceleration land and S. Turkey Creek Road intersection across-east of-cut, and Parmalee Gulch Rd overpass	To achieve the rock slope configuration, the slope angle was chosen based on the primary rock structure that dips toward the roadway. The contractor utilized a cushion blasting drilling and the prevalent rock structure to reduce overbreak. Ripping with an excavator was also used to remove the rock and round the cut slopes to transition into the natural slopes. In many areas, the excavator also pulled portions of the rock at the face back to the existing fractures resulting in a more stable and natural appearing slope.	This site is an example of the use of cushion blasting followed by machine scaling to create a more natural rock slope that follows existing joint structure. The result is a more natural appearing slope with flatter benches for vegetation.

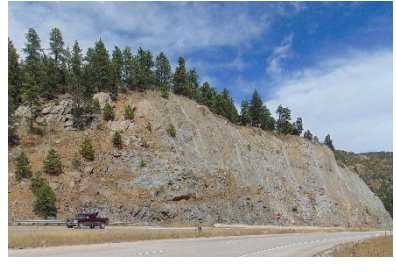
US Highway 285, westbound, NW side, MP 246, 9.5 miles NE of Conifer, and 6 miles SW of Morrison; Indian Hills area/Parmalee Gulch Road intersection US Hwy 285  REGION 1 <a href="#">us2852460</a>

Gneiss, generally foliated/layered, migmatite; a NW-SE trending fault across middle of cut is part of parallel faults in area	Height: 100 ft Length: 1,150 ft 69 to 72 degree southeast facing slope	Westbound 23 seconds; Eastbound 29 seconds; static view from Parmalee Gulch Rd intersect, overpass, on ramp, decel and accel lanes; houses on north end Brookmont Rd S of cut	Cushion blasting and machine scaling were used to follow existing major joint patterns in the formation. Where the cut crosses zones of more closely spaced joints, scaling and draped mesh were used to reduce the rockfall hazard.	Light colored draped rockfall mesh blends well with the natural rock.
<b>US Highway 287</b>						
US Highway 287, northbound, northeast side, MP 363.4, 17.5 miles north-northwest of Ft. Collins  REGION 4 <a href="#">us2873634</a>

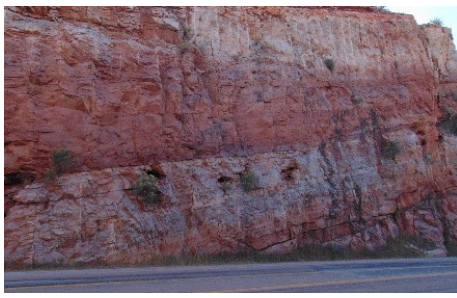
Location	Example (ctrl click link or photo for more)	Geology	Slope Dimensions	Visibility	Construction Methods	Comments
<b>US Highway 287</b>						
US Highway 287, southbound, southwest side, MP 363.4, 17.5 miles north-northwest of Ft. Collins  REGION 4 <a href="#">us2873634sw</a>

Sedimentary rock-layers sandstone, shale, limestone; areas of shale undercut sandstone ledges; dissolution cavities with vegetation, apparent water seepage; dip of rock layers 17 degrees to the east-southeast direction	Height: 40 to 50 ft Length: 940 ft 77 degree north-northeast facing slope	Southbound 22 seconds; Northbound 18 seconds; possible static view from residence to the northwest near intersection of W Co Rd 72 and US 287	Presplit drilling and blasting were used to excavate even and near vertical faces through interlayered sandstones and shales.	Nearby natural slopes are near vertical cliffs. Half casts from presplit drilling are visible in the more massive sandstone layers. Differential weathering in the softer sandstone and shale layers has eroded the half casts

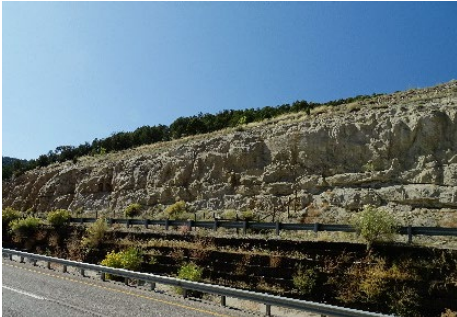
<b>US Highway 550</b>						
US Highway 550, southbound, west side, MP 2.3, 15 miles south of Durango  REGION 5 <a href="#">us55023</a>

Sedimentary rock-layered sandstone and shale; weaker shale undercuts massive sandstone; dip of rock layers estimated as nearly horizontal	Height: 60 to 70 ft Length: 1,380 ft 60 to 90 degree east-southeast to southeast, cut on curve	Southbound 20 seconds; Northbound 61 seconds; possible static view from two-track road intersects SH 550 at rock cut; residence to SE has view of cut; possible fishing activity Animas River adjacent to highway	Cushion blasting and machine scaling were used to avoid half casts common with presplit methods. The underlying shale is highly erodible and was buried after excavation to prevent erosion and undercutting of the overlying sandstone.	The excavated face matches well with the surrounding natural cliffs. The fill placed to cover the erodible shale provided a medium for revegetation and reduced the rockfall hazard without the use of reinforcement or draped materials.

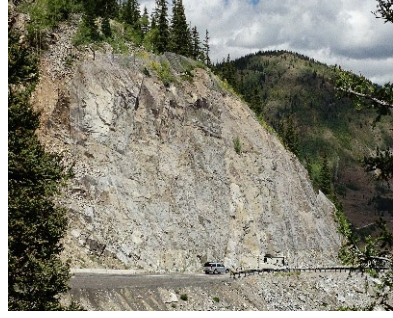
US Highway 550, southbound, west side, MP 68.5, 2 miles south of Silverton  REGION 5 <a href="#">us550685</a>

Granodiorite with feldspar phenocrysts	Height: 80 to 90 ft Length: 350 ft, 45 to 70 degrees east-southeast facing slope	Southbound 13 seconds; Northbound 29 seconds; No static view identified.	Cushion drilling and blasting along with machine scaling were used to avoid half casts. Where possible, the excavation follows natural fractures in the rock. Rock bolts were used to stabilize large blocks and light-colored draped mesh was installed as rockfall mitigation. Excavation of the pioneer road to access the top of the cut created an unstable slope at the south end of the project.	Rock reinforcement and draped mesh have been effective at mitigating the rockfall hazard. The mesh blends well with the excavated rock face.  Additional restrictions in the plans and specifications regarding site access may have prevented creation of unstable slope conditions.

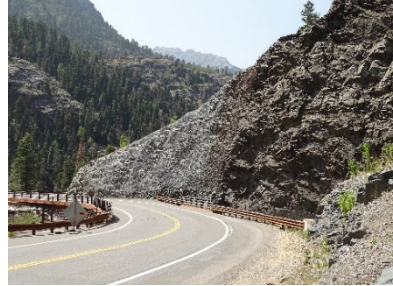
US Highway 550, northbound, east side, MP 90.5, Bear Creek Bridge  REGION 5 <a href="#">us550905</a>

Slate and phyllite, foliated, jointed and fractured.	Height: 60 ft Length: 235 ft 70 to 75 degree south-southeast facing slope	Northbound 17 seconds; Southbound 6 seconds; Static view from scenic pullout and Bear Creek Bridge overlook structure	Presplit drilling angled to final cut slope. Machine and hand scaling to remove majority of half cast traces. Limited catchment ditch required draped mesh for rockfall mitigation.	Excavated face closely resembles adjacent natural cliffs. Light colored rockfall mesh is visible. Construction picture shows temporary brown mesh is less visible.
US Highway 550, northbound, northeast side, MP 106.3, 2.6 miles north of Ridgway  REGION 5 <a href="#">us5501063</a>

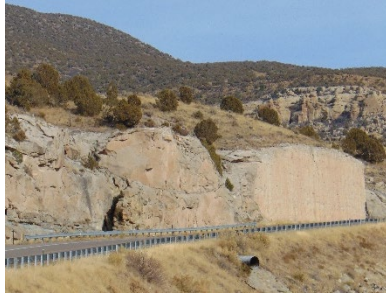
Location	Example (ctrl click link or photo for more)	Geology	Slope Dimensions	Visibility	Construction Methods	Comments
<b>State Highway 65</b>						
State Highway 65, northbound, north side, MP 55.1, 13 miles NE of Palisade  REGION 3 <a href="#">sh65551</a>

Sedimentary rock; massive sandstone with minor mudstone;	Height: 20 to 25 ft Length: 195 ft 85 to 90 degree south facing slope	Northbound 10 seconds; Southbound 31 seconds; pullout on south side and driveways at east end may have static view of cut	Two different blast techniques were used to excavate the rock. The intent of using two different drilling and blasting techniques was to evaluate the appearance and performance of the methods. The right half or upstream portion of the cut was drilled and shot using a traditional presplit and production blast pattern.	The site photos illustrate the different results from two blasting methods.

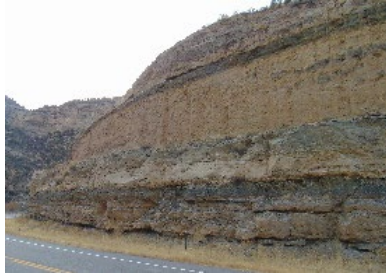
State Highway 65, northbound, north side, MP 58.2, 10 miles NE of Palisade  REGION 3 <a href="#">sh65582</a>

Sedimentary rock; Interbedded sandstone and shale, some carboniferous; dipping approximately 10 degrees toward north; river gravel on top of cut	Height: 50 to 60 ft Length: 640 ft 80 to 90 degree SE facing slope	Northbound 36 seconds; Southbound 14 seconds; driveway at west end may have static view of cut	This cut is excavated through several different materials and rock types. The top of the cut is capped with a cemented alluvial deposit composed of rounded cobble sized rocks over layers of interbedded sandstone and shale. A presplit line is still visible in the more resistive sandstone layers.	Use of terraced excavation along the soft shale layers allows revegetation on the slope.
<b>State Highway 82</b>						
State Highway 82, eastbound, west side, MP 29, 10 miles NW of Aspen  REGION 3 <a href="#">sh82290</a>

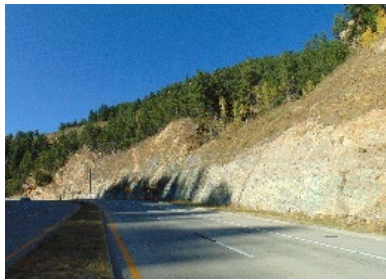
State Highway 119, northbound, east side, MP 6.2 to 6.4, 0.25 miles southeast of Black Hawk  REGION 1 <a href="#">sh11962</a>

Metamorphic rock; gneiss with biotite and pegmatite, strongly foliated	Height: 60 to 80 ft Length: 1,020 ft 73 degree SW facing slope	Northbound 34 seconds; Southbound 24 seconds; static view from trail/path SW of cut	The majority of the rock cut was blasted using a presplit and production drill pattern due to the poor quality of the rock and prevalent adverse rock structure. The slope brow was rounded using an excavator to limit erosion in less resistive rock and soils. The ditch width varied along the rock cut to accommodate the hydraulic requirements and to break-up the appearance of the newly excavated rock face. Brown colored draped wire mesh was applied to the final face.	The half-casts are less visible in areas of bedrock foliation. Unpainted (green) rock anchors and mesh anchors are visible. The brown-colored mesh blends well with the rock face. Due to variability of the soil cover, the brow line undulates across the site.

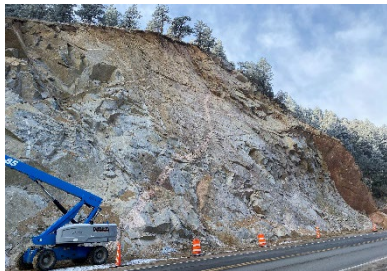
State Highway 119, northbound, south side, MP 39.3, 1.7 miles west of west Boulder  REGION 4 <a href="#">sh1193931</a>

Granodiorite, granitic rocks weakly to strongly foliated	Height: 140 ft Length: 220 ft 45 degree north-northeast facing slope	Eastbound 13 seconds; Westbound 14 seconds; Static view from recreational trail users along Boulder Creek NE of SH 119	Blasting and ripping were used so that the excavation follows existing rock structure.	Rock bolts were used to stabilize large blocks in areas of adverse jointing.
<b>State Highway 133</b>						
State Highway 133, westbound, north side, MP 24.1 to 24.4, north of Paonia dam at Paonia Reservoir, 16 miles NE of Paonia; 33 aerial miles SW of Aspen  REGION 3 <a href="#">sh133241</a>

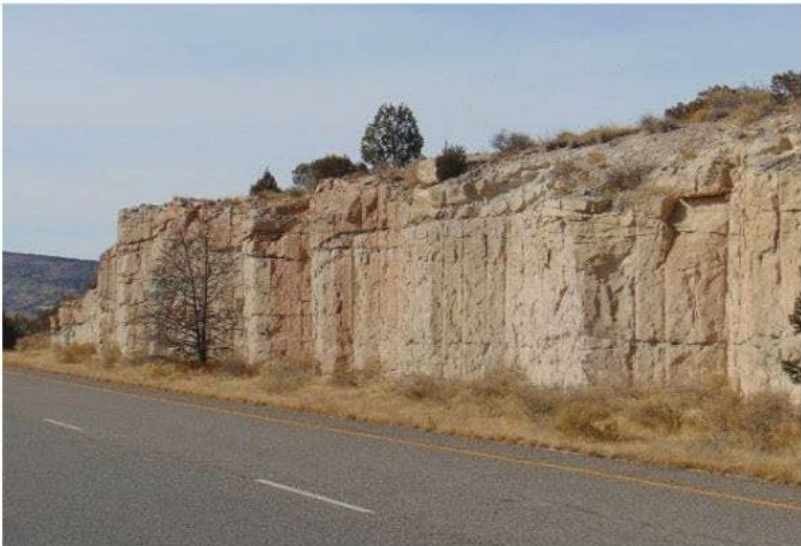
**Varied ditch widths**

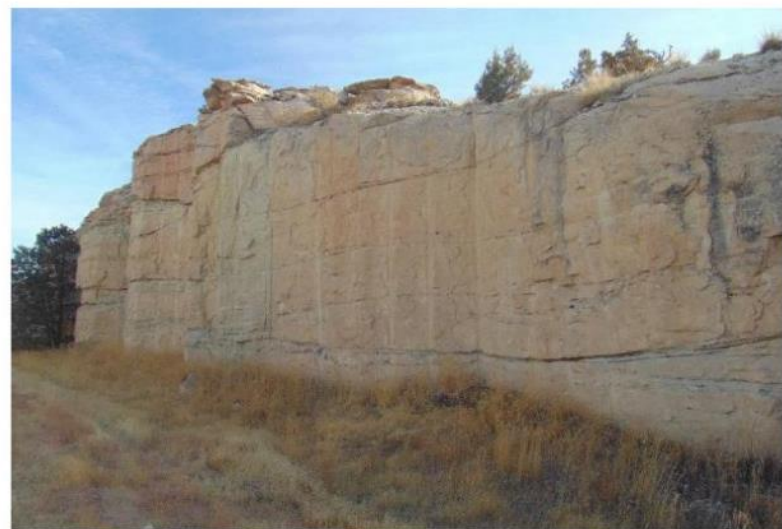
**Varied ditch widths**

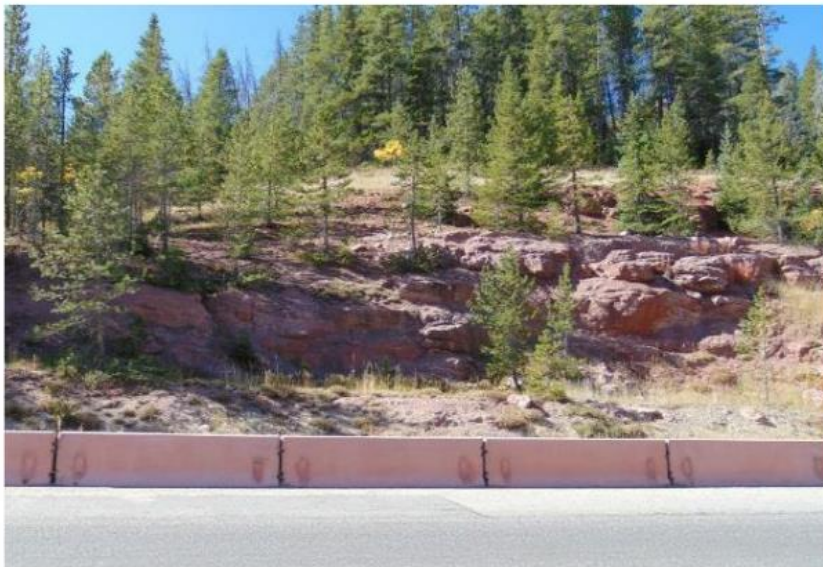
**Bedding plane cuts with planting pockets**

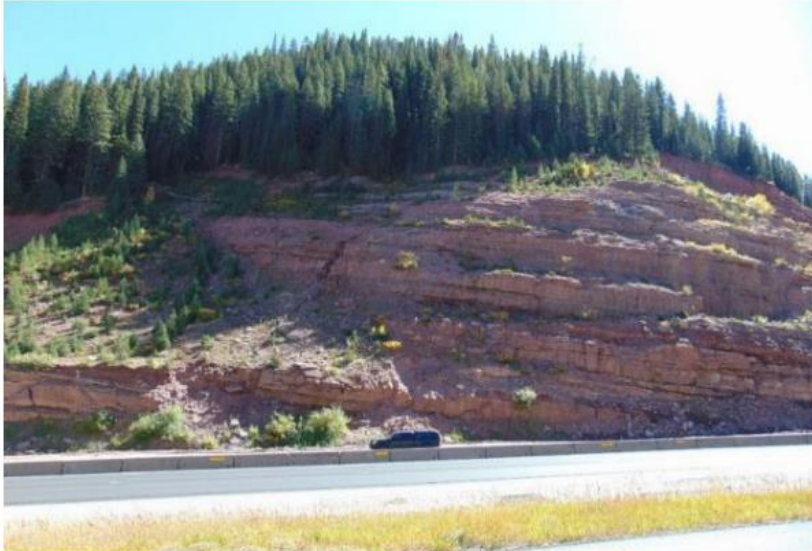
**Terraced, bench slopes with revegetation**

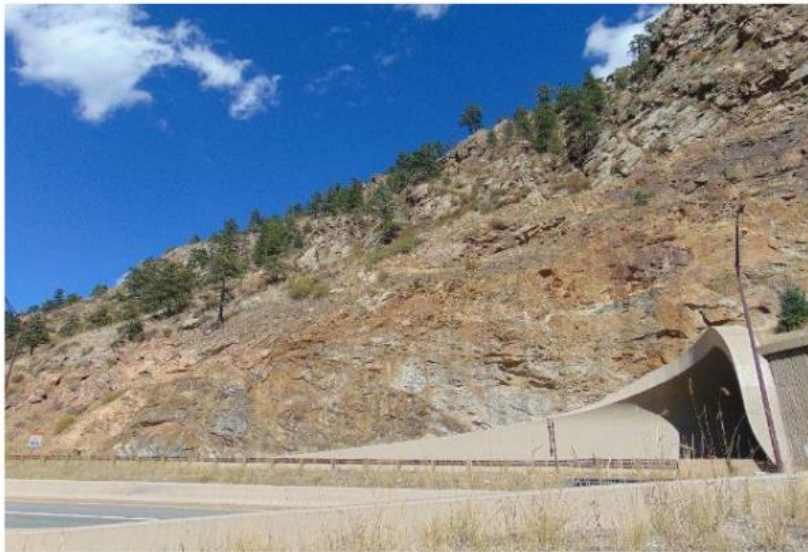
View to north, joints, foliation layers

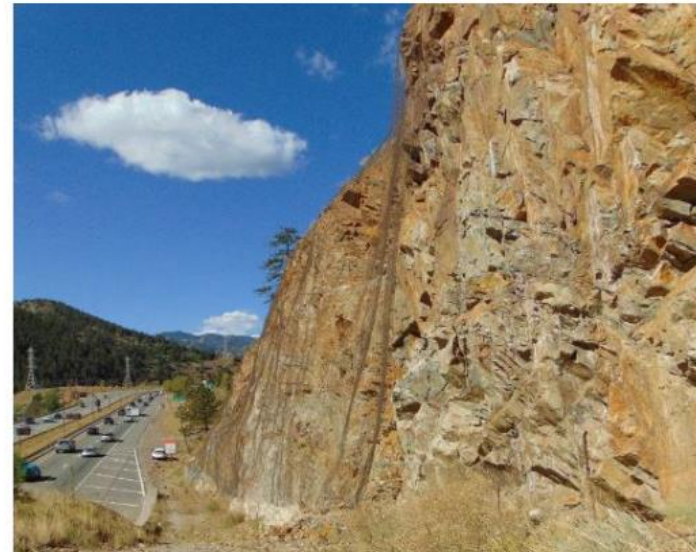
View to west, draped mesh

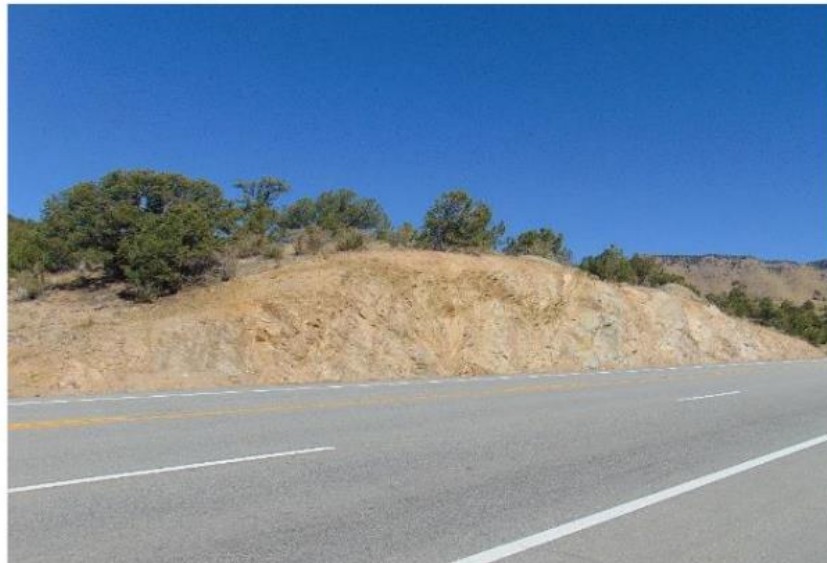
View to north-northeast

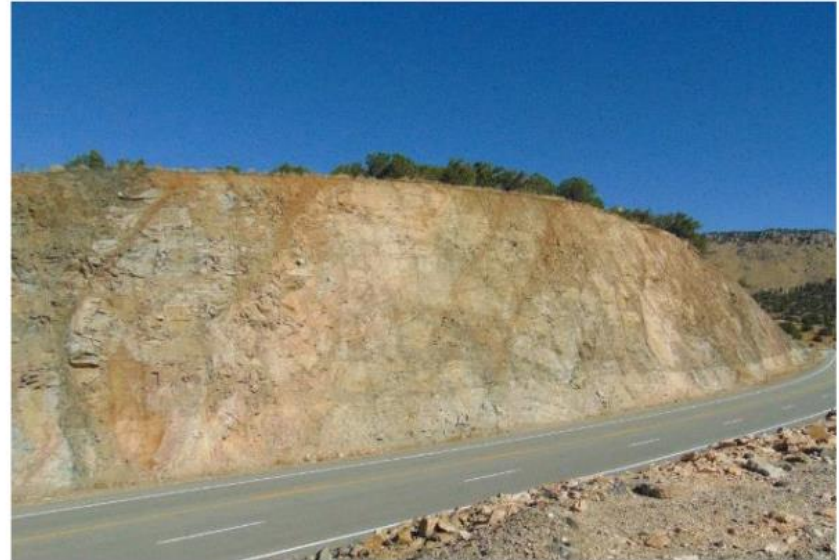
View to north, draped mesh, foliation angle

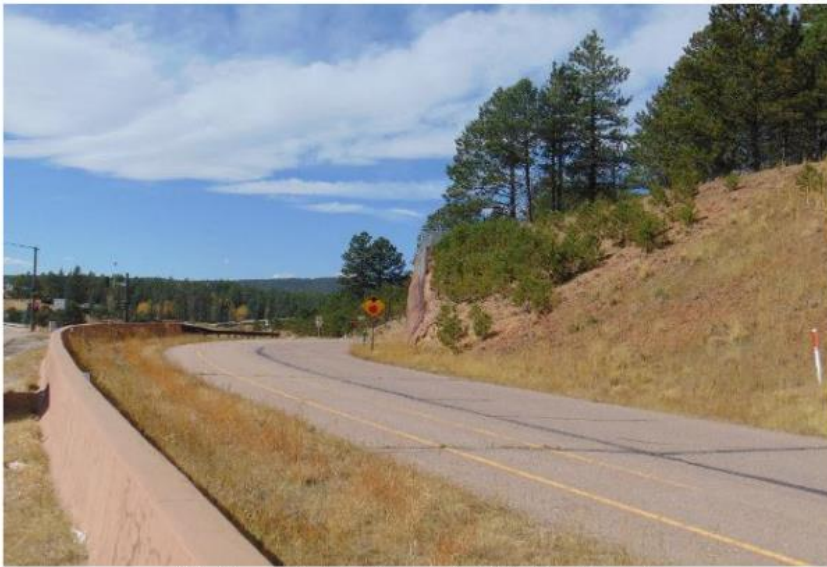
Westbound viewshed, cut right of yellow sign

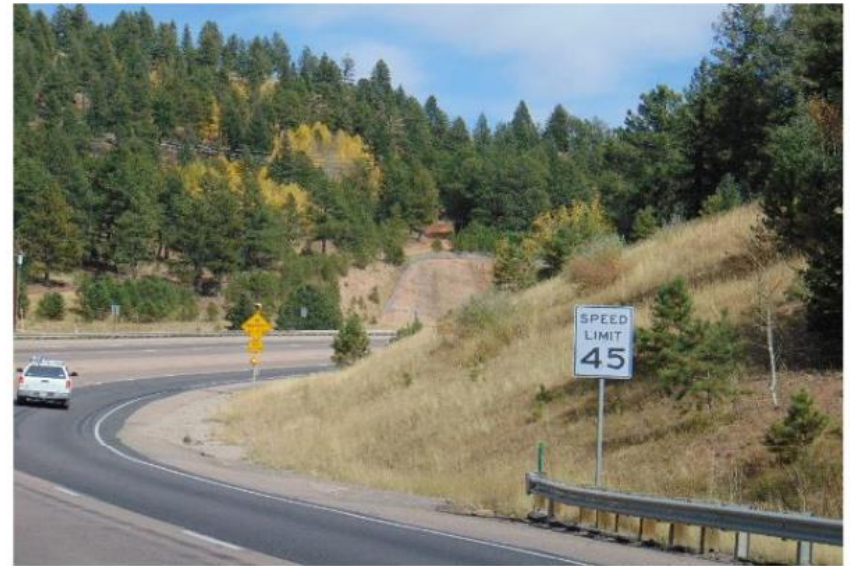
Eastbound viewshed, cut in center, right of yellow sign

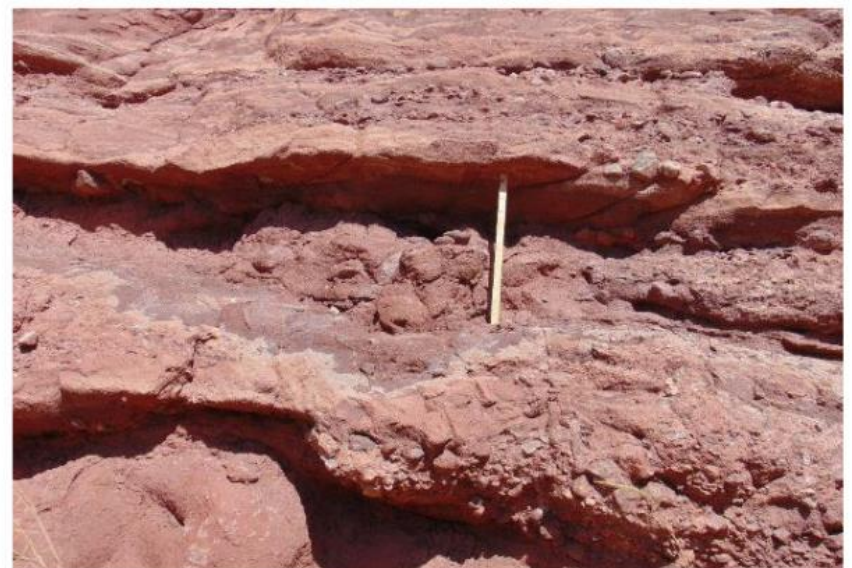
View to north, conglomerate layers with boulder size clasts

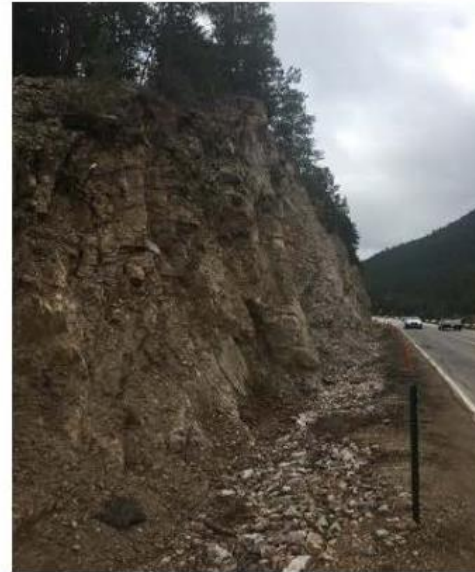
Cobbles in ditch, view to southeast

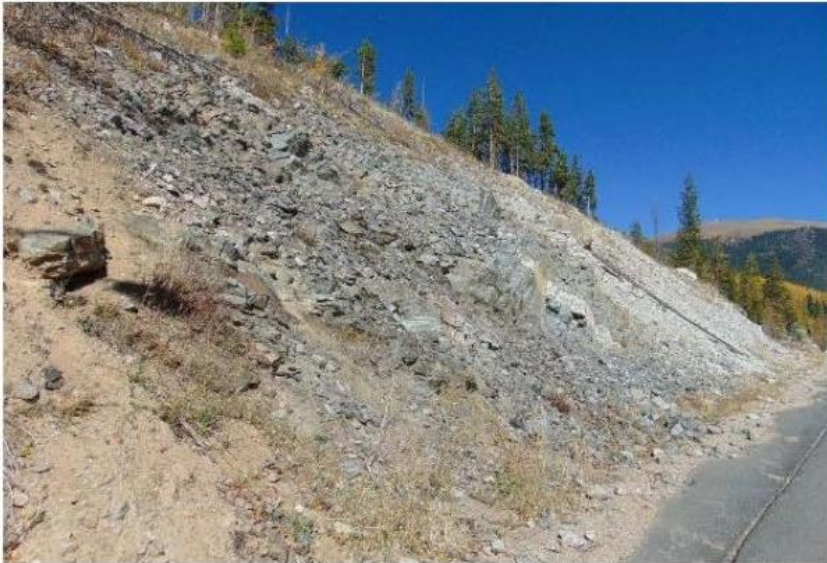
Angular rock debris (scree) on slope and at shoulder, looking east

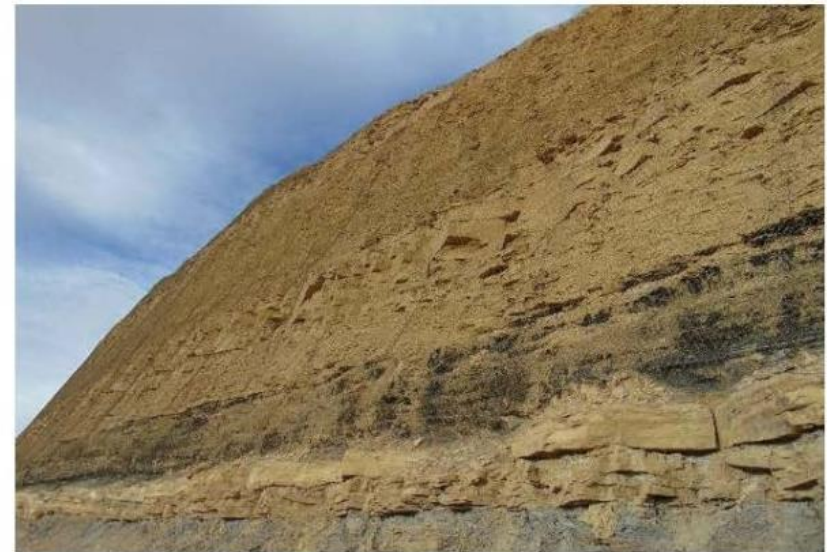
Draped mesh and soft carboniferous (coal) layer

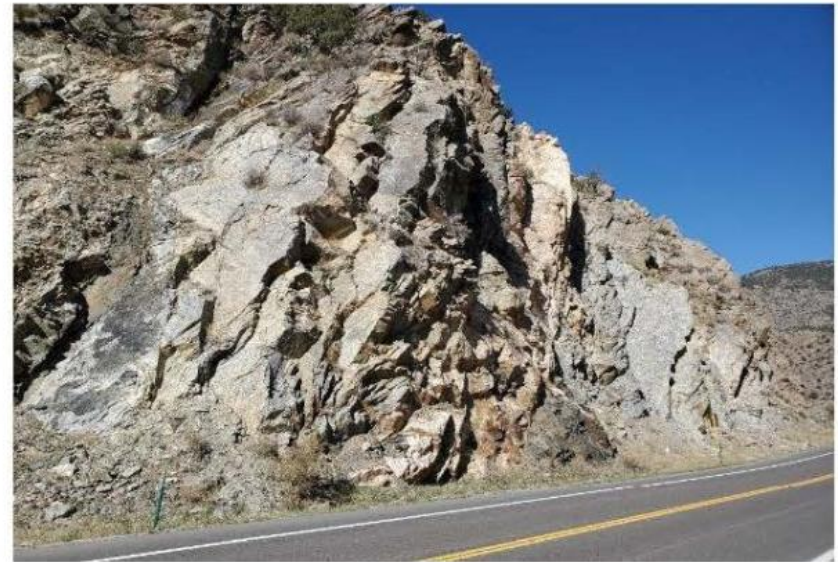
Westbound view, looking west, rocks piling at bottom of cut

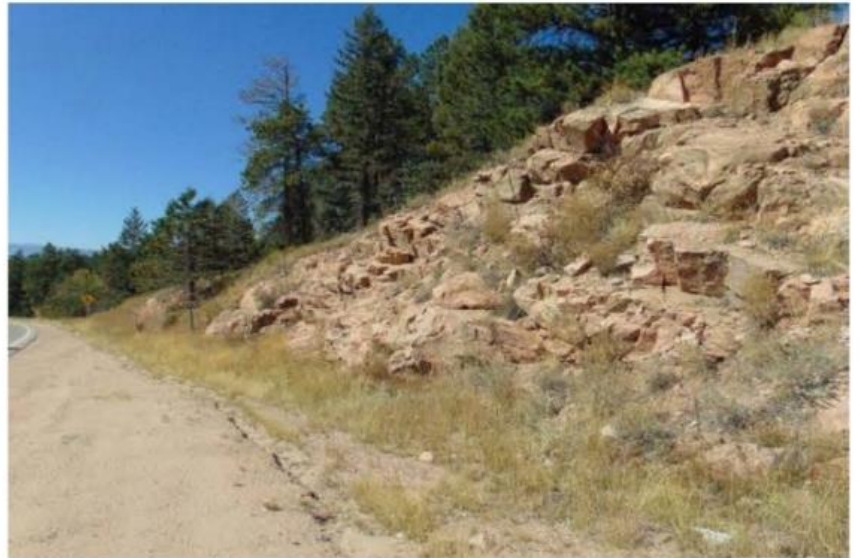
Foliation plane tilted toward roadway

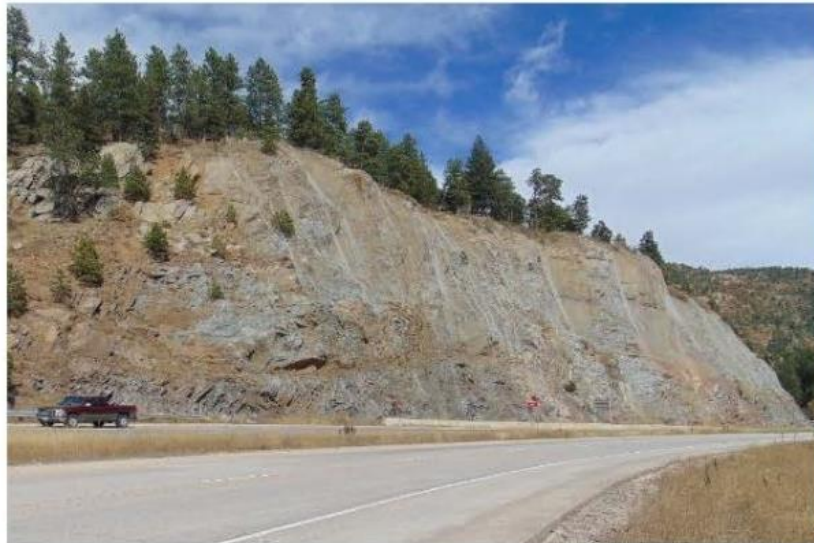
Draped mesh

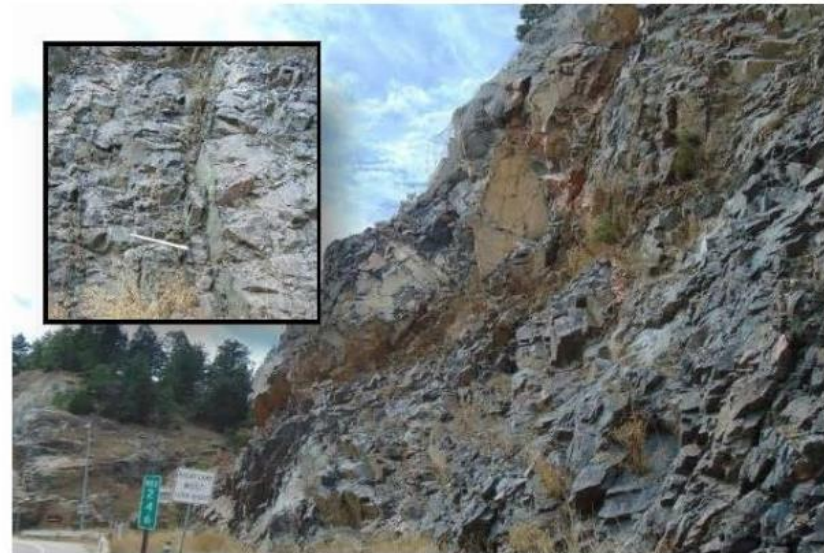
Blocky fracturing

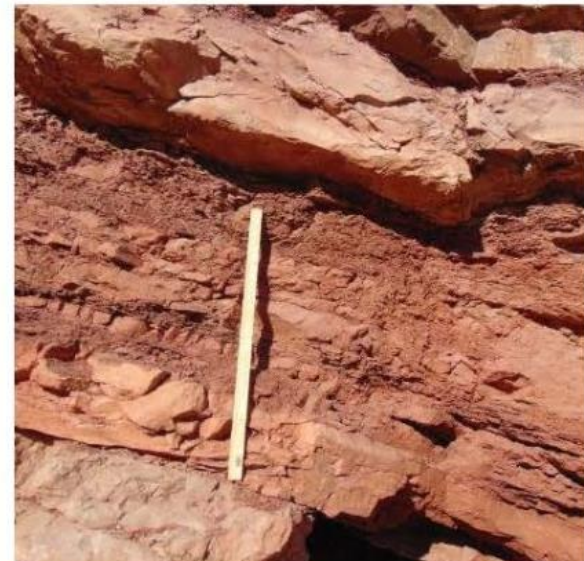
Sandstone undermined by softer shale

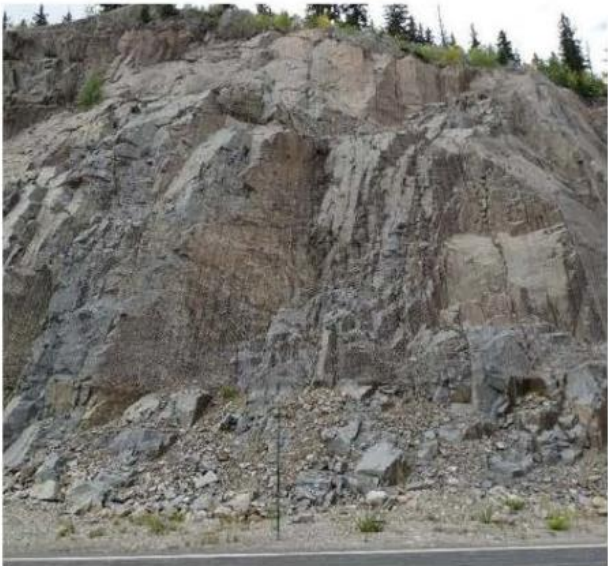
9/16/2019	Foliation and joints		DSC00031	Foliation and joints, fractures				
	9/16/2019	Draped mesh and bolts		DSC00030	Draped mesh and bolts looking north

Foliation and joints
