# Rock Cut Blasting Aesthetics Best Management Practices Phase II

## Technical Report Documentation Page

1. Report No. CDOT-2021-02	2. Government Accession No.	3. Recipient's Catalog No.	
4. Title and Subtitle ROCK CUT BLASTING AESTHETICS BEST MANAGEMENT PRACTICES PHASE II		5. Report Date June 2021

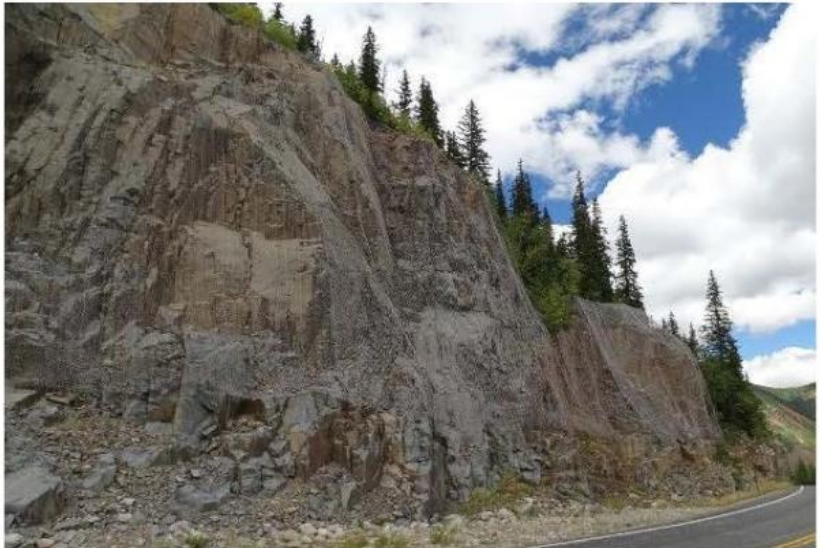
Draped mesh and bolts

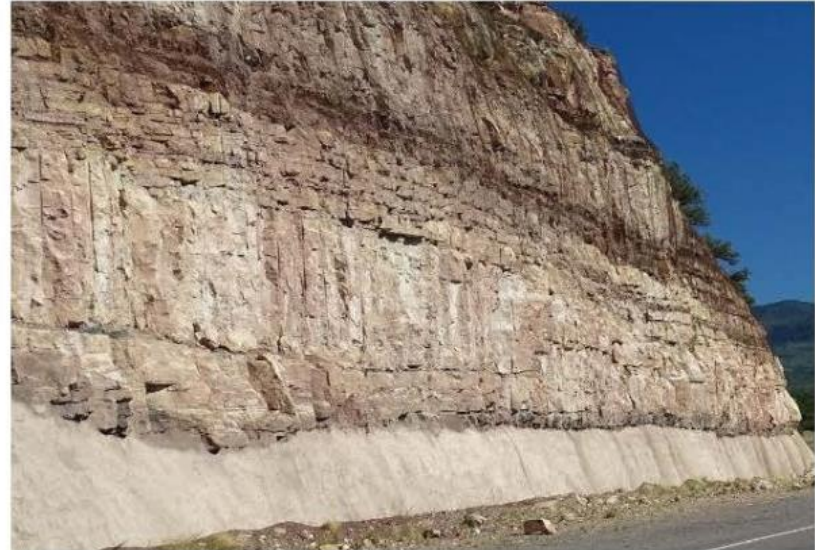
Rocks in ditch

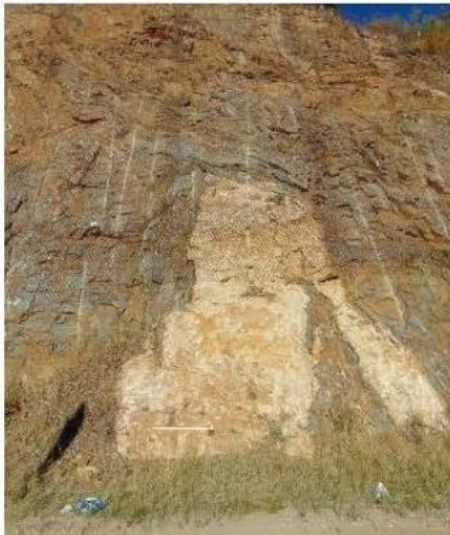
Draped mesh over half cast blast features

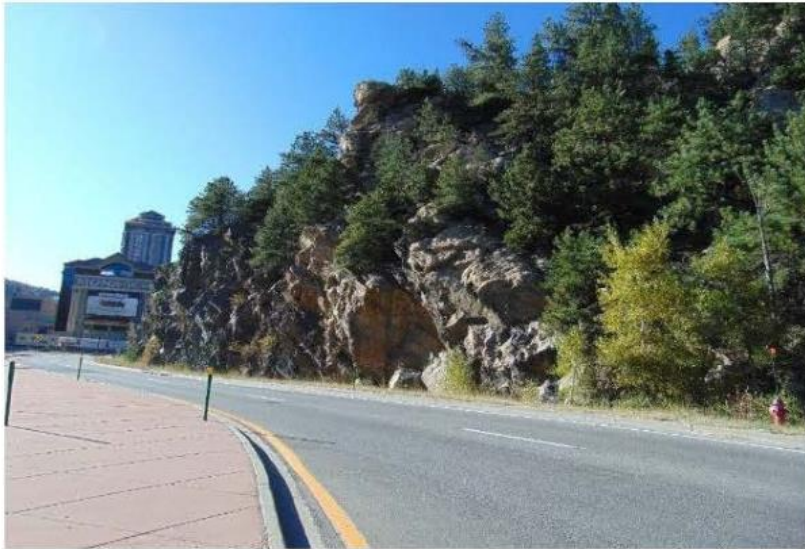
View to west

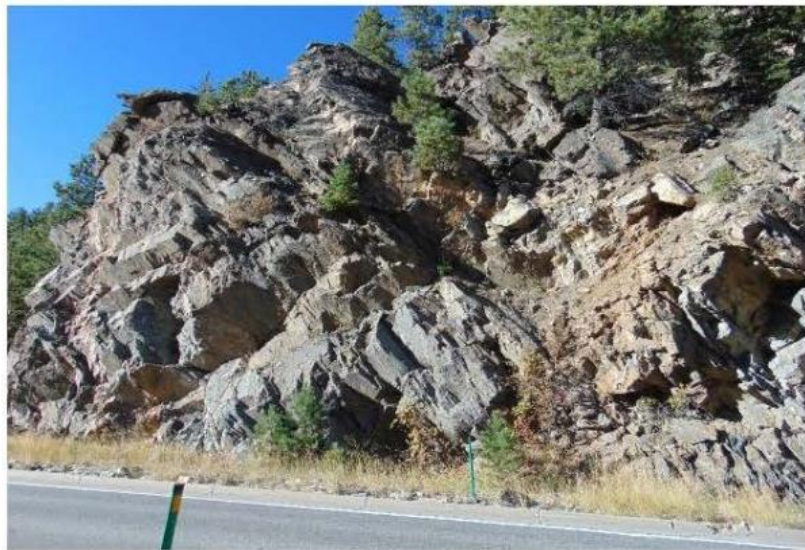
Tilt of foliation planes

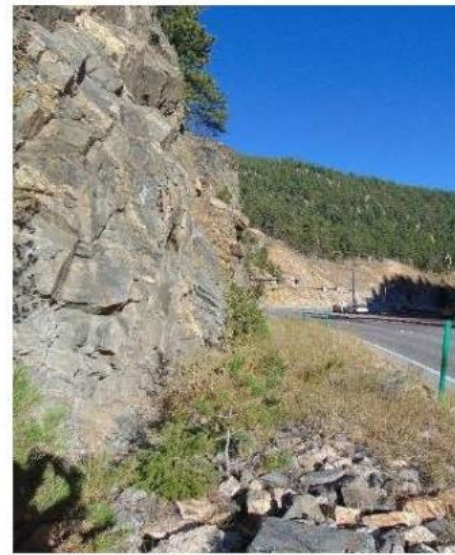
Rocks mantling ditch

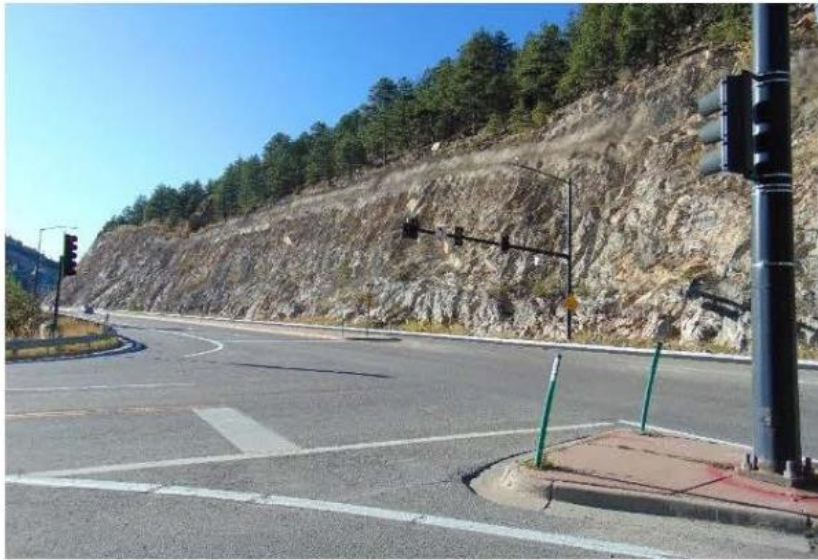
Northbound view

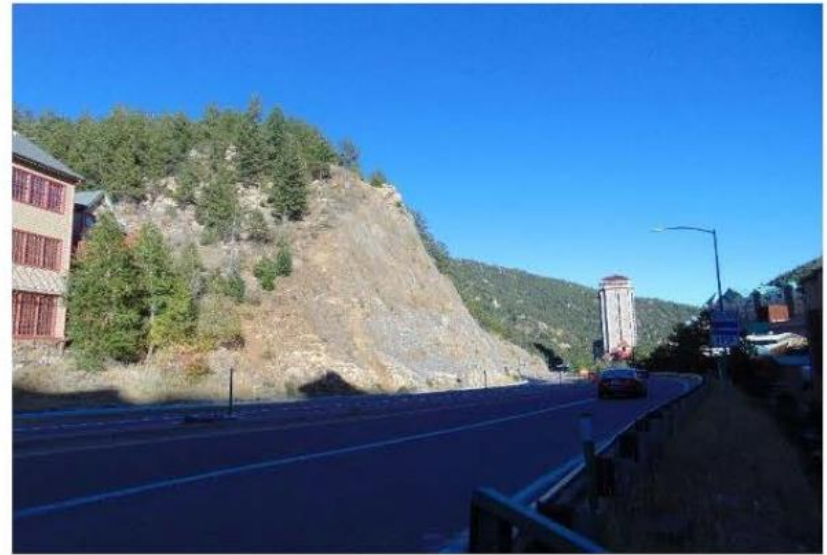
Southbound view

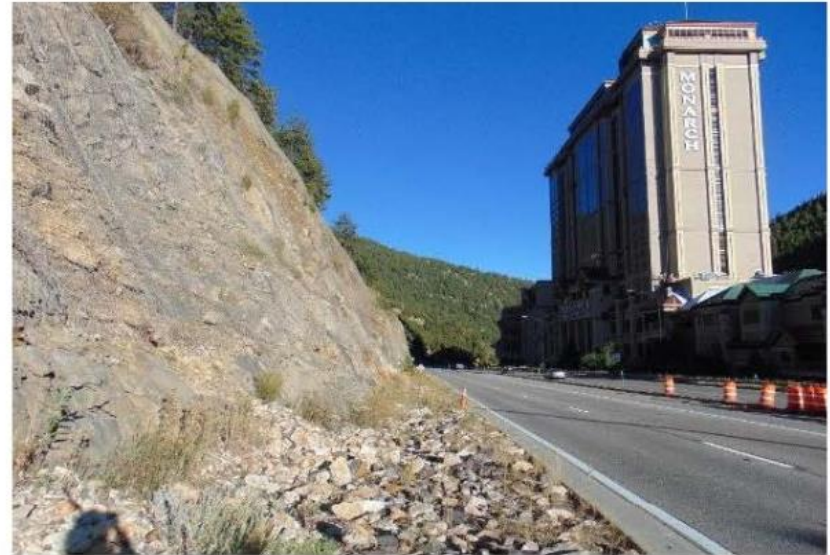
Rocks in ditch

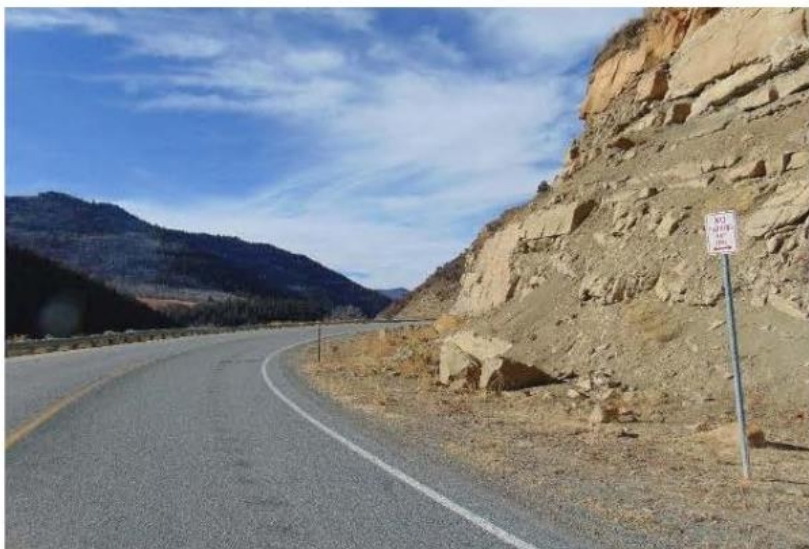
Westbound viewshed, cut in center distance

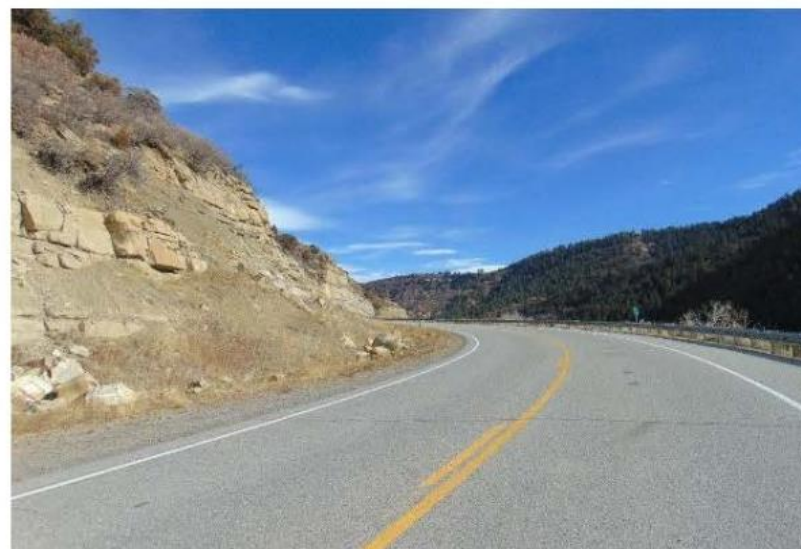
Eastbound viewshed, cut in center distance
