STATE HIGHWAY 9 AND U.S. HIGHWAY 6 IMPROVEMENT PROJECT  
AT THE  
INTERSTATE 70 SILVERTHORNE/DILLON INTERCHANGE

LAUNCH PHASE TECHNICAL SUMMARY

February 2011

Colorado Department of Transportation  
Region 1

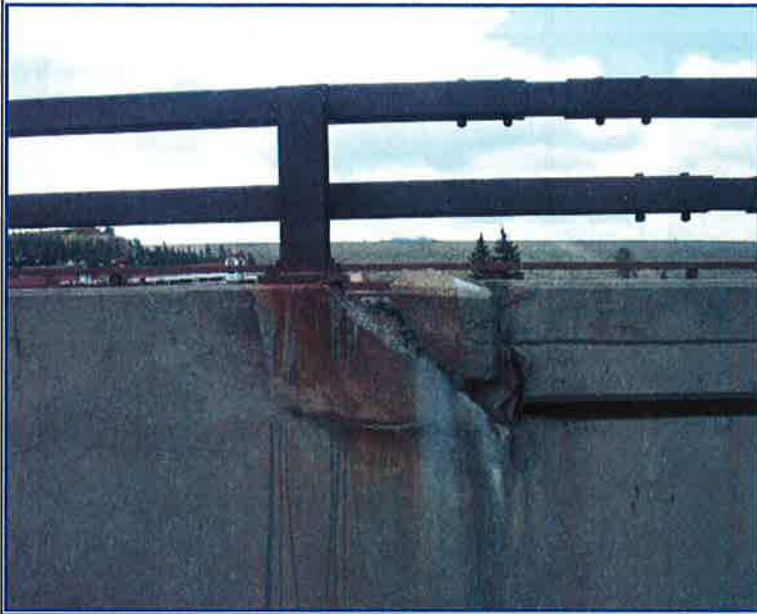
F-12-R Curb broken at left corner of Abut. 5..JPG taken: 2003/06/308:43

Repair damaged concrete curbs.

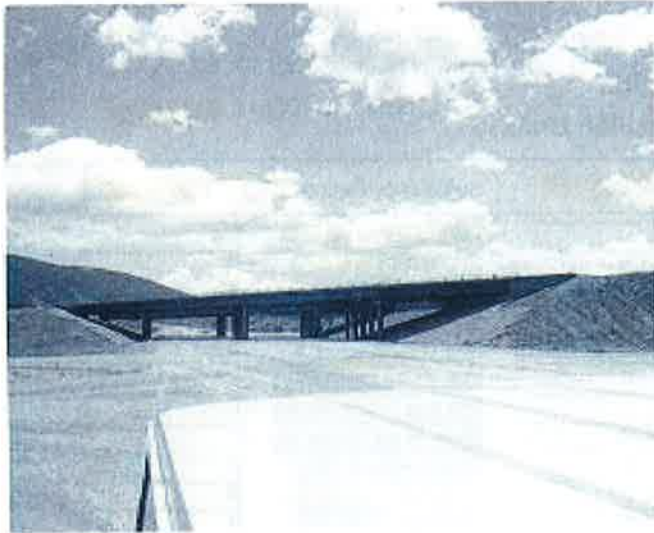
F-12-R Sand & concrete built up on abut. seats (Abut. 1 shown)..JPG taken: 2003/06/308:47

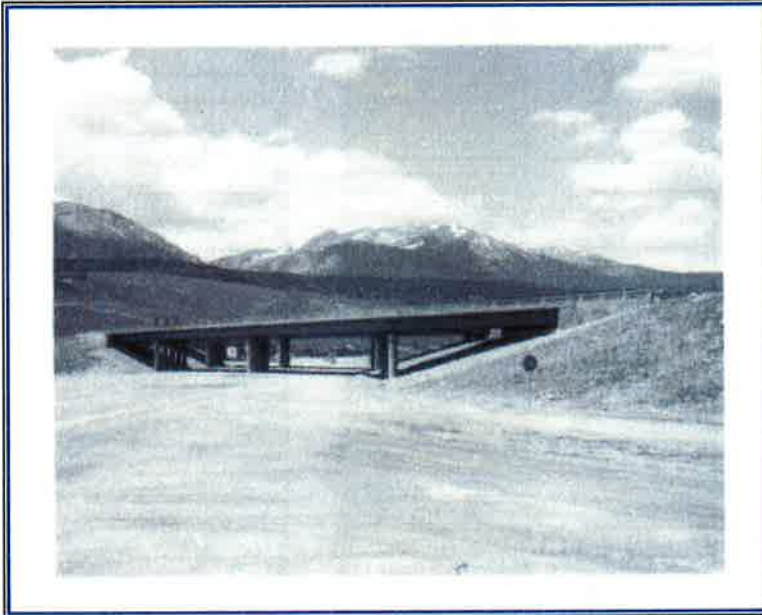
F-12-S Curb broken at Abut. 5, right corner..JPG taken: 2003/06/308:48

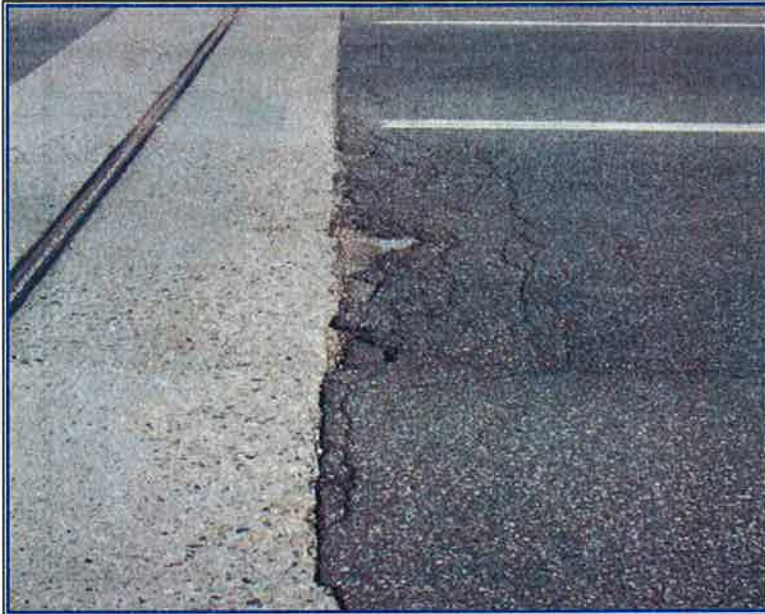
F12X 072307 A5 approach with potholes forming along the strip seal.jpg taken: 2007/07/2611:30

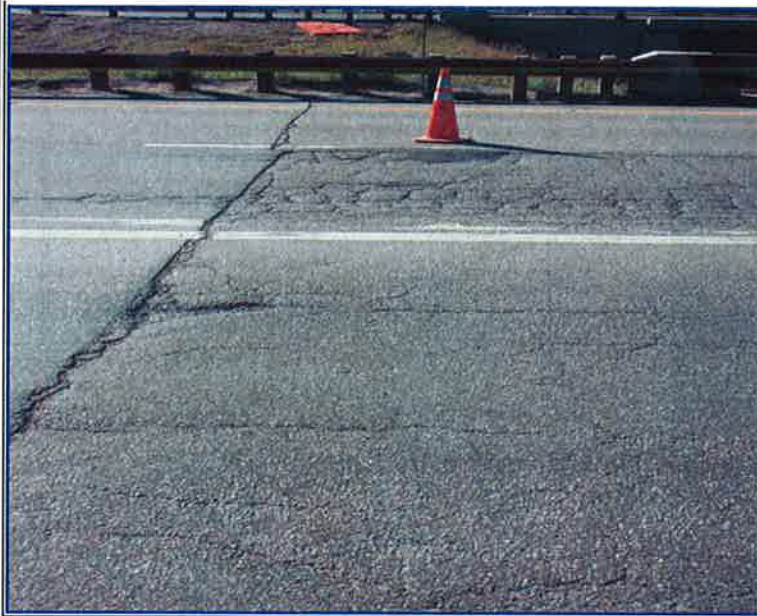
F12X 072307 A5 Approach has some settlement, Heavy alligator cracking with potholes forming.jpg taken: 2007/07/2611:28

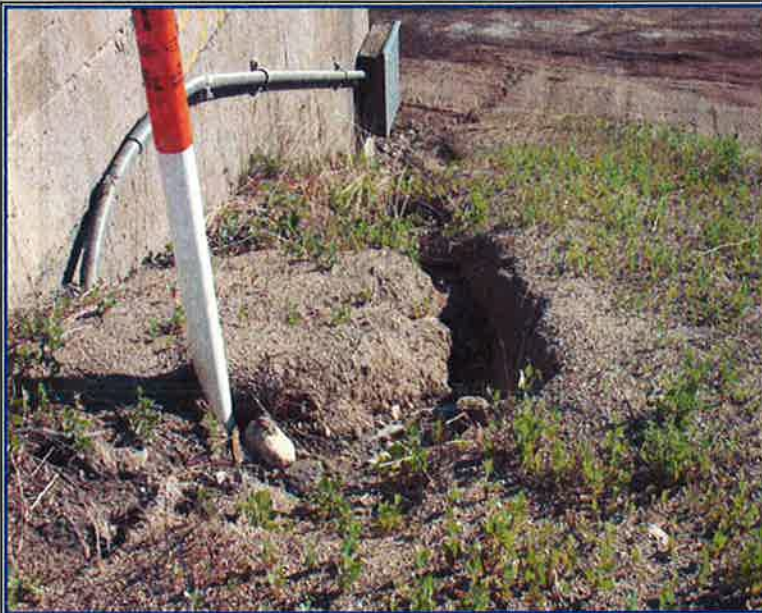
F12X 072307 A1 left side erosion trough..JPG taken: 2007/07/23 7:58

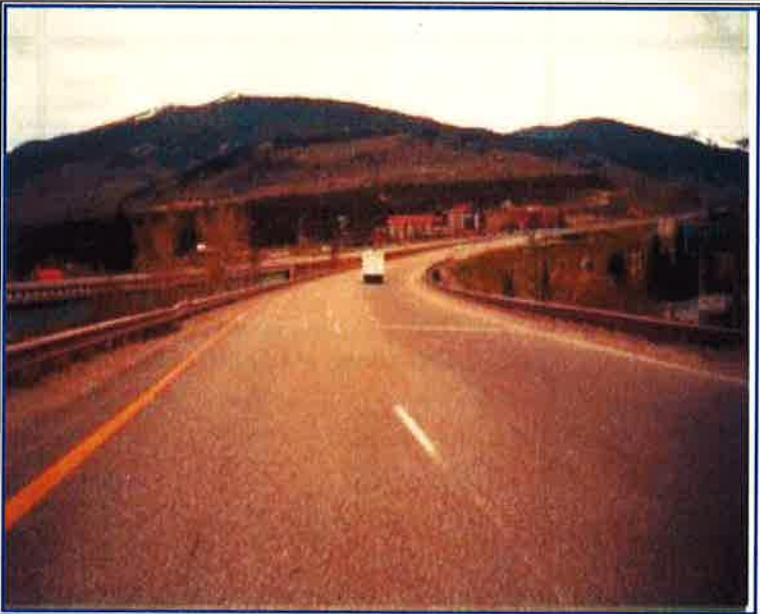
F12Y Raveled or rutted asphalt exposing previous layer and had to be patched, a little rough now, note unsealed moderate crack taken: 2005/09/21 9:36

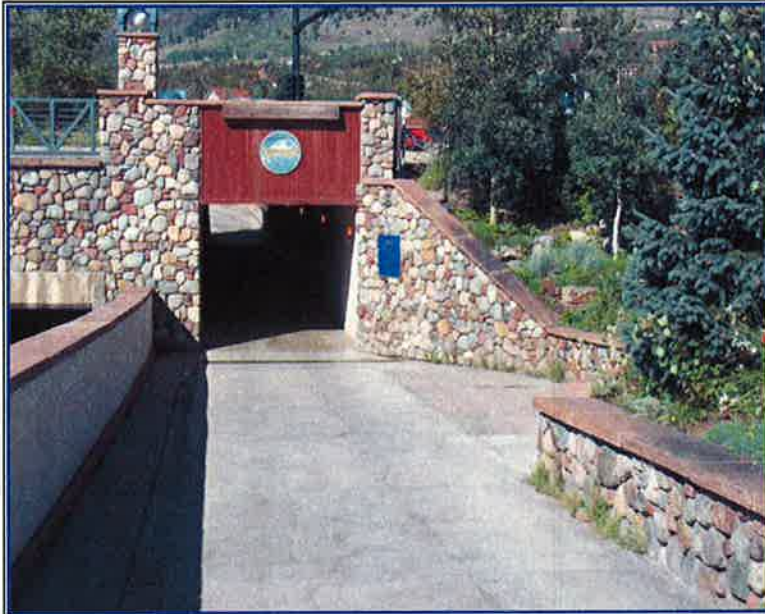
F12BP Cell 1 for pedestrians is higher and more widely spaced from the other cells.jpg taken: 2007/09/11 3:15

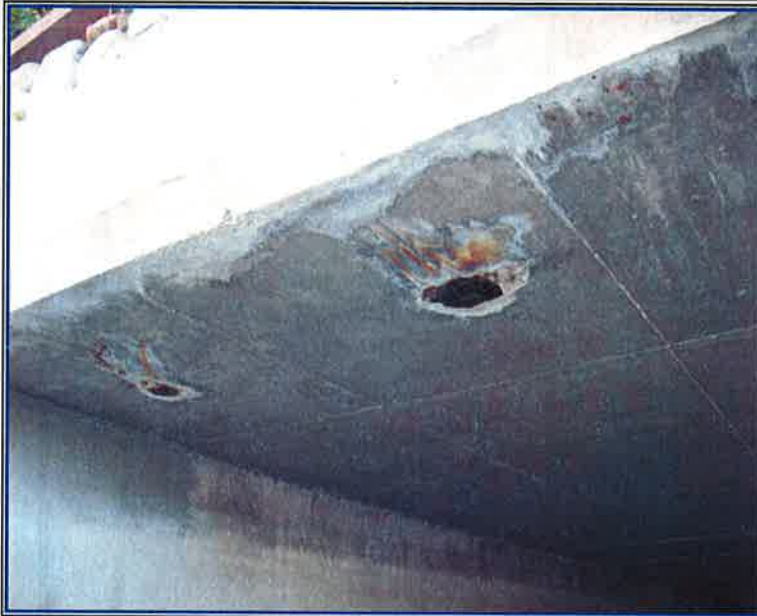
F12BP Active drainage or seepage from drain holes cut through the right end of the top slabs.jpg taken: 2007/09/11 3:45
